## "Looks Can Be Deceiving" The Story of an Ugly House

Harvy P. Jones

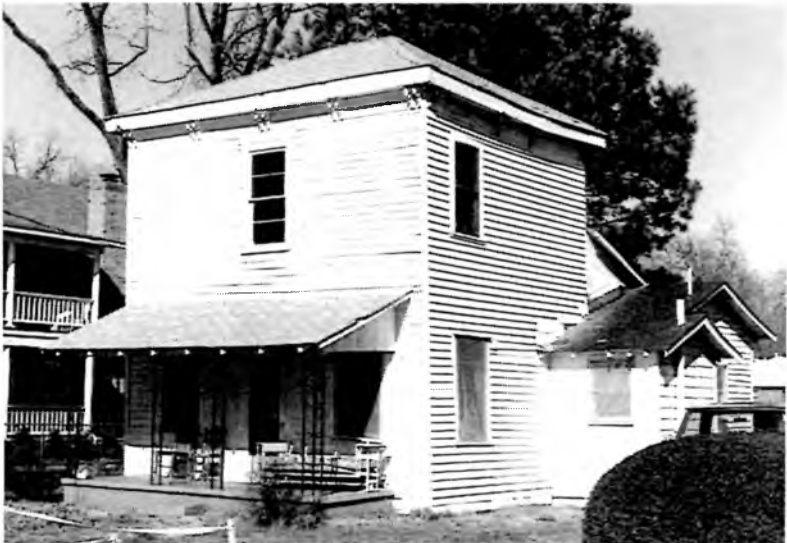
*February, 1991 photograph before restoration. Chimney is gone, original tall sashes replaced by short “ranch house” sashes, original veranda replaced by a makeshift shed, site filled-in about 12 to 18 inches deep, giving the house a stumpy proportion. Roof cornice-mould gone.*

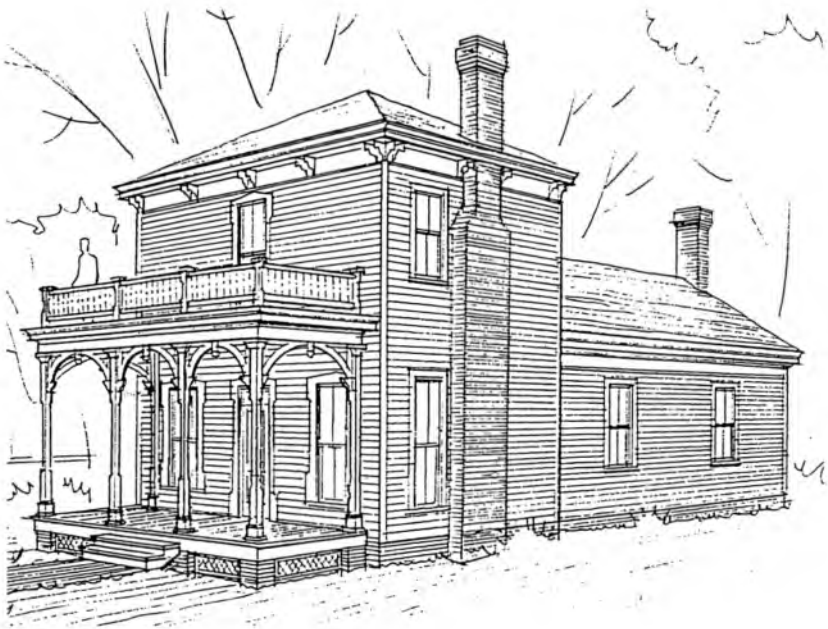
*Restored view sketch of May 15, 1993 traced over the photograph of the unrestored house to illustrate its potential restored appearance.*

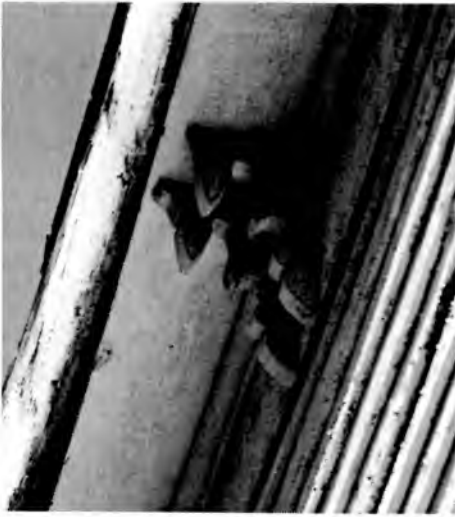
*LEFT: 1993 photograph of the unrestored roof cornice. The 1881 brackets, frieze, bed-mould and fascia remain, with only the top cornice-mould missing.*

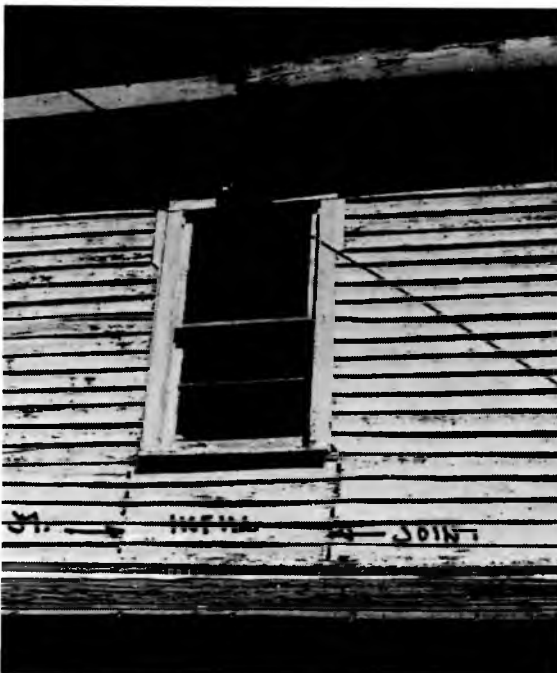
*BELOW: 1993 photograph of the upper front wall showing the mid-20th century short ranch-style window that replaced the tall Italianate windows and the second floor door that let onto the veranda roof-balcony. The joints in the infill clapboards below this modern window reveal the height of the tall 1881 opening.*

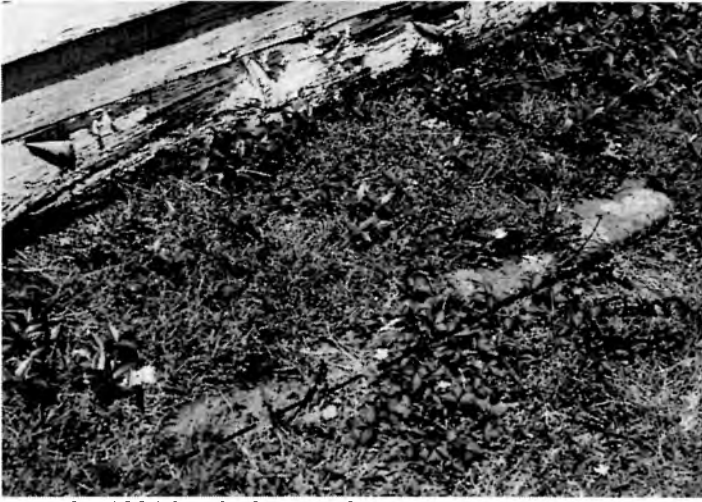
ABOVE: The 1881 brick chimney-base remained at the south side of the house, giving the size of the chimney. Joints in the roof fascia patch gave the size of the top stack of the chimney.
