Uncovering Pieces of a Puzzle: The Lowe House Dependency

FRANK J. NOLA, JR., AIA

The following article has been adapted by the Quarterly editors from the Lowe House Dependency Preservation Planning Study. The study, prepared by Frank J. Nola, Jr., AIA, was commissioned by the University of Alabama in Huntsville Foundation and was funded by a grant from the Alabama Historical Commission, with matching funds provided by the UAH Foundation. The study sought to illuminate the historical and architectural significance of a rare survivor from Huntsville's antebellum period, and to investigate the feasibility of renovation, restoration and adaptive re-use planning to accommodate the current needs of the University of Alabama in Huntsville.

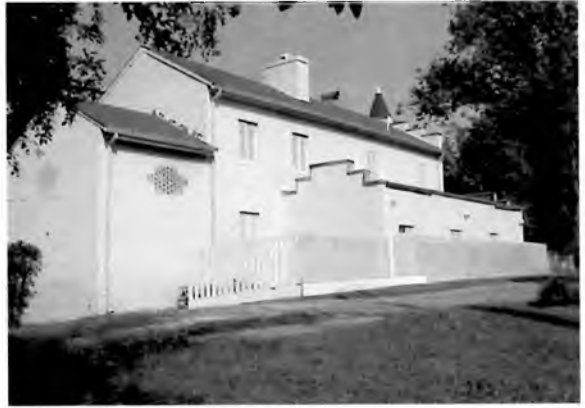
Southwest view showing smokehouse at left. One-story addition with parapet was added about 1950

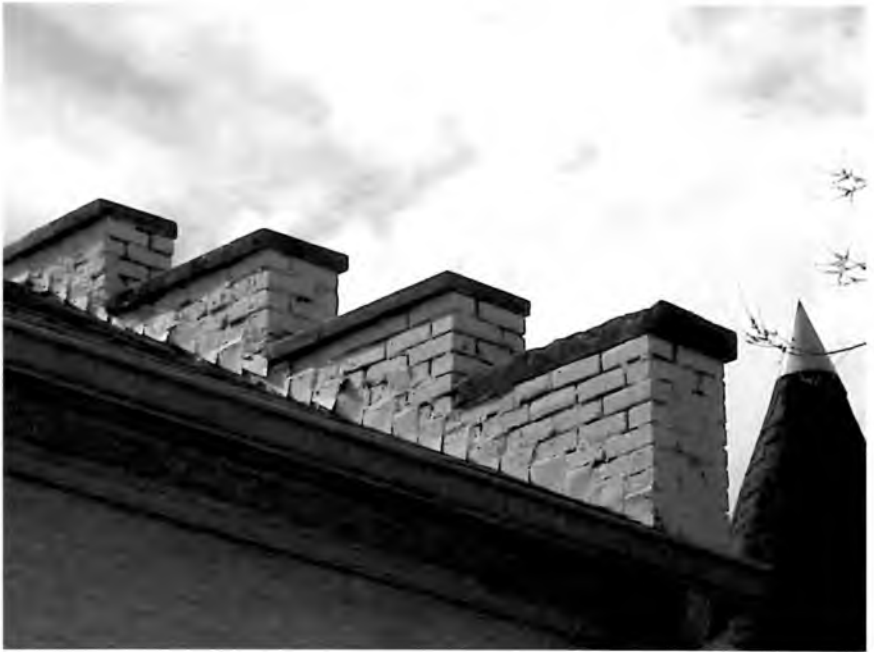
Detail of stepped parapet with sandstone coping. The parapet was probably constructed when the main part of the Federal-style house was removed. The sandstone coping material is possible salvage from the main house.

It seems likely that the unusual stepped parapet on the north wall was constructed following demolition of the main house, around 1900. A change in masonry technique makes for a clear horizontal demarcation in the north wall where the parapet was likely added to create a satisfactory resolution to this wall once the main house was removed. The parapet configuration is similar in appearance and construction to that of a neighboring dependency at the circa 1825 Mastin House at 310 Williams Avenue. The Lowe wing's sandstone coping materials were most likely salvaged

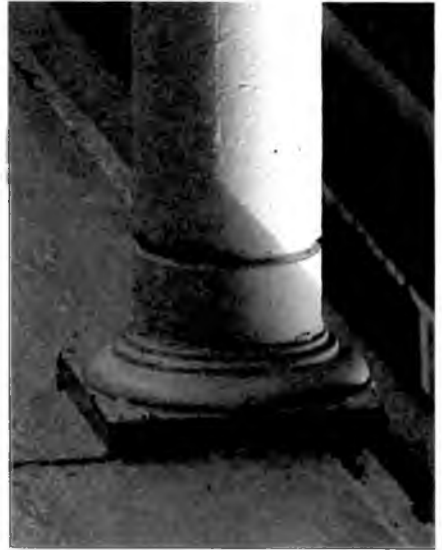
The upper and lower galleries on the west side of the building appear to be original. With no internal doorway between rooms, the galleries serve as the only means of circulation to the rooms of the “L.” The **upper gallery** is supported by seven slender round columns with no bases and primitive capitals suggesting the Doric order. Although highly attenuated, the columns are turned with entasis, and were conceived with an obvious aesthetic intention. Two of the columns are replacements. Between the columns is a unique railing system without surviving precedent in the area. A cambered top rail, with elliptical profile, spans from column to column, and is mortised into the column shaft. Vertical pickets at 5 inches on center are mortised into the bottom of the rail, and into the floor itself,

Detail of upper gallery column, modified Doric style capital with filleted neck

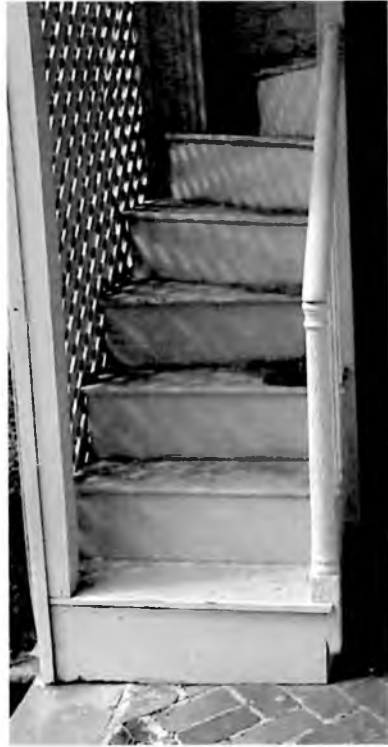
Detail of exterior stair at lower level gallery. Components appear to be re-assembled from previous construction.

The floor of the lower gallery is early 19th-century brick laid in a herringbone pattern. The floor-to-wall joint is articulated with what appears to be a Federal Period baseboard, with a simple beaded profile at the top. The stairs at the north end of the gallery would have been reconstructed when the gallery was shortened. The stairs are constructed of early 19th-century stair components reassembled for their new location.

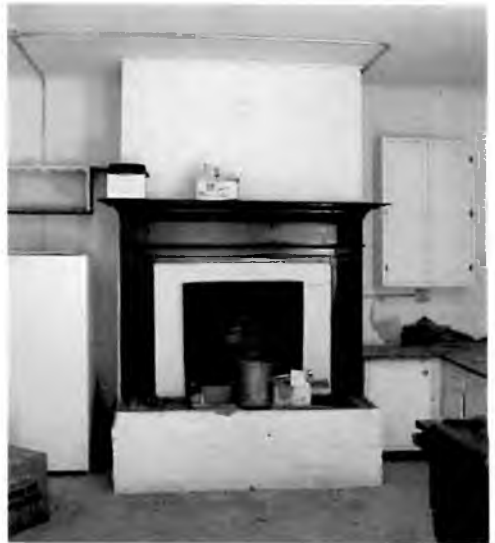
The **lower level north room** was converted into a garage sometime in the mid-20th century. Evidence of a masonry wall removed from the space above confirms that this was originally two rooms. The level of the hearth suggests that the floor level was lowered approximately 30 inches. [see page 30]

The only surviving mantel is in the lower level north room. The floor level of the room was lowered approximately 30 inches when it was converted to a garage.

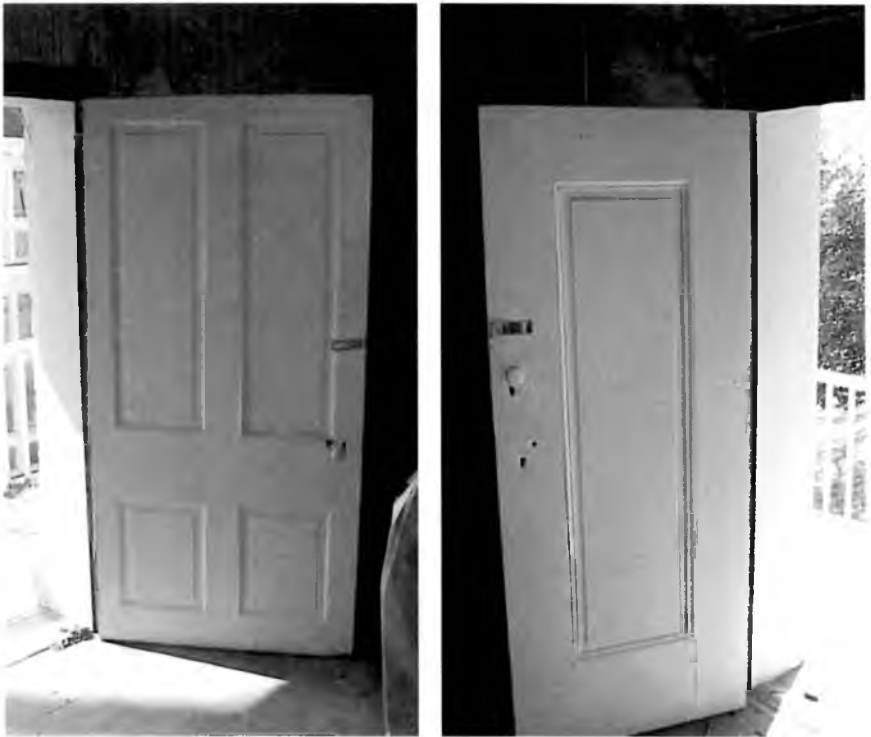
Doors throughout the structure are mixed and matched from different styles and periods. Most have been modified to fit their openings and were probably salvaged from the original house. Not shown here, the plank door of the smokehouse appears to be original.

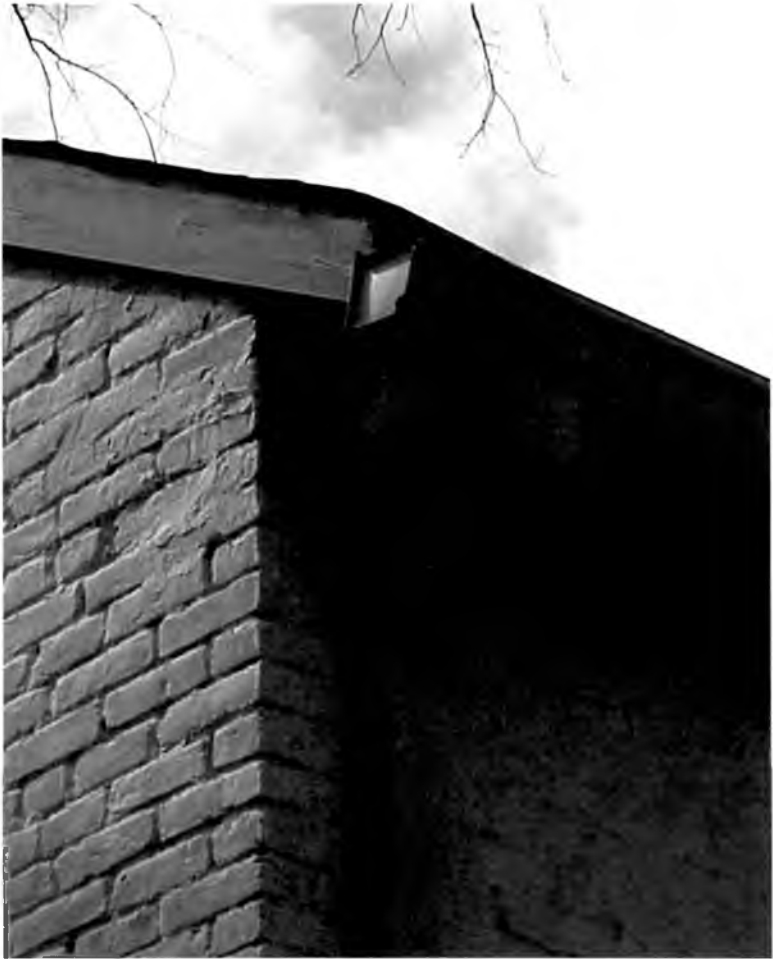
Detail of boxed eave at west side of structure. The ogee gutter and corrugated downspouts are recent additions
