Some Guidelines for Storefront Rehabilitation

Some Guidelines for STOREFRONT REHABILITATION

*A proposed rehabilitation plan
for one block of Washington street,
by April Eberly*

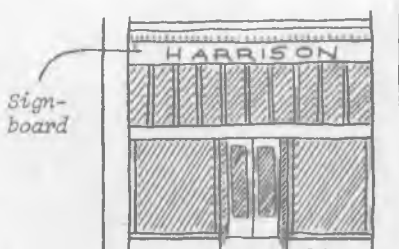
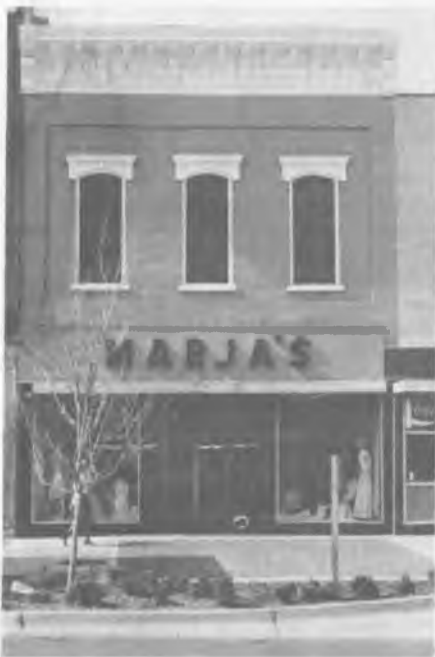
Marja's Dress Shop on North Side Square (c. 1883) immediately struck me as being a prime candidate for a new storefront design. The upper facade was virtually unaltered; the original storefront had been entirely replaced.

Views from old photographs revealed that it once had a quite standard storefront for Huntsville with large display windows, central, recessed door opening, lower window panels, and a series of segmented transoms across the top. The cornice and flanking pilasters would have been a combination of wood and pressed metal. My proposal for Marja's, as shown in the drawing, is basically a recreation of this traditional 19th century storefront design. A retractable canvas awning would complete the front. The large sign would be replaced by a smaller, more pedestrian oriented sign. The upper facade

needs new replacement window sashes, but little else, unless a new painting is desired.

Marja's was my first attempt at a storefront design, and looking back, this solution may be too literal an adaptation of a Victorian storefront. Not truly a restoration, it can almost be termed a reconstruction which is more often than not an extremely expensive and less honest way to design. Perhaps
