Winston-Orgain-Sammons House: The Evolution and Restoration of a Federal House

Aida Reinbolt

401 Lincoln Street

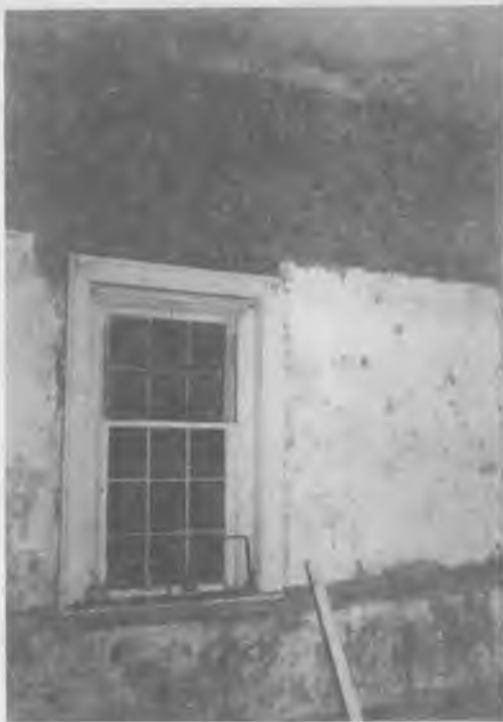
Restoration work upstairs in the north bedroom revealed where the ceiling had been raised to the height of the newer ceiling in the Federal addition - during the process of removing old wallpaper layers, the plaster came off with the wallpaper on the later, higher area of wall, but but remained attached to the original wall.

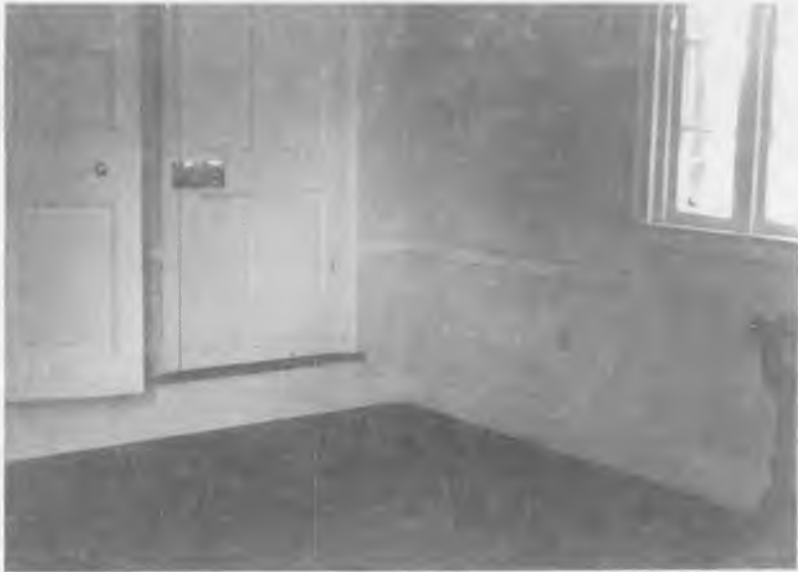
North bedroom after restoration. Note the raised closet door and hallway door (left), both opening to the higher-level floor of the Federal addition.

roofline with that of the addition. The second-story floor in the new portion, being higher than the floor in the older part, made the original bedroom a "sunken" room reached by two steps down from the new hall. In this sunken room there are also two steps up to a unique raised closet. This closet and another one on the opposite side of the upstairs hall are additions of the Victorian period.

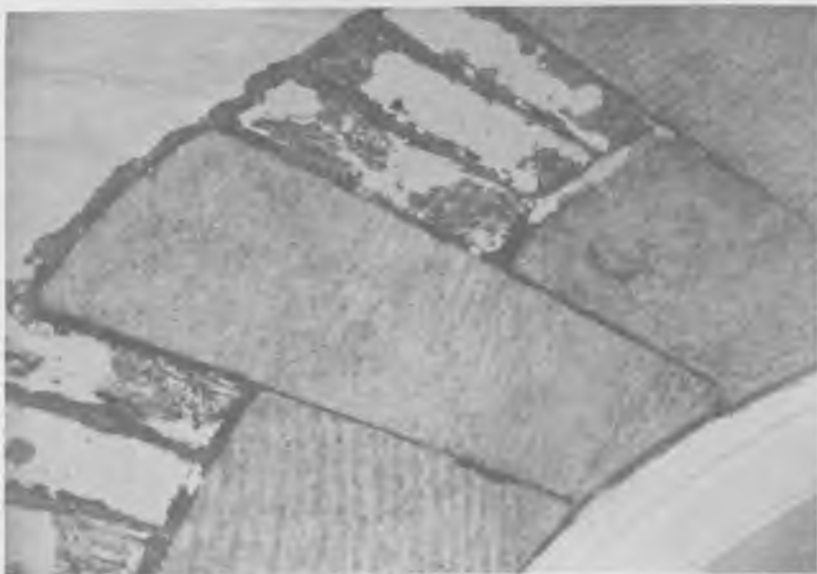
Detail of limestone and brick arch surrounding the Federal doorframe of the front entrance.

The doorway is outlined by a Roman arch faced with large limestone blocks which had been painted, as had the exterior of the brick house. Dr. and Mrs. Sammons removed the paint from the blocks, revealing the natural beauty of the stone. These limestone blocks enhance the nat-

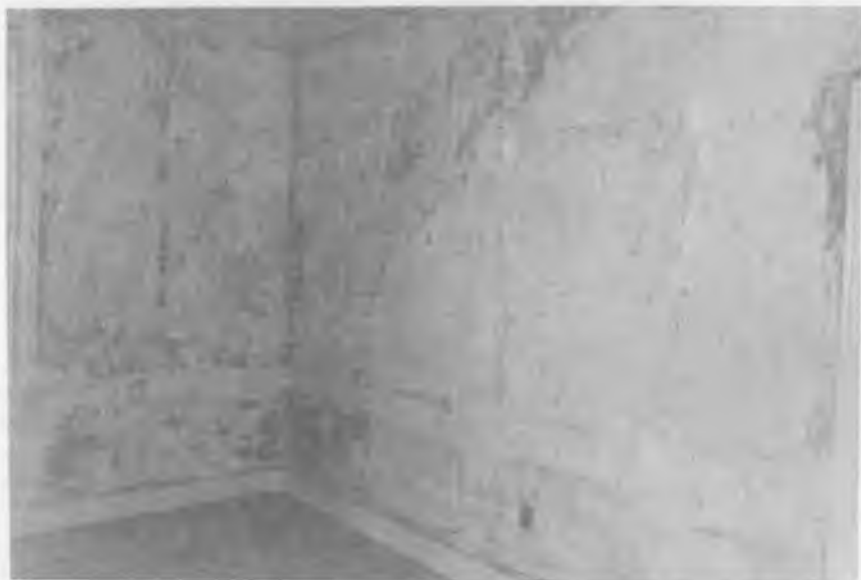
ABOVE: In the north room on the first floor, the outline is clearly visible of the original corner staircase and, under it, the original doorway to the office. Chair rail outlines also are visible.

brick walls. The outline of the original corner staircase was clearly visible, as were the original doors and windows that had been boarded up or bricked in. Outlines of the original chair-rails were evident, too, downstairs and upstairs.

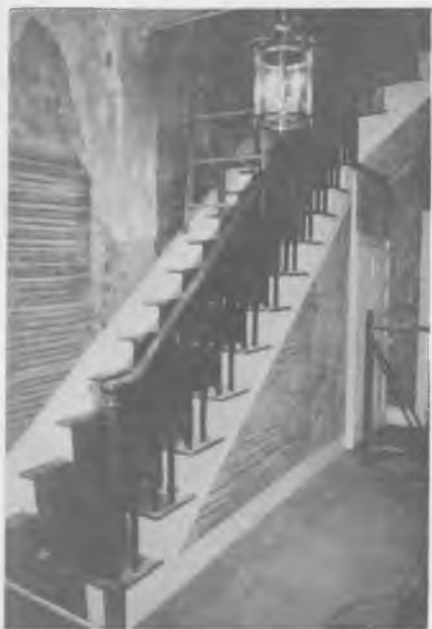
OPPOSITE, TOP LEFT: In the center hall of the Federal addition, the original exterior doorway (left) and window (behind stepladder) are visible to the left of staircase. They were later filled in with lath and plaster. (In solid brick construction, plaster is laid directly on the brick.)

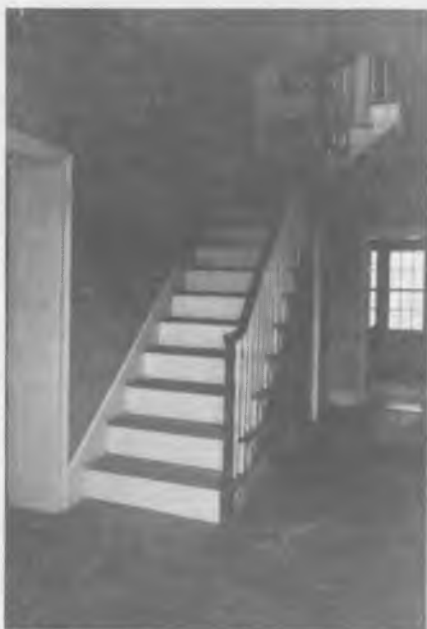
OPPOSITE, TOP RIGHT: The center hall as it appears after restoration.

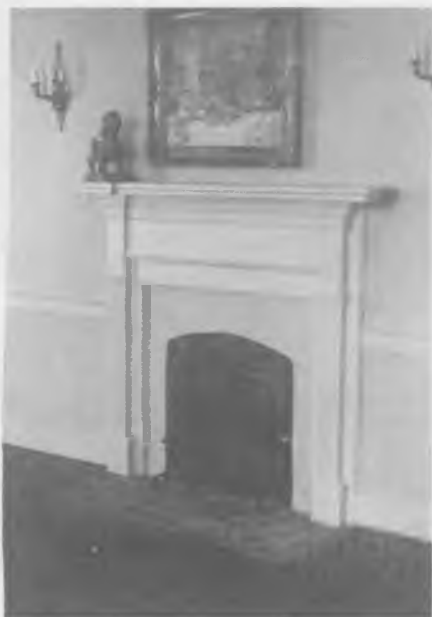
OPPOSITE, BOTTOM LEFT: The arched fireplace, which had been sealed up, after restoration.

Removing wallpaper and plaster was dirty work, but the biggest mess came, according to Mrs. Sammons, with the opening of the sealed fireplaces. Previous occupants had burned coal, and the accumulation of soot was overwhelming. Again, the effort was rewarding when a charming arched fireplace was revealed in one of the upstairs rooms, and it has been retained in its original shape. The mantels above the fireplaces were restored when possible, copied, or re-

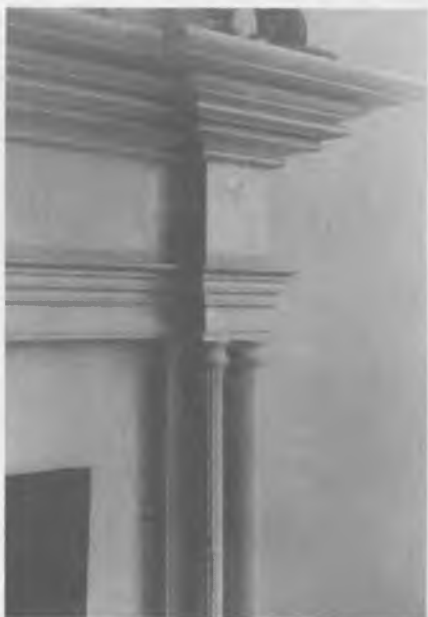
OPPOSITE, BOTTOM RIGHT: Detail of Federal mantel in the first floor south room of the Federal addition.

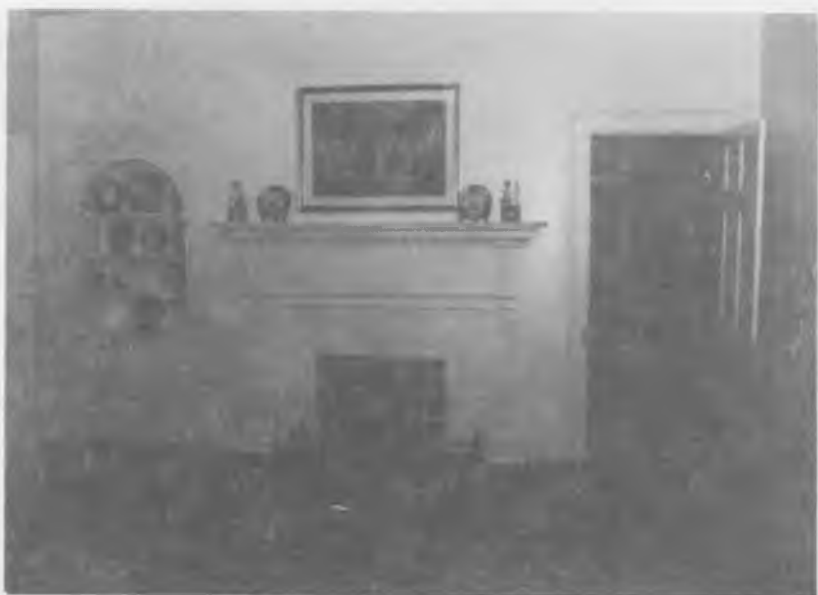
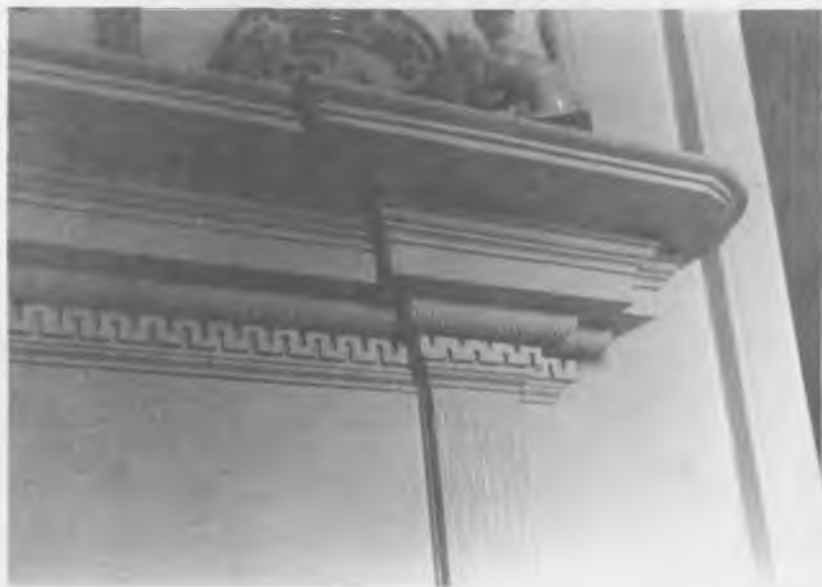
TOP: North room on the first floor, after restoration. The mantel is original but the arched china cabinet was probably added later. **BOTTOM:** Detail of the north room mantel. It took Dr. Sammons at least a year to refinish this beautiful mantel with its many finely carved details.

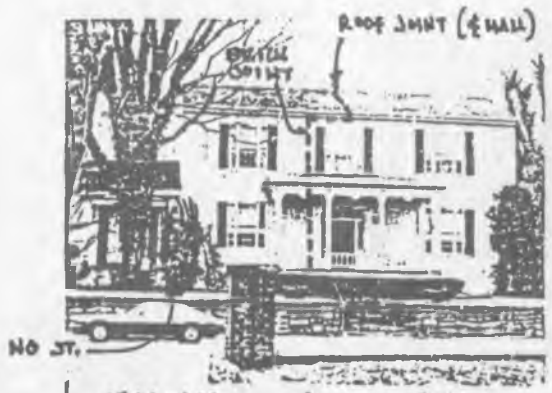
ORIGINAL HOUSE: 401 Lincoln Street
 FINISH BOND, EXPOSED STONE FNDN, PUNCHDOWN FL JOISTS
FED. ADDITION: RUNNING BOND (NO HEADERS) NO EXPOS. STONE FNDN. SAWN (+ HEWN) JOISTS

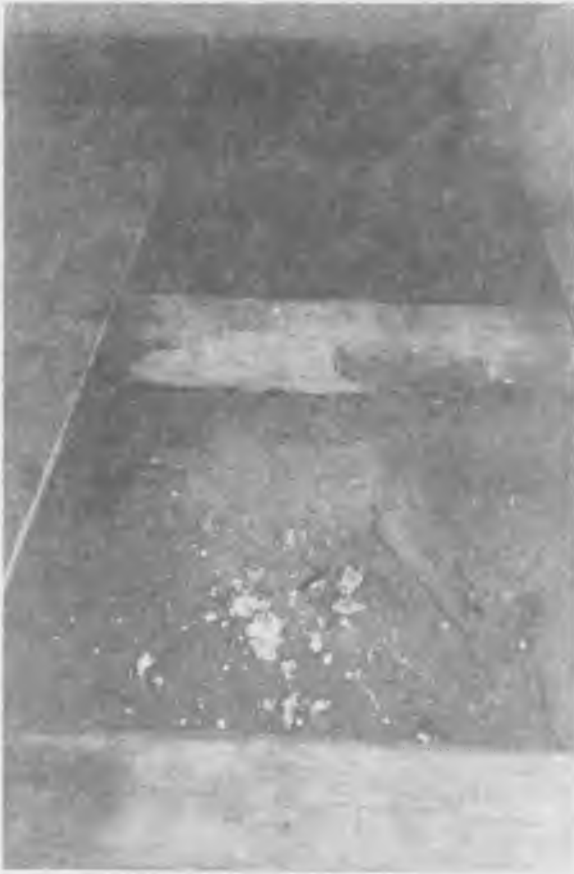
Large peeled puncheon* joists, found under the original part of the house, were laid directly on the ground. The thick heartpine floorboards were then laid directly on the joists. Even after one-hundred-seventy-plus years on the ground, the yellow poplar wood, which is highly resistant to insect infestation and rot, is in good condition and remains in place under the house. The more conventional joists under the Federal addition were rotary sawn and hewn.

Attempts at modernization while preserving the original features led to problems. The floor of the original part of the house was laid directly upon huge peeled puncheon joists which, in turn, were laid directly on the ground. This arrangement left very little crawl-space in which to install plumbing, wiring and ductwork for heating and air-conditioning. The problem was solved by having the smallest worker available to maneuver in this limited space. Another problem occurred when the solid brick walls, twelve inches thick, had to be breeched to accommodate electrical wiring.
