# How Spaceflight Affects the Detachment of Zinc Whiskers

*Kayla Capitan - Department of Mechanical and Aerospace Engineering*

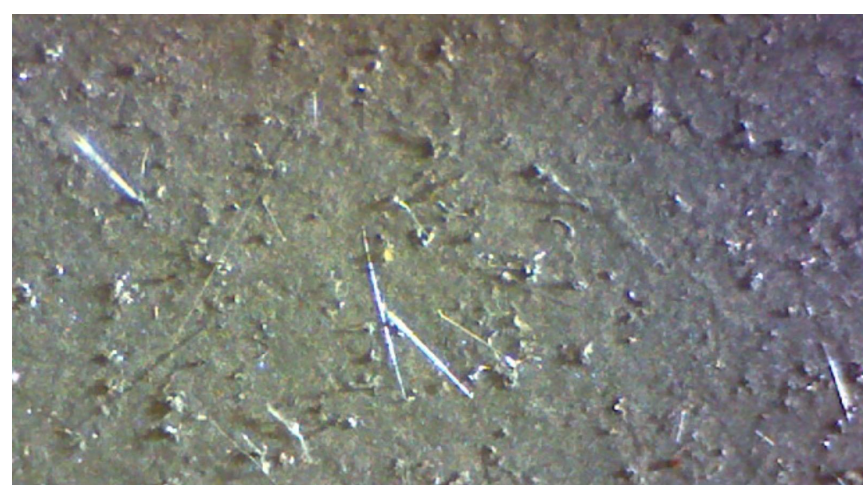
Figure 4: Whiskers Visible On Sample

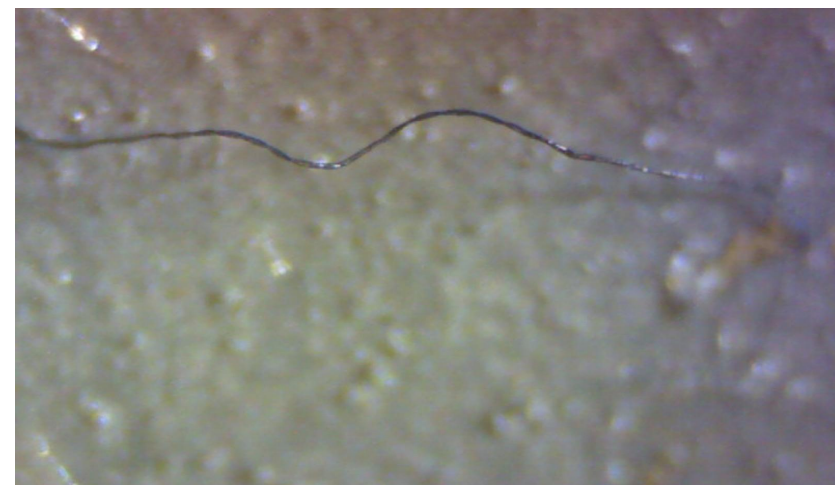
Figure 5: Fiber Present On Sample

- Fragmenting of whiskers may have occurred due to stresses of spaceflight
- Greater fragmentation occurred near area of sample placement in middle of FME
- Air pockets, creases, and carbon fiber increased difficulty in lighting and analyzing

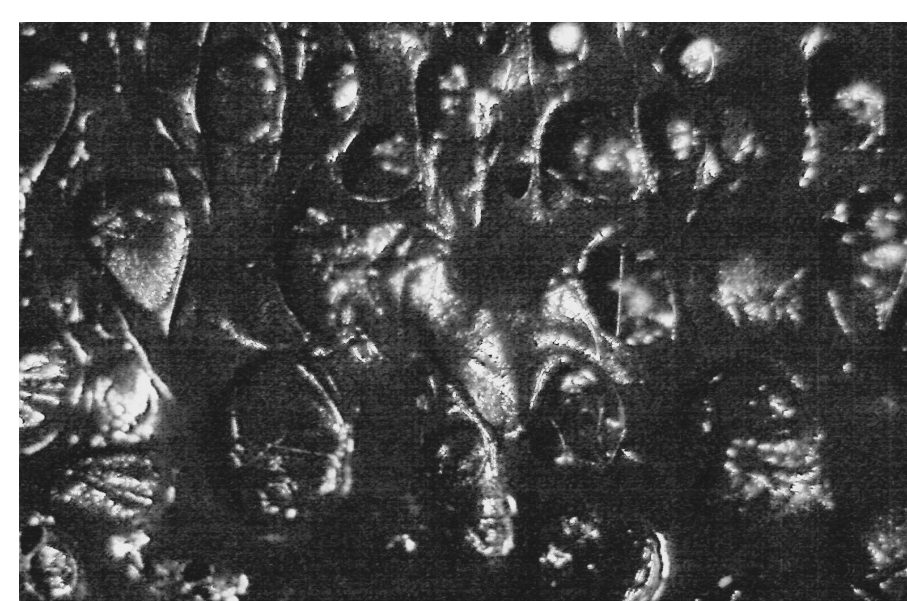
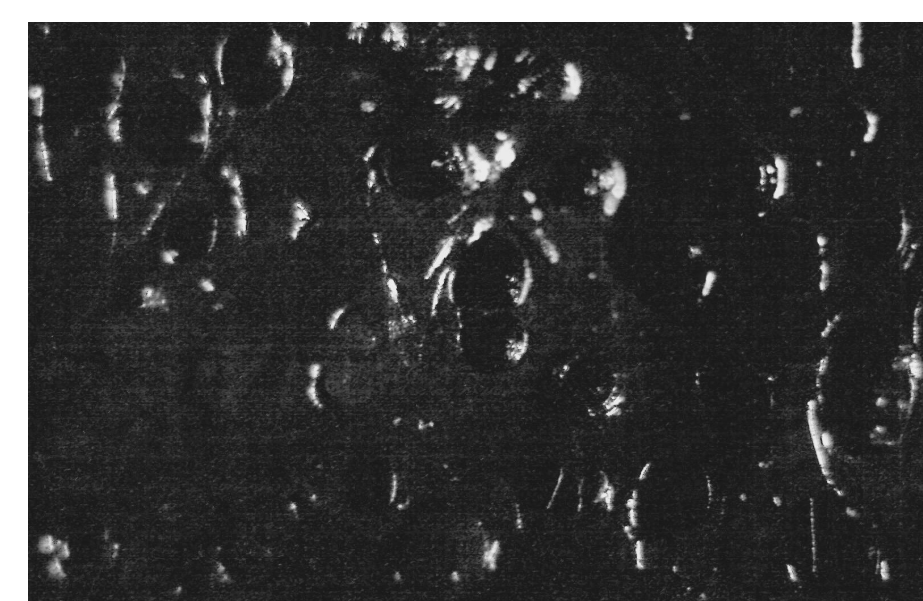
Figure 6 and 7 (Left, Right): Microscopic view (40x) of carbon fiber tape that surrounded the sample

In order to better understand “airborne” and detachment behaviors of whiskers, a zinc-whiskered floor tile sample was exposed to a microgravity environment. Through systematic photographic analysis of the sample and the double-sided carbon fiber tape that surrounded the sample in its Fluid Mixing Enclosure (FME), a significant number of detached whiskers were observed and analyzed. By surveying whiskers that detached from the sample and were captured by the carbon-fiber tape, preliminary results (using a Celestron Digital Microscope Imager) indicate that fragmentation of whiskers may have occurred due to the stresses of spaceflight conditions.

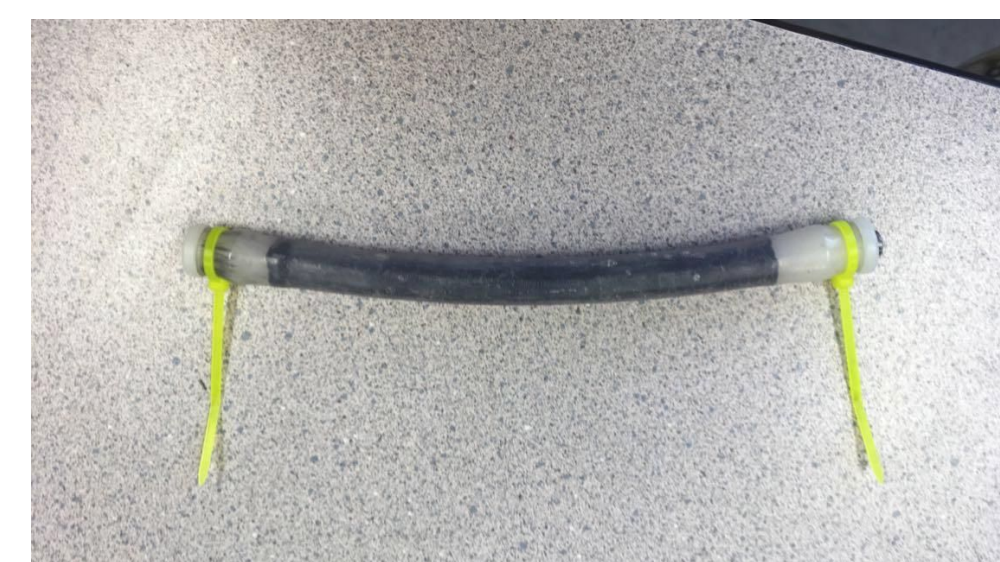
Figure 8 (Right): Sample and double-sided carbon fiber tape secured in Fluid Mixing Enclosure (FME).

Systematic photographic analysis of sample and double-sided carbon tape that surrounded the sample in its Fluid Mixing Enclosure (FME).

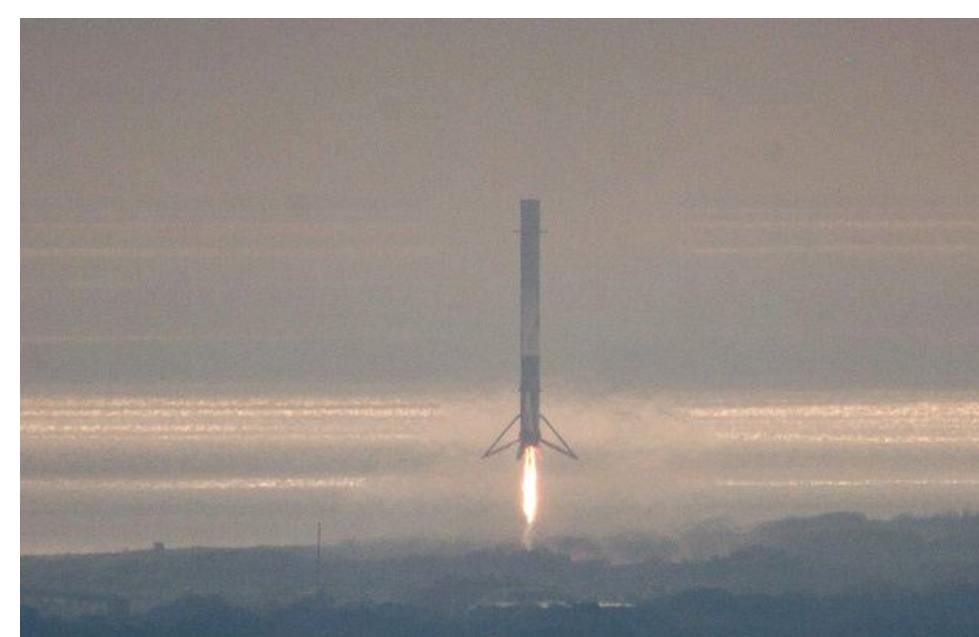
Figure 9 (Right): February 19, 2017 - Mission 9 experiment was delivered to the International Space Station (ISS) via SpaceX CRS-10
