How Spaceflight Affects the Detachment of Zinc Whiskers

Kayla Capitan -

Department of Mechanical and Aerospace Engineering

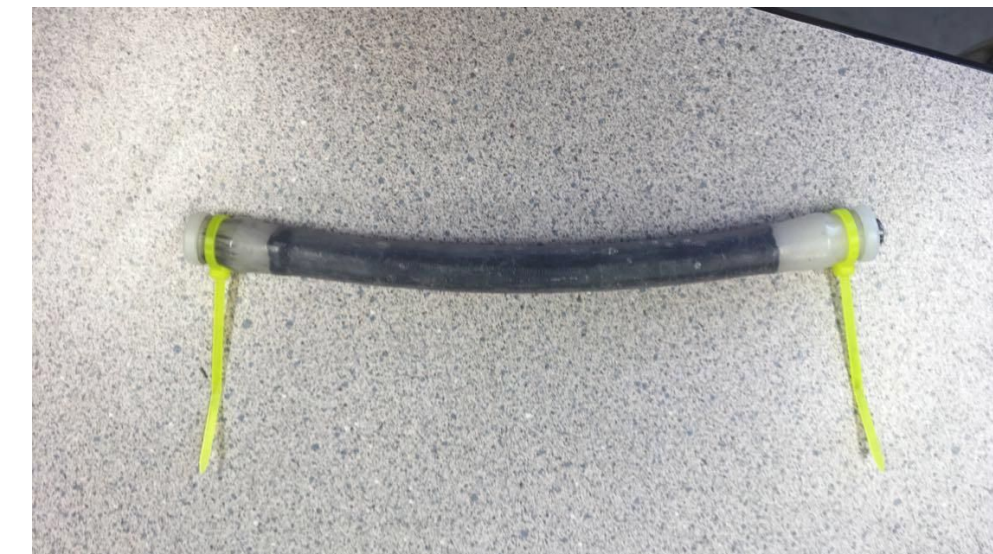
Figure 4 (Left): Sample and double-sided carbon fiber tape secured in Fluid Mixing Enclosure (FME).

- Study focuses on the detachment of zinc whiskers on a zinc-whiskered floor tile sample through the rigors of spaceflight
- Systematic photographic analysis of sample and double-sided carbon fiber tape that surrounded the sample in its Fluid Mixing Enclosure (FME)

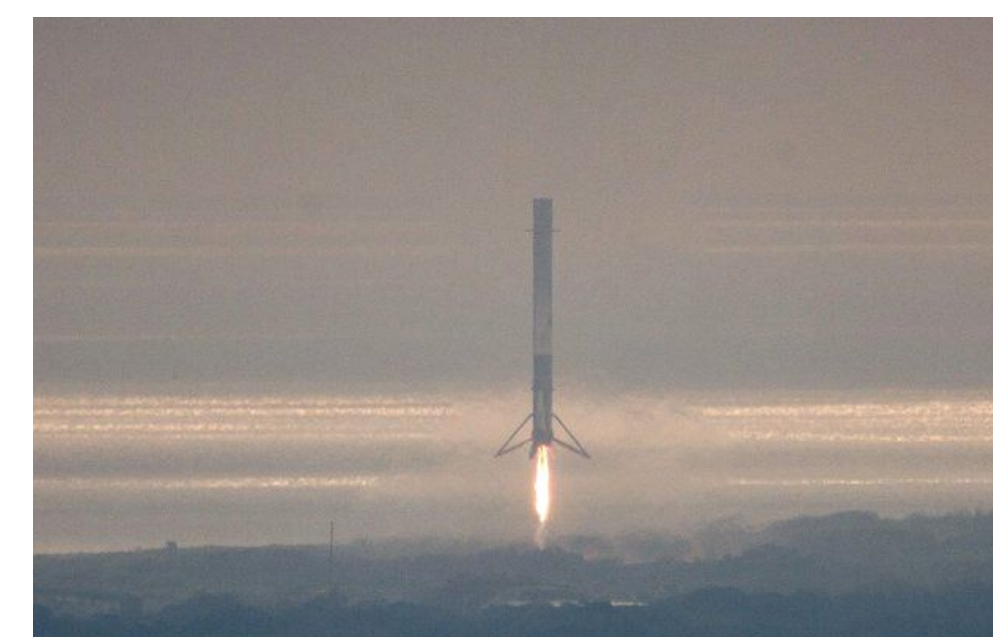
Figure 5 (Left): February 19, 2017 - Mission 9 experiment was delivered to the International Space Station (ISS) via SpaceX CRS-10

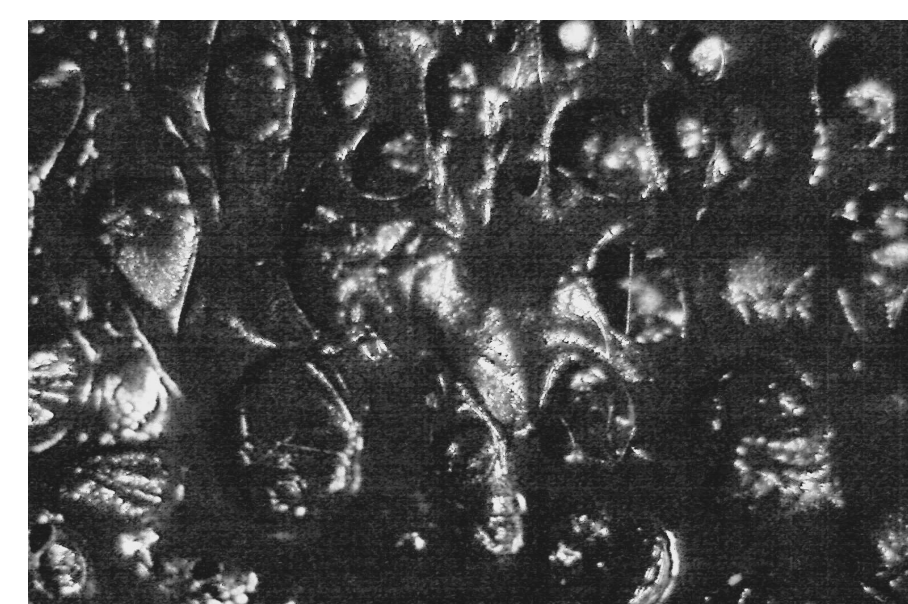
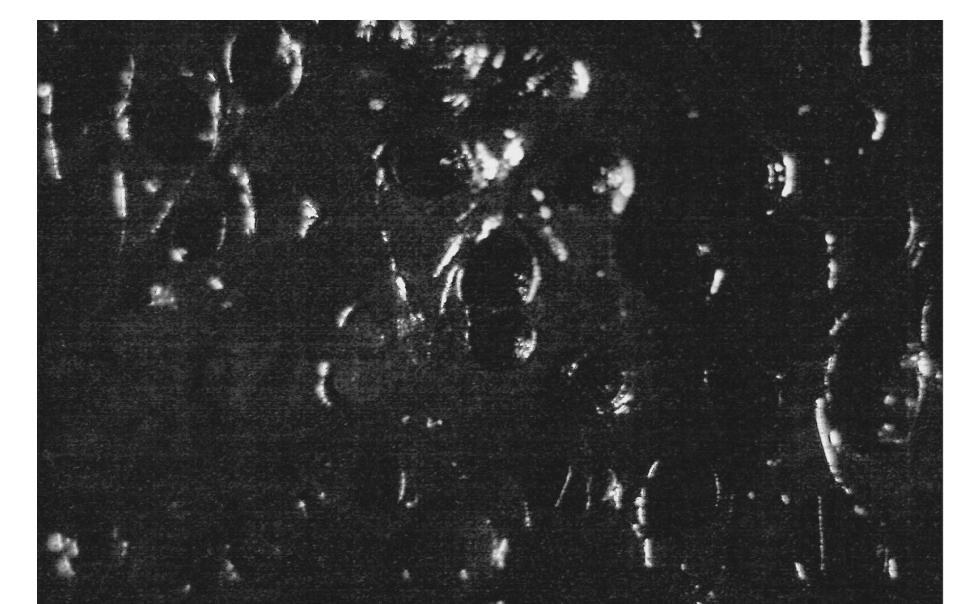
Figure 6 and 7 (Left, Right): Microscopic view (40x) of carbon fiber tape that surrounded the sample

- Fragmenting of whiskers may have occurred due to stresses of spaceflight
- Greater fragmentation occurred near area of sample placement in middle of FME
- Air pockets, creases, and carbon fiber increased difficulty in lighting and analyzing

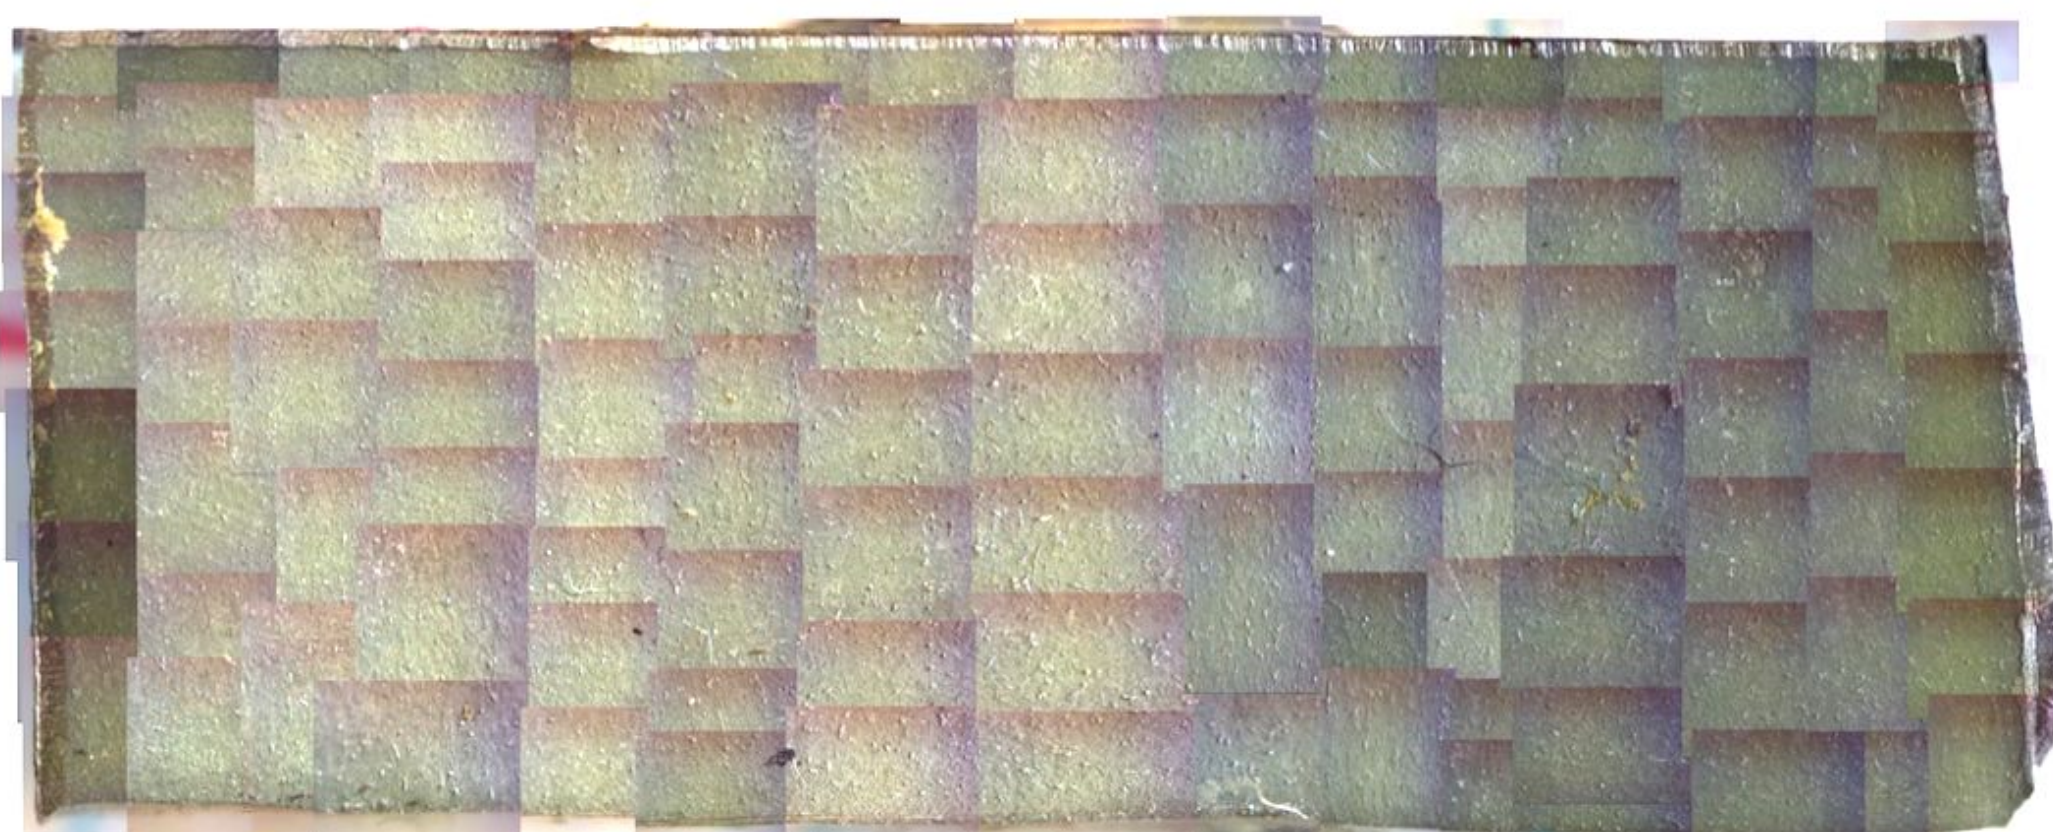
Figure 3 (Above): 1 x 2.5 cm donated zinc-whiskered raised access server room floor tile from NASA Goddard Spaceflight Center

- Provides unique perspective on zinc whiskers that focuses on detachment rate of zinc whiskers in spaceflight conditions
- 132 Whiskers were identified during pre-launch analysis
