The Maria Howard Weeden House

Harvie Jones

THE MARIA HOWARD WEEDEN HOUSE

The Structure

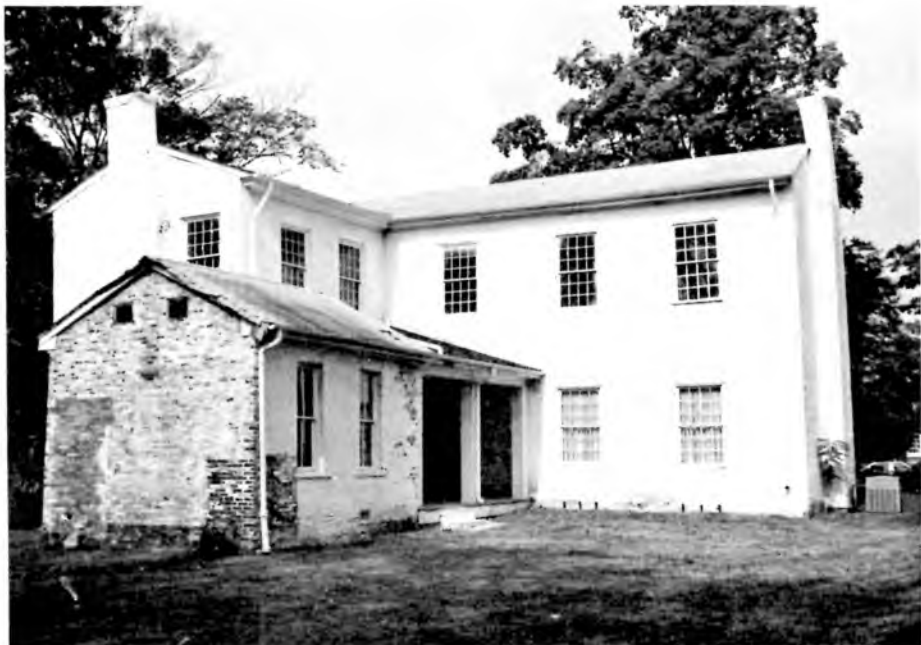
Rear view of the Weeden House from the southeast

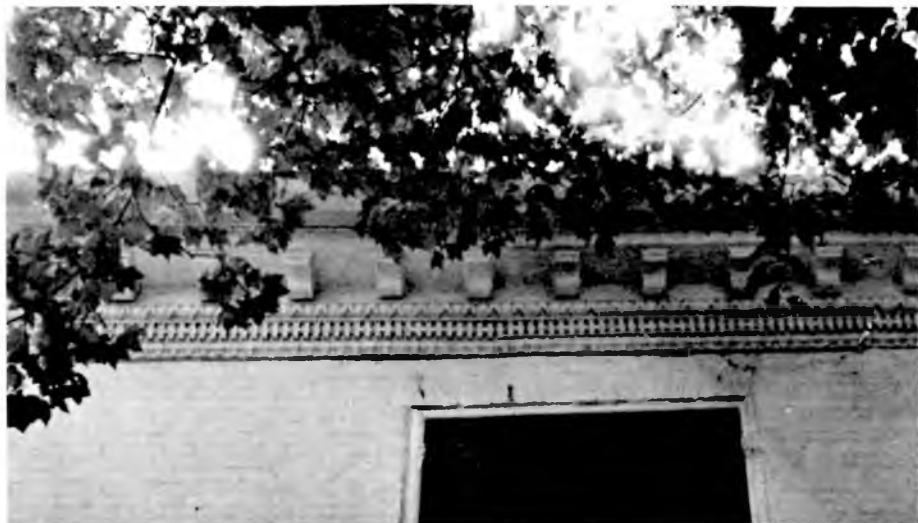
The roof cornice and frieze on the front facade.

carved piece. (These flutes are repeated at a much smaller scale on one of the upstairs mantels--an interesting example of design continuity.) The underside of the boxed cornice is decorated with a series of carved wooden blocks called, in the Corinthian order, modillions.

Constructed in 1819, the Weeden House is a two-story, ell-shaped, brick house having a gabled roof and a center hall layout. It is called a five-bay house because there are five windows across the facade on each level. The roof cornice and the frieze below the front roof eave are loosely based on the classical Corinthian order. The frieze features a leaf-patterned, cast lead design topped by a band of small vertical wooden flutes; each of these hundreds of flutes is a separate, hand-

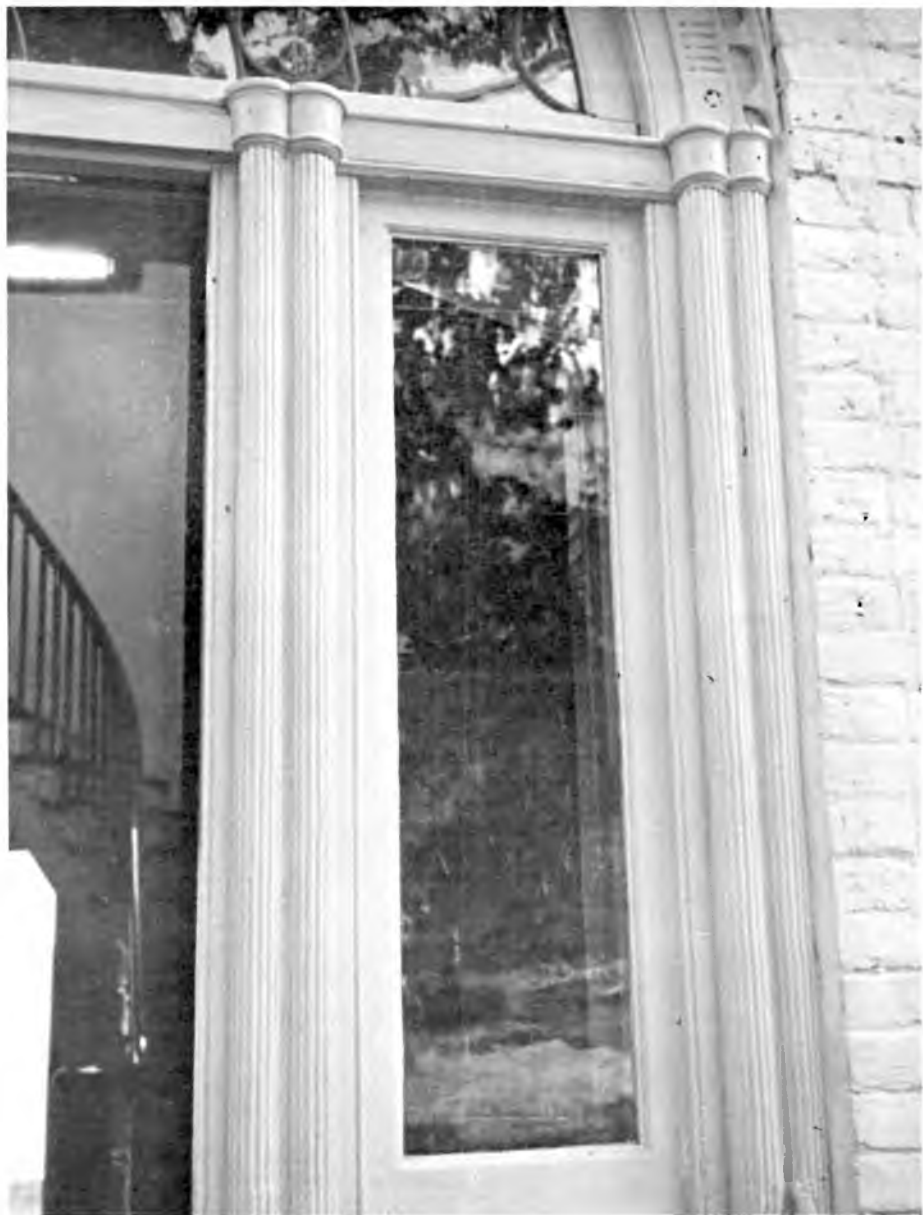
The sidelights of the front entry are flanked by extremely attenuated, reeded columns grouped in pairs. The leaded glass of the sidelights has been replaced.

The entry with its semicircular, leaded glass fanlight and slender, reeded colonettes is particularly beautiful. The glass sidelights also were leaded in a pattern of semi-circles, as is evident by the cut-off ends of the lead came that remain along the edges of the sidelights.

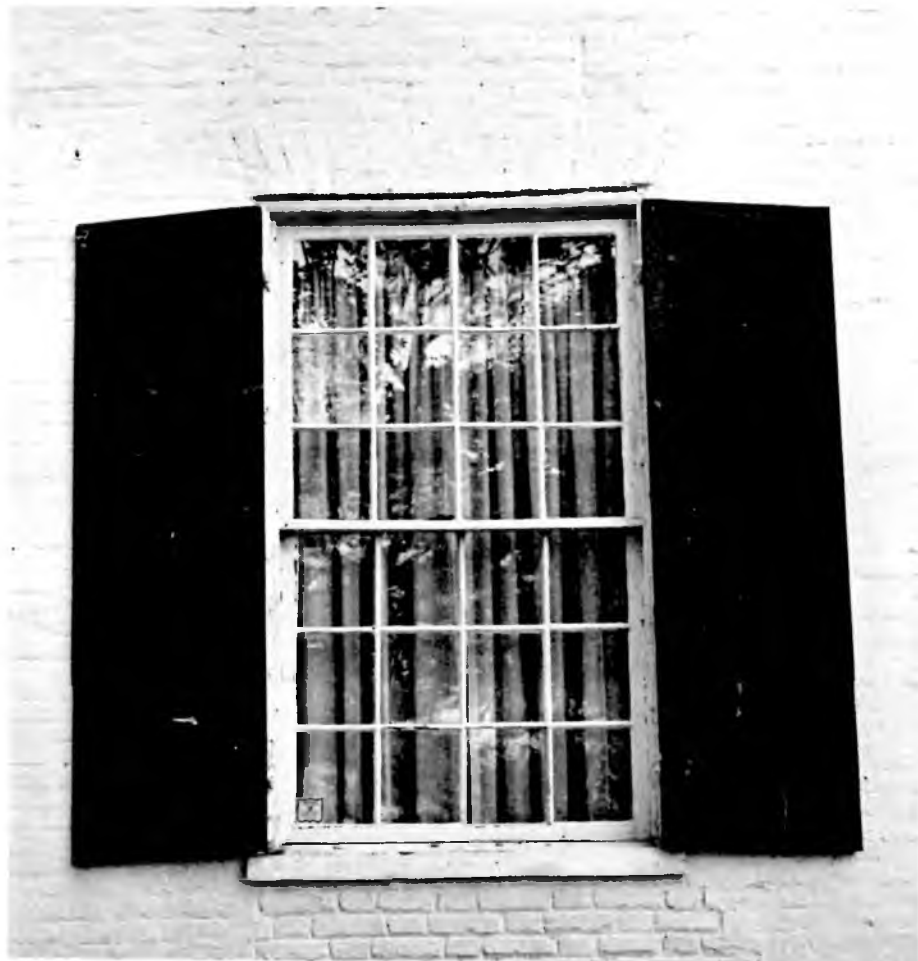
A typical Weeden House window with twelve panes in each sash, lintels of brick, sills of wood, and wooden blinds.

The Weeden House has flat arches of brick over its windows, whereas many of the Federal period brick houses have lintels of heavy eight inch deep cedar. The Weeden window sills are of wood, which was the normal practice; the writer has seen no brick sills on Fed-

eral period houses. The window jambs (vertical wooden sides of a window) are semicircular on the outward edges--a frequent and elegant touch in Federal period architecture.

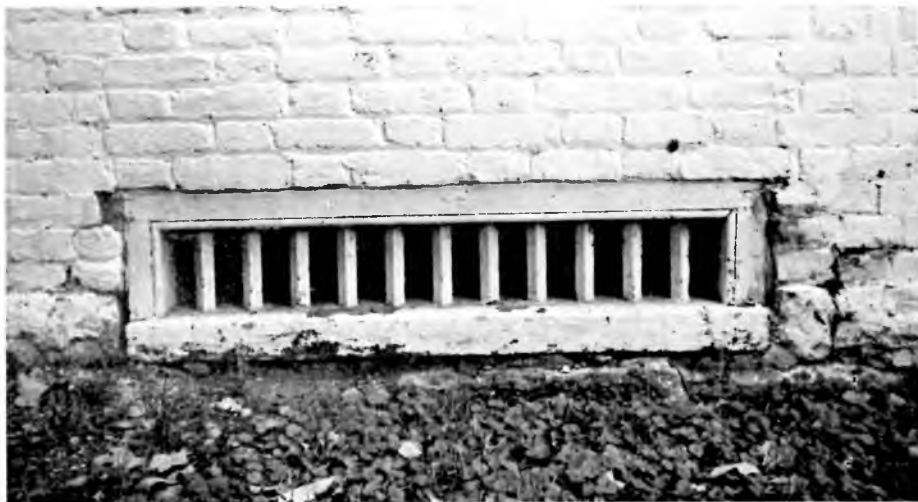
A foundation vent illustrating the diagonally placed bars and the three-quarter round mold framing the opening. Notice the Flemish bond of the surrounding brickwork.

The design of the wooden foundation vents is common for houses of this period but is, nevertheless, very elegant for so prosaic a device. The vertical bars of the vents are

twisted forty-five degrees so that their vertical corners, rather than their flat faces, face outward. This produces a rhythm of angular adjoining faces in lieu of a dull row of flat bars. Another refinement can be seen at the corners of the frames where a three-quarter round mold is used to create a decorative bead, which adds greatly to the appearance of these vents.

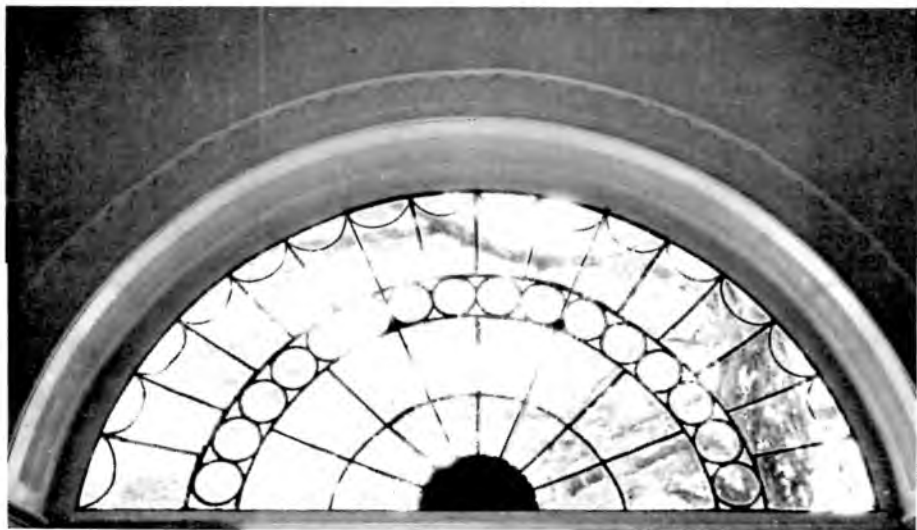
The leaded-glass fanlight of the front entry as seen from the inside.

The glory of the Weeden House interior is its entry, which is brilliantly lighted by the large leaded-glass fanlight, the sidelights, and the window over the gracefully spiralling stair. (In 1970 this entry

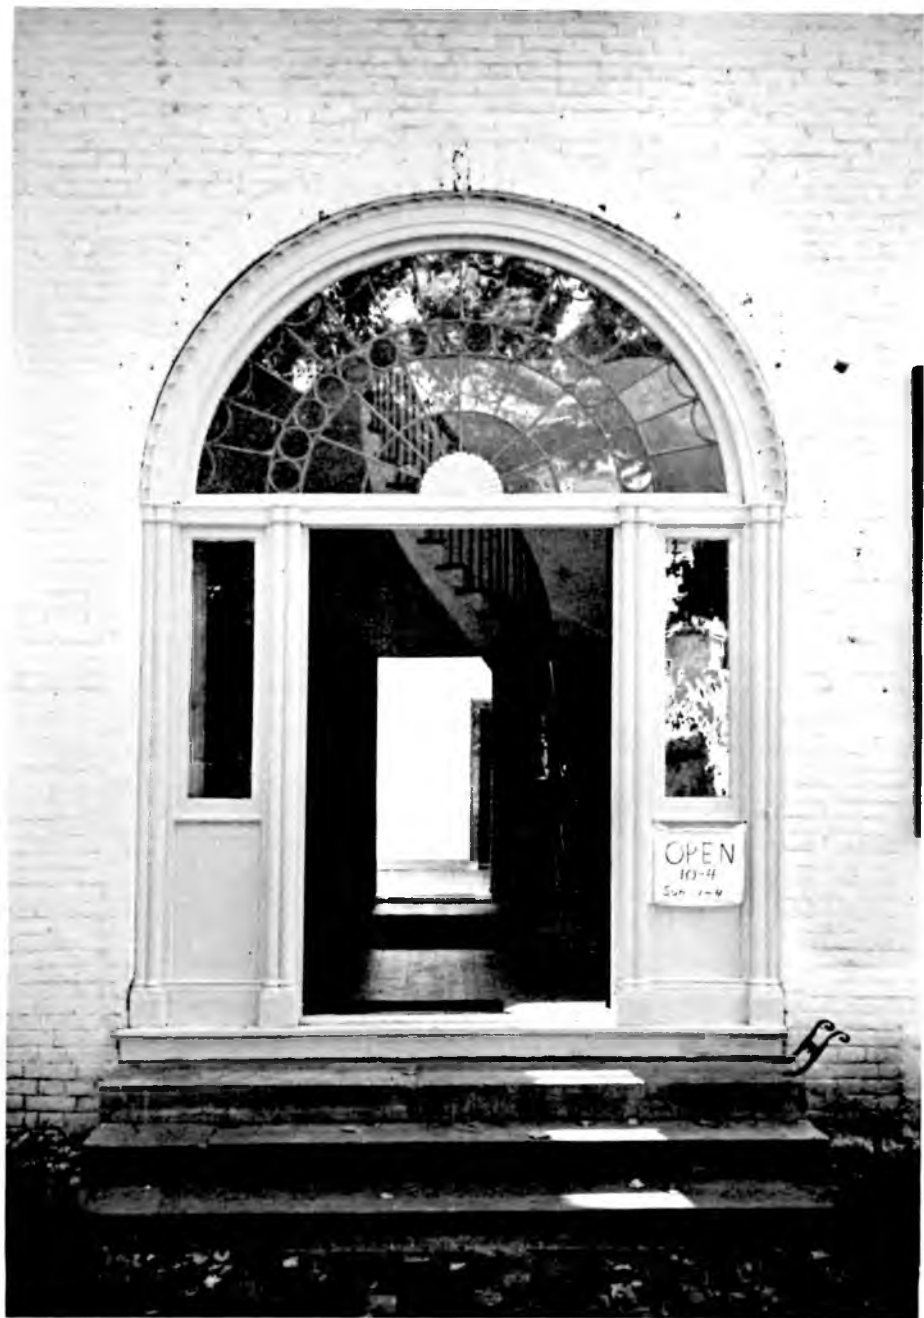
The front entry of the Weeden House

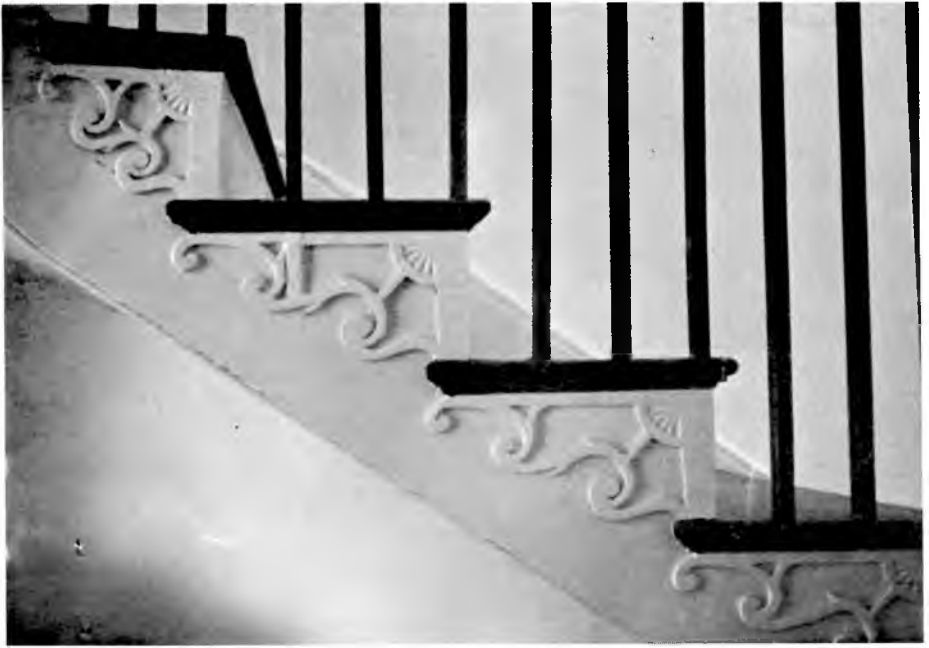
This detail of the stair scrolls shows how the pattern compresses as the stairway begins to curve.

One interesting detail of the Weeden entry stair is the manner in which the scroll pattern on the stair edge compresses, yet holds its design, where the stair steepens at the start of the spiral. Another is that several of the balusters are not of wood but of iron--a clever and unobtrusive structural device, which stiff-

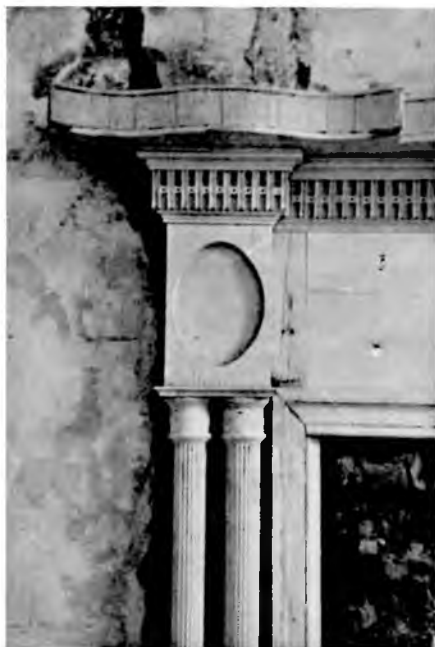
This mantel, located on the unrestored second floor of the Weeden House, displays the delicate reeding and fluting that were typical of Federal period decoration.

orate in Madison County and is intact except for a missing chair rail in the northwest parlor and the above mentioned mantels and door. Because the design of the chair rail is not known, the rail has not been replaced. Delicate reeding and fluting are extensively used as a decorative motif, particularly in the panels surrounding the windows. Rep and chevron patterns also appear in these panels and in the northwest parlor: these were made by gluing hundreds of pre-cut sticks into a gouged channel in the baseboard or window sill.

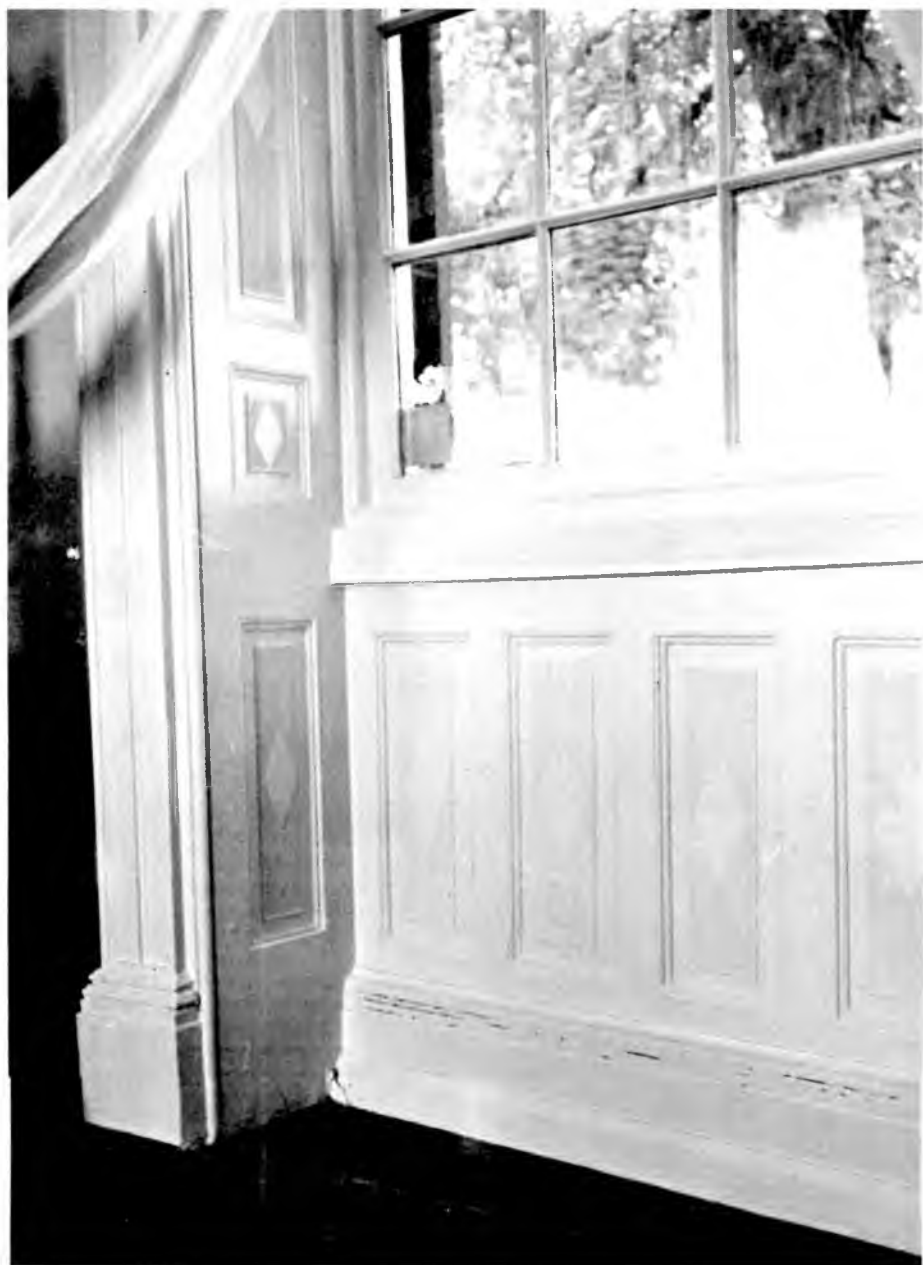
This window in the northeast parlor of the Weeden House is elaborately ornamented with a variety of decorative motifs.

In the northeast parlor, bull's-eye corner blocks appear at the top of the door and window frames; decorative corner blocks are unusual in Federal period houses although other examples do exist. However, the backbanded window and door trim found in the other rooms is quite typical for the period.
