How Does Spaceflight Affect the Detachment of Zinc Whiskers

Kayla Capitan - Department of Mechanical and Aerospace Engineering

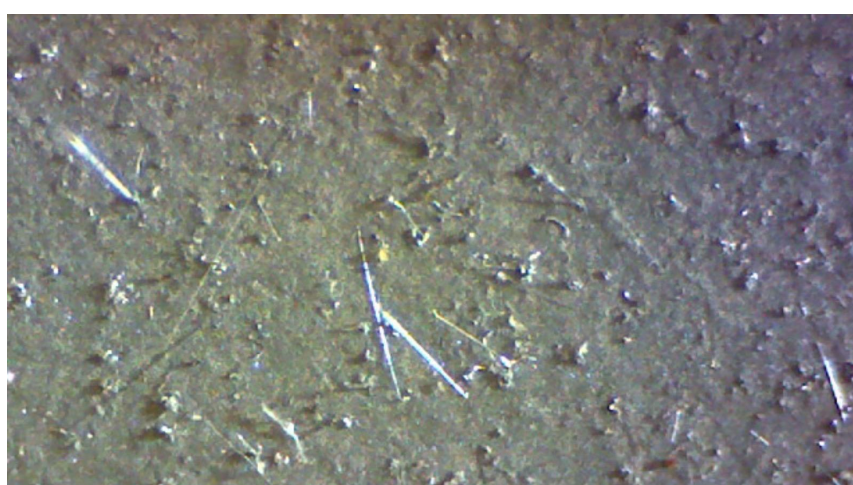
Figure 4: Whiskers Visible On Sample

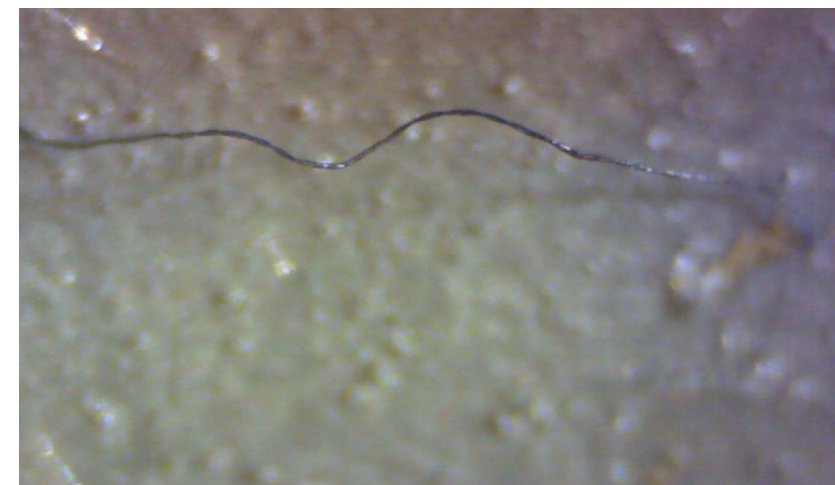
Figure 5: Fiber Present On Sample

- Fragmenting of whiskers may have occurred due to stresses of spaceflight
- Greater fragmentation occurred near area of sample placement in middle of FME
- Air pockets, creases, and carbon fiber increased difficulty in lighting and analyzing

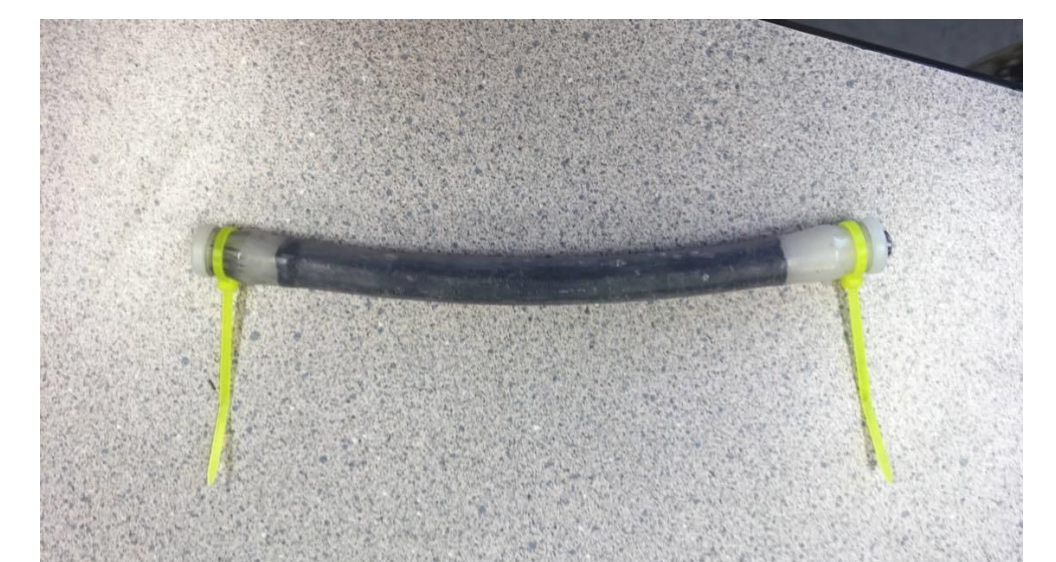
Figure 8 (Right): Sample and double-sided carbon fiber tape secured in Fluid Mixing Enclosure (FME).
