## The Historic Park, Restoration 101: From the Ground Up

### Restoration 101: From the Ground Up

Charles Pautler  
Curator of History

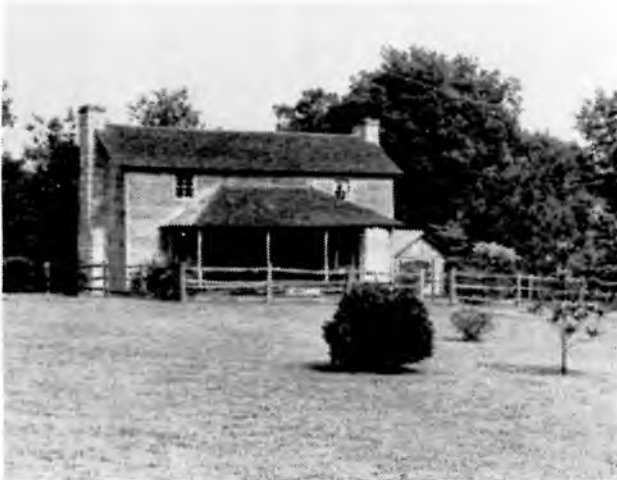
*The  
Balch  
House  
in its  
second  
location,  
1984.*

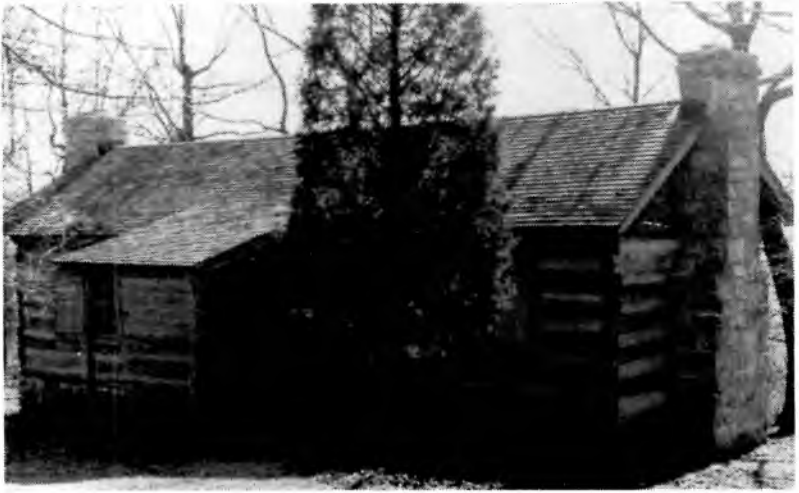
*The Chandler House as it appeared in its second location, 1991*

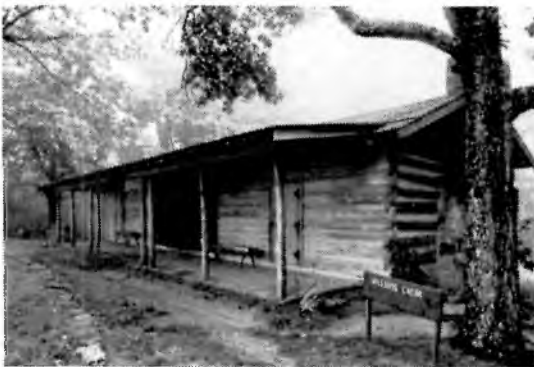
*The Smith-Williams House as it appeared in its second location, ca. 1980.*

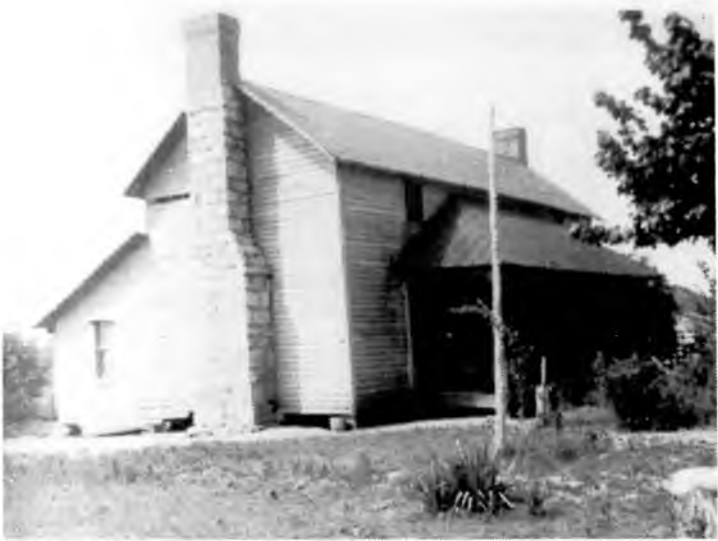
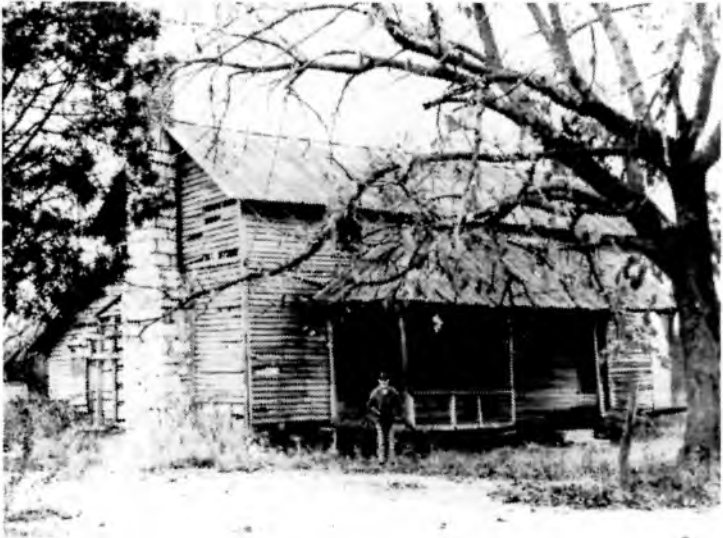
*Above: The Balch House on its original site in Nebo, Alabama, ca. 1950. Below: As it appeared during the 1970's in Nebo, Alabama.*

The first to be moved was the Samuel Balch House, originally built in Nebo, Alabama in 1887 and added to in 1898. The area selected for the house was the land behind the Burritt Mansion, comprised of about 12 acres. Once the appropriate land in the Historic Park was selected, in 1985 the Balch House was relocated for the second time. Because of museum reorganization and another project happening simultaneously, the actual restoration did not start until 1989, with completion of the project occurring in 1991. During the four-year span between relocation and restoration, basic research was conducted to bring the house back to how it probably appeared in 1898, after its substantial historical addition. By 1980's standards, the restoration was a vast improvement over its 1960's counterpart, but yet was not perfect.

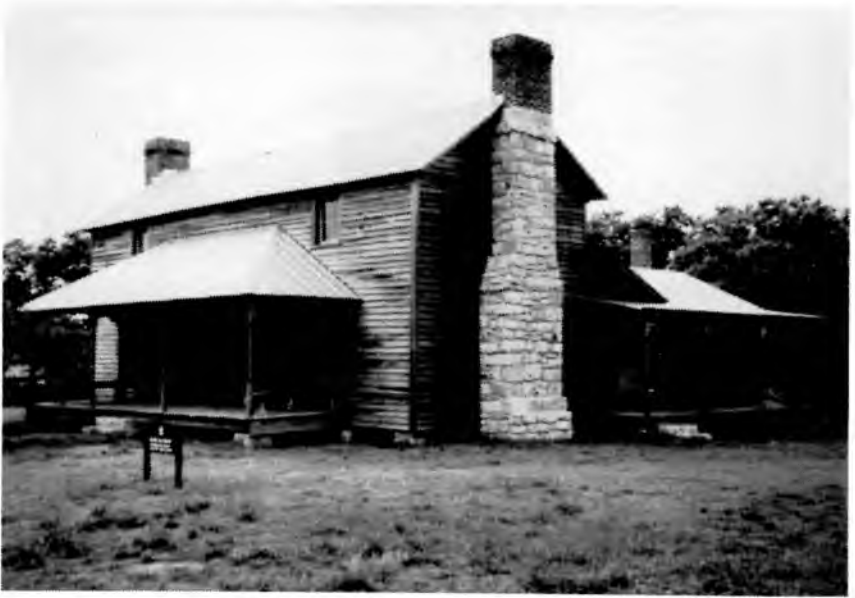
*The Samuel Balch House soon after completion, 1992. Note the 1898 rear kitchen addition.*

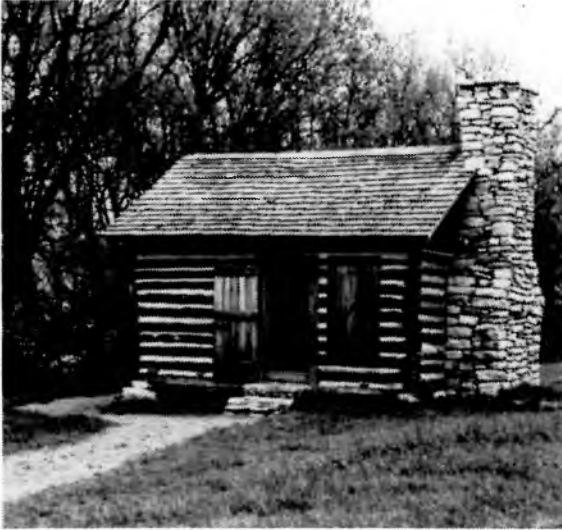
*The Gardiner Cabin soon after restoration. Note the stacked rock limestone chimney. April, 1991*

It is difficult to determine when a structure crosses the restoration/reconstruction line. Technically, a **reconstruction** is a new structure that is built of reproduction or authentic materials that when complete represents a former structure that no longer survive. A **restoration** is an authentic structure that has been taken back to a specific time period, through the use of reproduction or original materials. In the case of the Gardiner Cabin the exterior is about 40 percent replacement, and the interior 100 percent replacement.

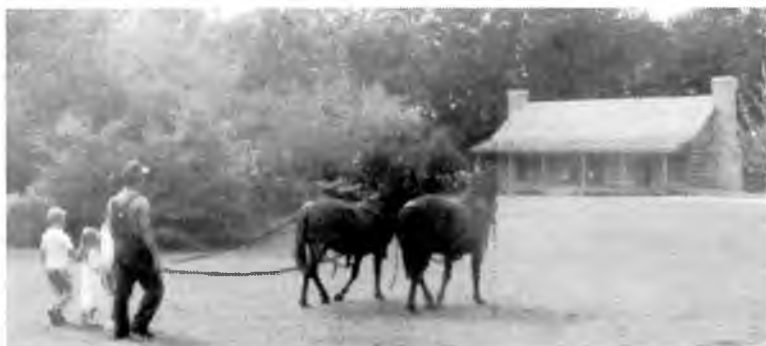
*Clouded in Sorghum Festival smoke, the Smith-Williams house as seen from the sorghum-processing area. The mules in the foreground pulled the cane press during the festival. September, 1992*

house looked. Based on his wide range of research photographs, Jones was able to configure what we believe to be a typical subsistence-level dogtrot house. It must be noted that the only original architectural elements left from the 1960's "restoration" were the wall logs themselves. At that time, all doors, windows, roof, joists, jambs, hinges, ceilings, and floors were replaced with modern kiln-dried pine lumber, cedar shingles, and aluminum hinges. This is not to condemn the earlier attempts, but to show how far the field has come since then.

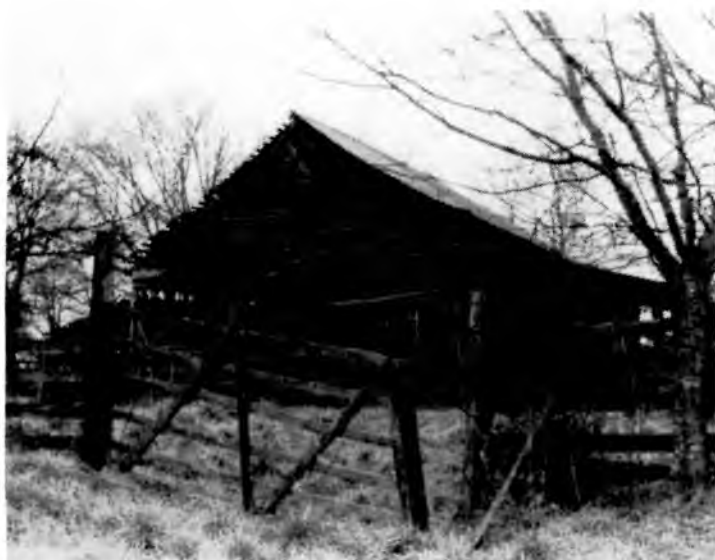
*Barn in  
original  
location,  
Minor  
Hill,  
Tennessee  
1991.*

The barn, disconnected at the breezeway log, was moved in two large sections, each on a flat-bed truck. The museum staff felt it better to keep as large a section together as possible when relocating a historic structure, as there was less room for accidents to occur, namely pieces disappearing during the move, from whatever reason. No matter how careful a person is to number and photograph a log structure before dismantling, accidents can happen; and there is a strong possibility the building will not go back together exactly as it came apart. That aside, there will always be a certain amount of dismantling that is unavoidable, such as roof rafters, and top and bottom logs that connect major sections. The barn rafters were carefully tagged and photographed, and the plate logs (those running across the top) removed as well. The staff did not have to worry about cutting any sill logs (those across the bottom), as nature had already rotted them in half.

Once the Smith-Williams House was completed, the barn was started, which meant a complete replacement of the exterior siding, air louvers, loft flooring, and roof shingles. About 15 percent of the wall logs were replaced with oak logs donated to the museum by Milly Wright of Florence, Alabama, who had worked with the Curator of History on other projects in the past. As with the Smith-Williams House, all sawn lumber for the project was specially milled to the proper historic dimensions and was of the correct wood-type. The restoration was conducted from start to finish by the museum's restoration team that had by now grown from two to five men. One very lucky aspect of the barn project was that the structure had remained relatively unchanged since its initial construction. Original sawn lumber, stall doors, and most of the flooring remained, which meant exact

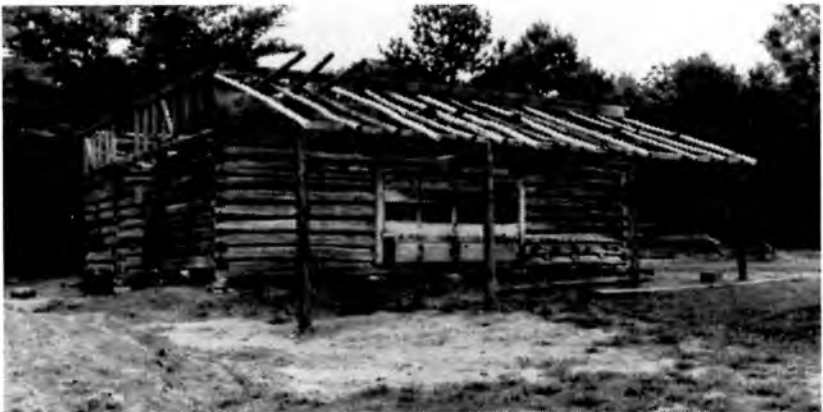
*Barn in progress, 1993.*

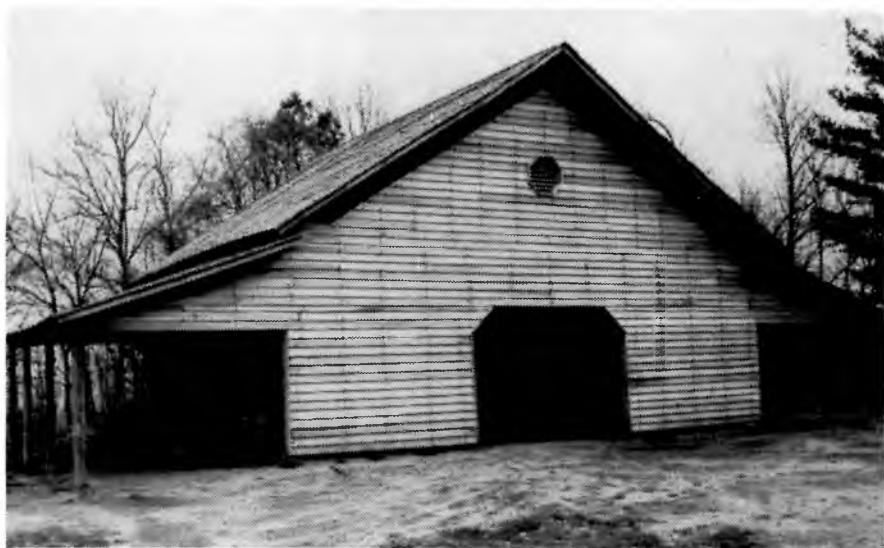
*Finished barn with clapboard siding, 1994*

reproductions could be milled to originals' specifications. Original architectural elements that were in good condition were retained for the building, to be reinstalled towards the completion date.

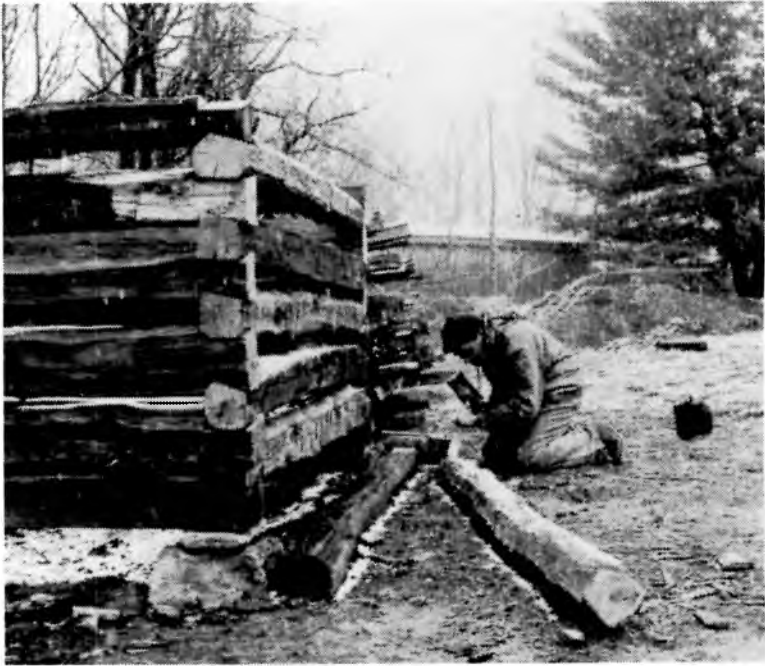
*Curator of History Charles Pautler, chiseling corner notches on the corn crib in the snow, March, 1993.*

At the same time the barn was undergoing restoration, a corn crib was being reconstructed between the former structure and the house. By this time the living history program was going full swing, and the volunteer labor force was ready to try a project that went beyond fence building and firewood splitting. The Curator of History and the lead volunteer interpreter, Marty Siebert, started the small single-room log structure in August, 1992. The building was based on several original examples in the surrounding counties, and

constructed entirely of salvaged logs and lumber from various restoration projects. All corner notches were newly made, and the walls were finished about six months later, mainly constructed during the living history program's hours, as well as on assorted weekends. All white oak shingles were hand-riven (split) on site, and laid board fashion, with one shingle covering each gap. The structure will be used in 1994 to house the heirloom corn crop that is grown in the park.

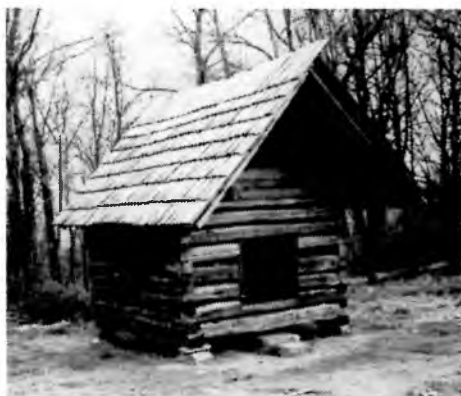
*The finished corn  
crib, built by  
volunteer staff. Note  
the hand-riven oak  
roof boards.  
January, 1994.*

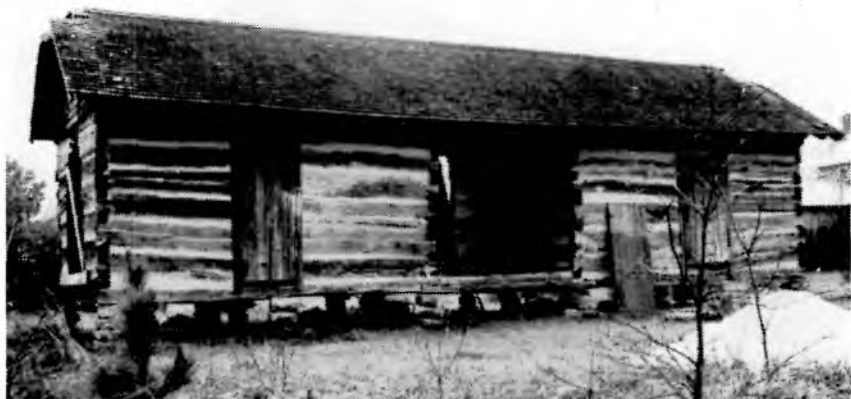
*Above: The Chandler House soon after its relocation to the Historic Park. Spring, 1992.*

*Below: Chandler rear kitchen addition reconstructed of newly-hewn logs. Note the brick chimney in progress. April, 1994.*

After the completion of the barn and corn crib, full attention was turned to the 1850 site. The only work done thus far had been the restoration of the Gardiner Cabin, the move of the Chandler House, and the installation of split rail fencing. All energies went into the development of the site, with massive amounts of research conducted, and the acquisition of the final Historic Park house. The Chandler House plans were drawn, materials purchased, and the restoration team started on the log replacement. A rear kitchen addition was reconstructed from new poplar logs that were hewn using only the tools and techniques of the 1850 period, such as felling axes, foot adzes, and broad axes. The project should be complete by early 1995.

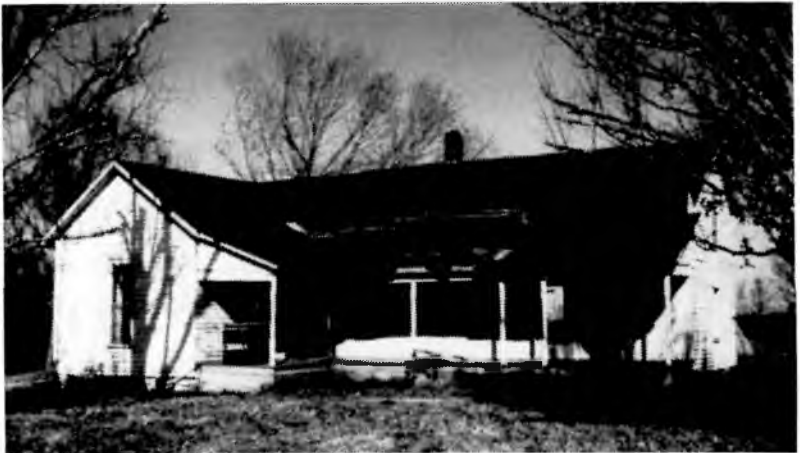
*The James A. Meals house in its original location,  
Lester, Alabama. November, 1992*

The additions that had to be removed from the house included an 1890 front room, a fallen circa 1870 rear bedroom, as well as a 1920's-era rear kitchen and bedroom. The entire process was scrupulously photographed, and most usable lumber was saved for the restoration and other future projects. What was uncovered was a late-federal era log

house made from virgin poplar timber, with each room differing somewhat in the workmanship. The interior was left as it was found until the following year.

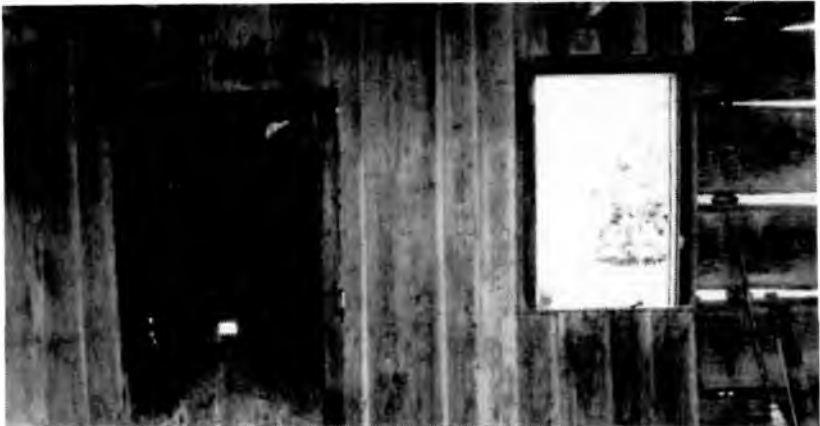
*Paneling in the parlor of the Meals house after cleaning. Note the original door and window as well as board and batten door with cut-out for electricity hookup. The window sash and glass have been removed during the restoration. All paneling is tongue-in-groove with a double-beaded edge on each side. 1994*

Underneath 1960's drywall was 1850's tongue-in-groove poplar paneling. Underneath seven layers of linoleum was heart poplar flooring. 1960's ceiling tile likewise became 1890's poplar ceiling boards, which, after many photographs, yielded to 1840's hewn beams. The structure went through a metamorphosis during the next two weeks, and the history of the occupant's lives unfolded before our very eyes. We decided to remove the paneling so it could be cleaned and reinstalled. The historical artifacts the staff inadvertently found behind the paneled wall were so significant they will be showcased in a special Burritt Museum exhibit. Found were bits of clothing, tools, spools of spun wool, seeds, a corn cob pipe, pieces of weaponry, natural dye agents, hand-forged items, mummified mice and rats, and tobacco paraphernalia, to name just a few objects.

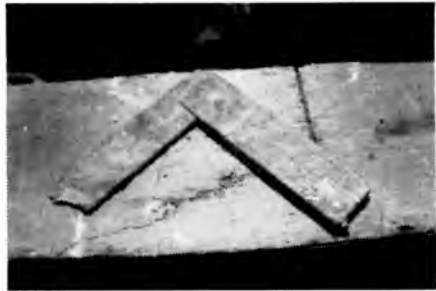
*Wooden builder's square found in Meals kitchen wall, 1994.*

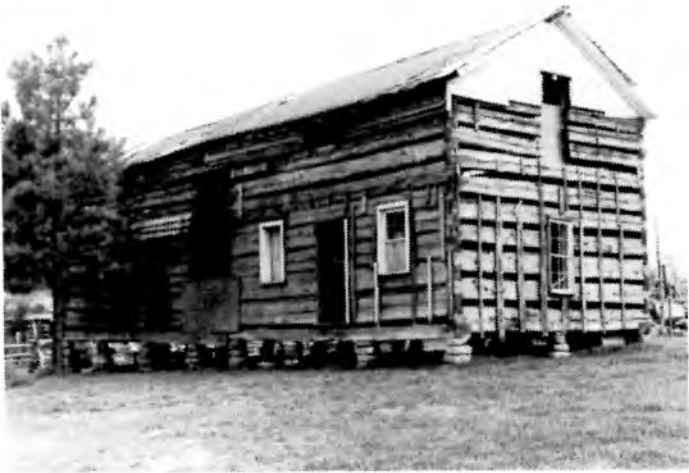
*Above: James A. Meals house on site at Burritt Museum. The clapboard siding has been removed to determine which logs need to be replaced. 1994.*

Summer, 1994 the log restoration will begin, to be followed by the house's restored full-length front and back porches, wood shingles, and a mammoth limestone chimney. For a project of this size, Harvie Jones was once again brought in, and at present is preparing the restoration plans. Once the house is finished, the visitor will be able to see the well-trimmed parlor next to the unfinished kitchen. Meals didn't finish the second room's interior until the 1890's. There are still many mysteries, but the existing clues available to us will make this project one of the most thorough restorations the museum has ever undertaken. This is fittingly so, as it shows the preservation community, both local and national, that even a small institution such as ours can provide a large window to the past.

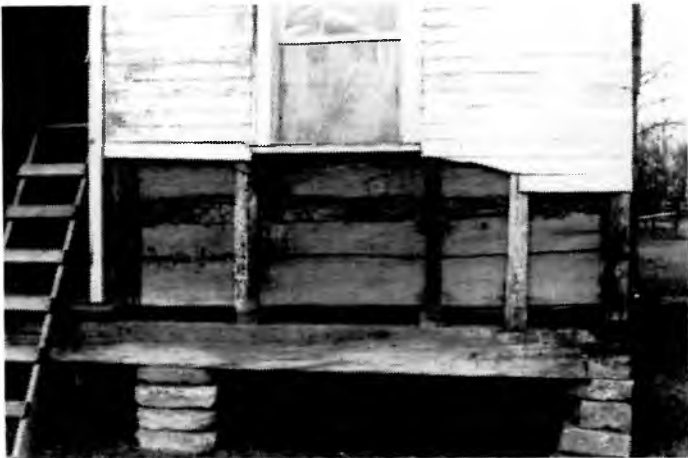
*Below: Removal of 1900-era siding to determine condition of logs. During the restoration, the house will be resided to bring it to its 1850 appearance. Note the chinking and mud daubing between the logs. 1994.*

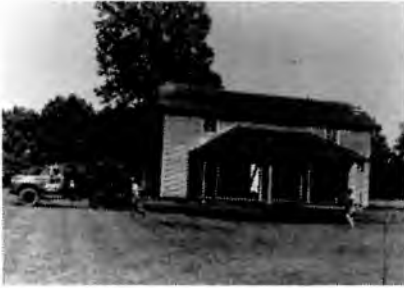
*The Balch House relocation in 1985. This was the first structure moved to the Historic Park*

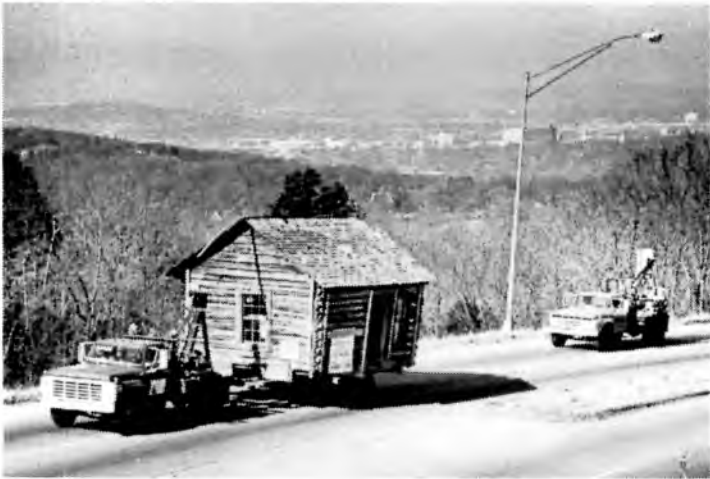
*the Gardiner Cabin coming up Governors Drive towards the Burritt Museum. Photo shot from the Outlook. February, 1988.*

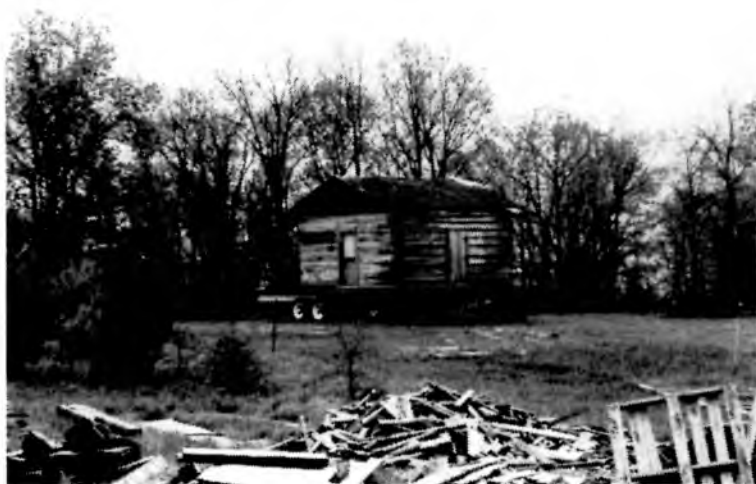
*Above: The Smith-Williams House being moved from the parking lot area to its present location in the Historic Park. August, 1991.*

*Below: The Chandler House being relocated to the Historic Park. 1991*

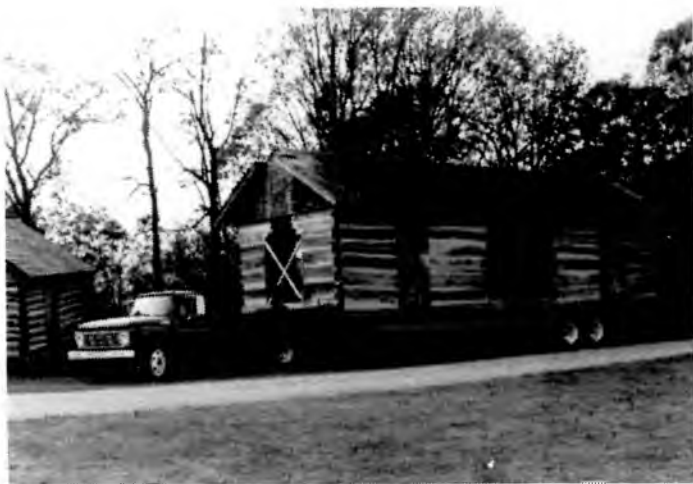
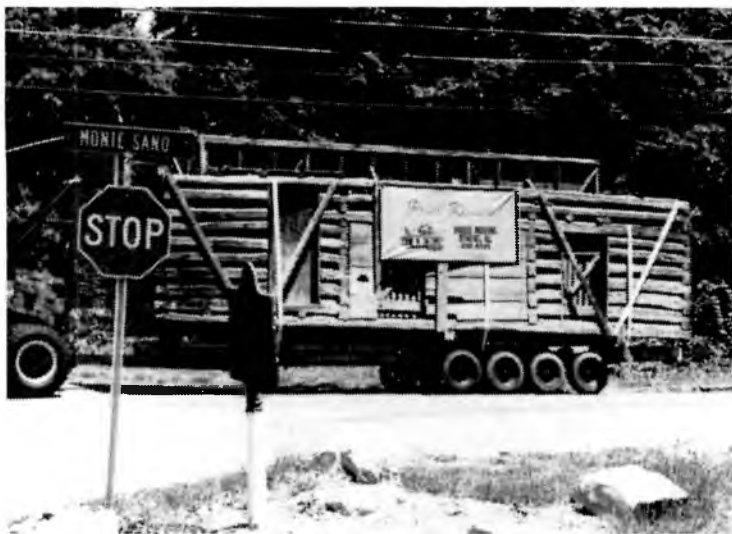
*Above: Barn in transit. May 5, 1992.*

*Below: The Meals House during relocation. The roof, having been transported separately, is placed on top of the lower portion of the building. July, 1993.*

On July 6, 1993, the James Meals House was driven down Governors Drive, following the same route the barn had taken the year before. Because of the sheer immensity of the house, an old service road through the woods near the Museum's entrance had to be used. It joined the paved driveway near the nature trail parking lot. Tree branches had to be cut along the entire way, as the house was 18 feet wide. The tight curve near the Burritt Mansion was the final obstacle, and the house was reunited with its roof the following day. The building was set in place, and two days later looked as though it had been there the entire time.
