The Historic Huntsville Quarterly

Volume 24
Number 2 *Log Houses: Building Blocks in
Madison County, Alabama*

Log House Restoration

Jan Allen

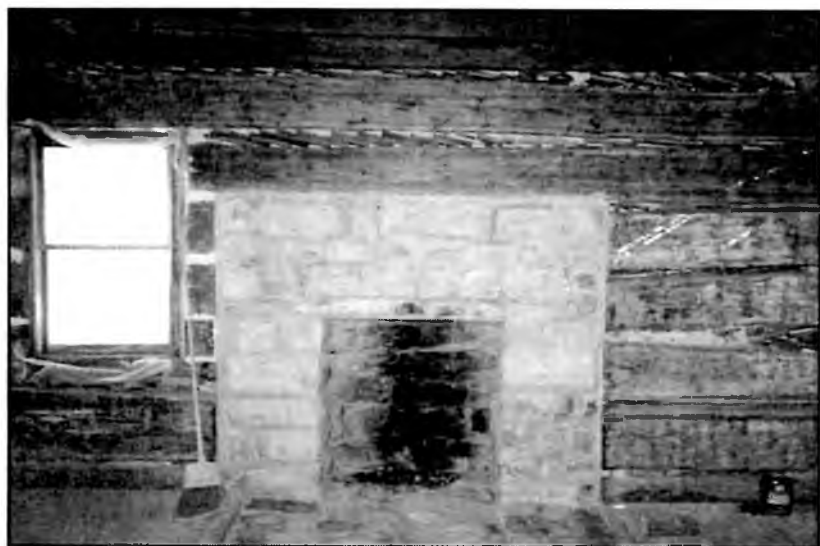
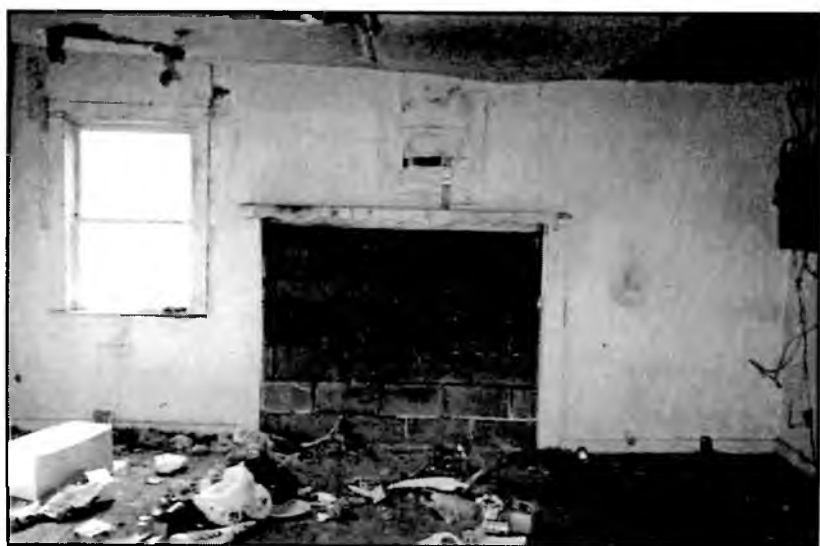
Fig. 3 Hollingsworth-Allen House fireplace, November 1994 & December 1995.

Originally there had been a fireplace in each of the two rooms, but one had been dismantled some time in the past; the opening was crudely boarded up leaving a hole for a stove pipe (fig. 3). The old tin roof had leaked in a few places, and the ceiling was sagging. Layers of trash, old wallpaper, sheet rock, and rotted wood littered the floor.

During November 1995, Robert Ervin rebuilt our chimney was rebuilt by Robert Ervin. Although the rebuilding process used much more mortar than the original chimney had contained, we were very pleased with the results. So that the fireplace can be used for cooking, we have had a crane hand built for it. By December 1995, the log house was enclosed.

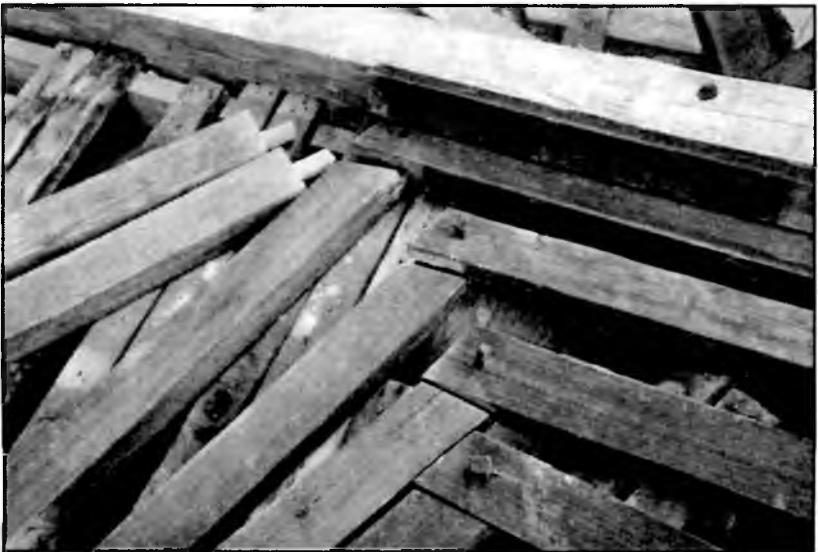
Fig. 4 Roof rafters, disassembled, Hollingsworth-Allen House, June 1995.

The house was 17 feet tall; however, the Whitesburg Bridge across the Tennessee River has a clearance of 15.5 feet. Therefore, we carefully numbered, lowered, and lay the rafters on the ceiling so they could be reassembled in their original location. Our part of the moving preparation was complete (fig. 4).

Our first job was to reset the rafters and to get the roof covered and protected from weather. Each rafter had a peg hole in the sill and was pegged at the apex where it met its counterpart from the other side of the roof. We discovered that the rafters were not spaced at regular intervals—they ranged from 22 to 29 inches apart. With the rafters in place, we recovered the roof with tarpaulins to protect the interior. Although the original roof had been covered with wooden shakes and later replaced with tin, we elected to recover the roof with tin (fig. 7).

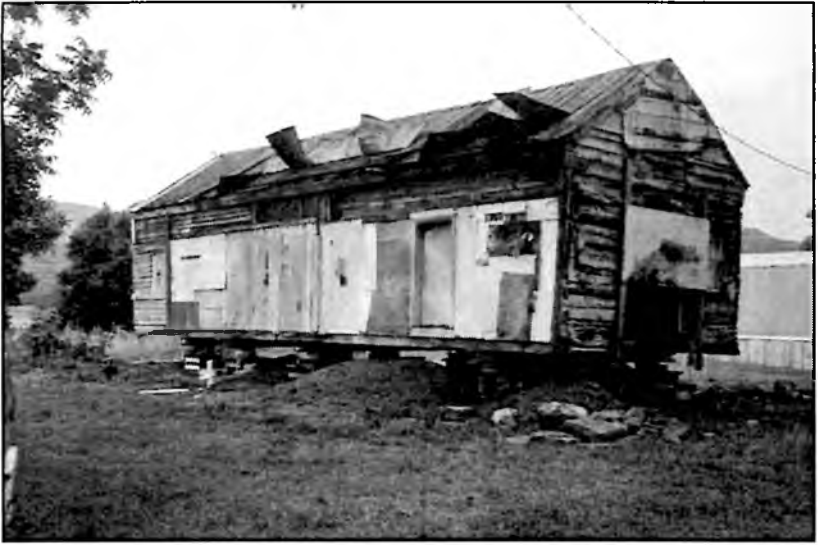
Fig. 5 Hollingsworth-Allen House in process of being raised, May 1995.

We sat back watching as the log house was slowly raised (fig. 5, page 41). By jacking first one side and then the other, the structure was raised until it was high enough for the large trailer to be backed under it. This very precise process took two days. The jacking process freed the large rocks on which the house had rested; we moved these to the new site. Once the house was on the trailer, we obtained a permit from the Alabama State Highway Department for use of U.S. Highway 431 as part of the route to Lacey's Spring.

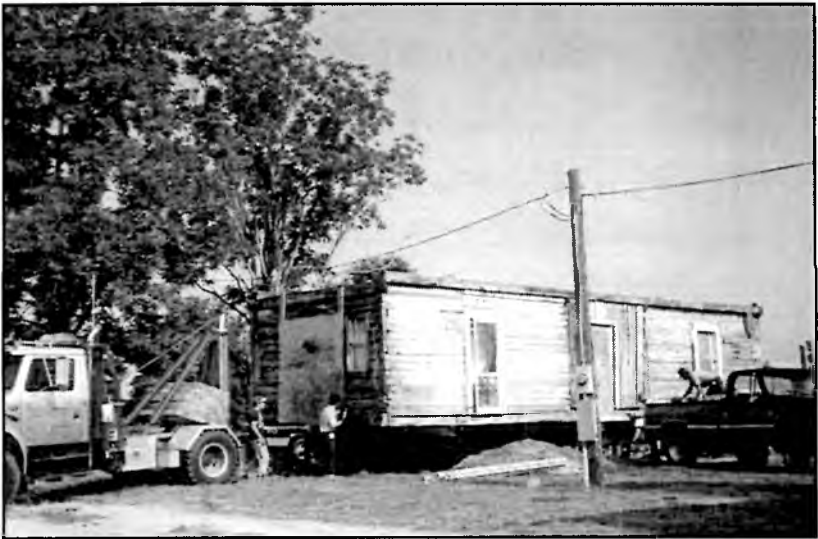
Fig. 6 Moving day! June 1995.

Moving day! We were excited (fig. 6, page 41). The 25-mile trip took all morning going a slow, steady speed with crews ahead warning traffic. The truck pulled carefully down our narrow road and then backed onto the new site. During the afternoon, the house was raised enough to remove the trailer. The jacks were left in place for a few days while we positioned the support rocks. At last the log house was on its new site. No damage was done to the log house during the raising, the move, or the lowering onto the rocks.

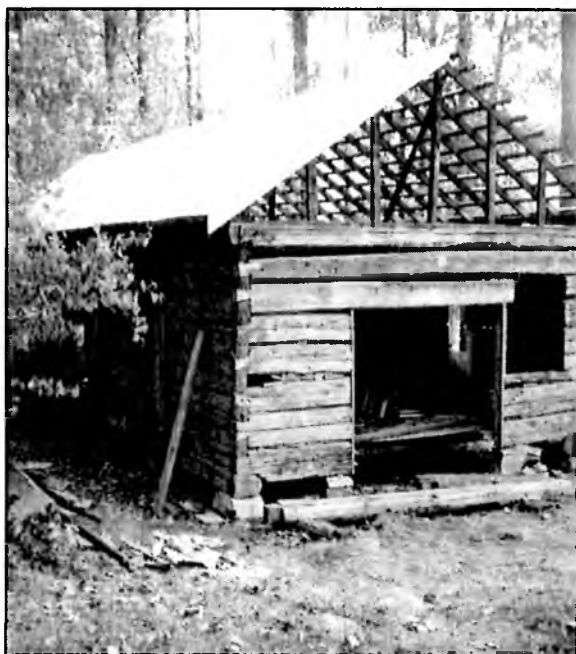
**Fig. 7 Replacing the tin roof,
Hollingsworth-Allen House, September 1995.**
Courtesy Jan Allen.

With help from the front end loader on our tractor and much ingenuity, my husband replaced the deteriorated logs on both house ends. We then replaced the roof with new tin and filled in the peak areas with wood boards salvaged from the exterior of the lean-to.

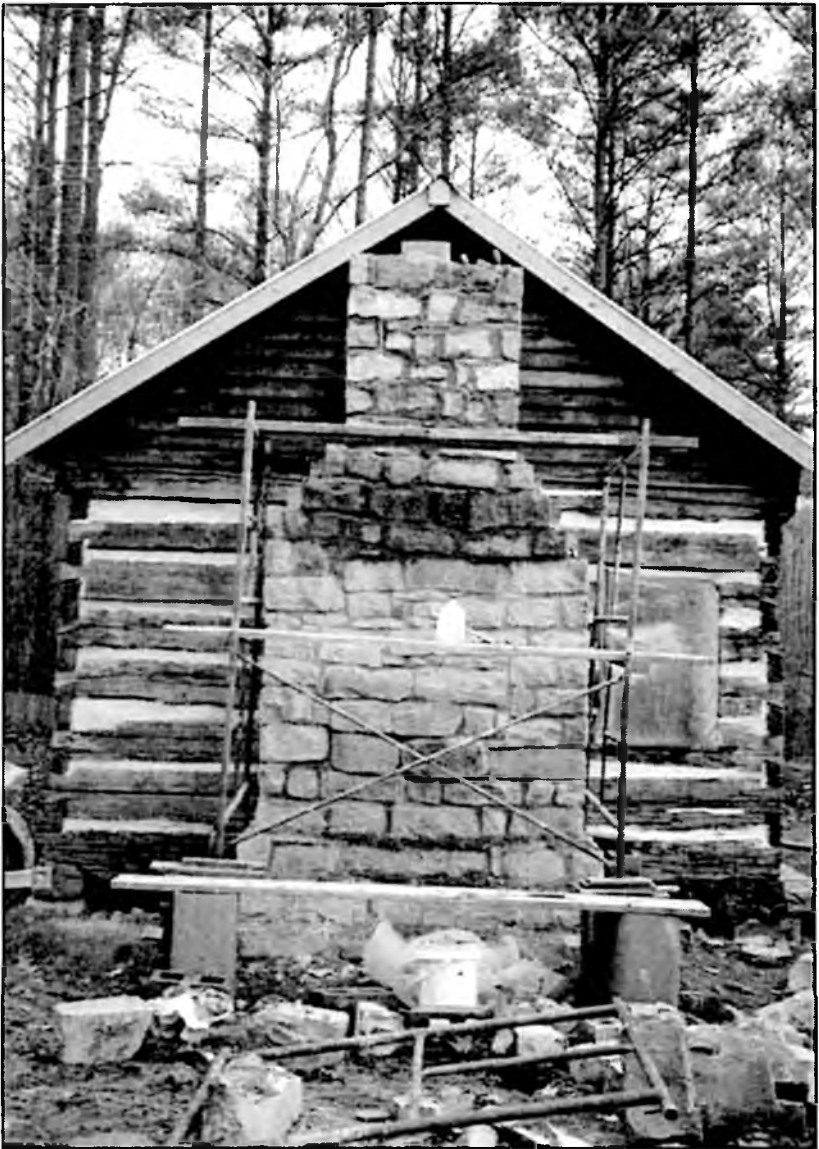
Fig. 8 Hollingsworth-Allen House, chimney rebuilding, December 1995.

The chimney had been constructed with limestone cut to fit and required the use of very little mortar. Dismantled rock by rock, the chimney was hauled to the new site. The front porch flooring was removed in three large sections and hauled to the new site.
