Volume 26
Number 1 *The 1939 Tennessee Valley
Architectural Photography of Frances Benjamin
Johnston*

THE
HISTORIC HUNTSVILLE QUARTERLY
OF LOCAL ARCHITECTURE AND PRESERVATION

FRANCES BENJAMIN JOHNSTON

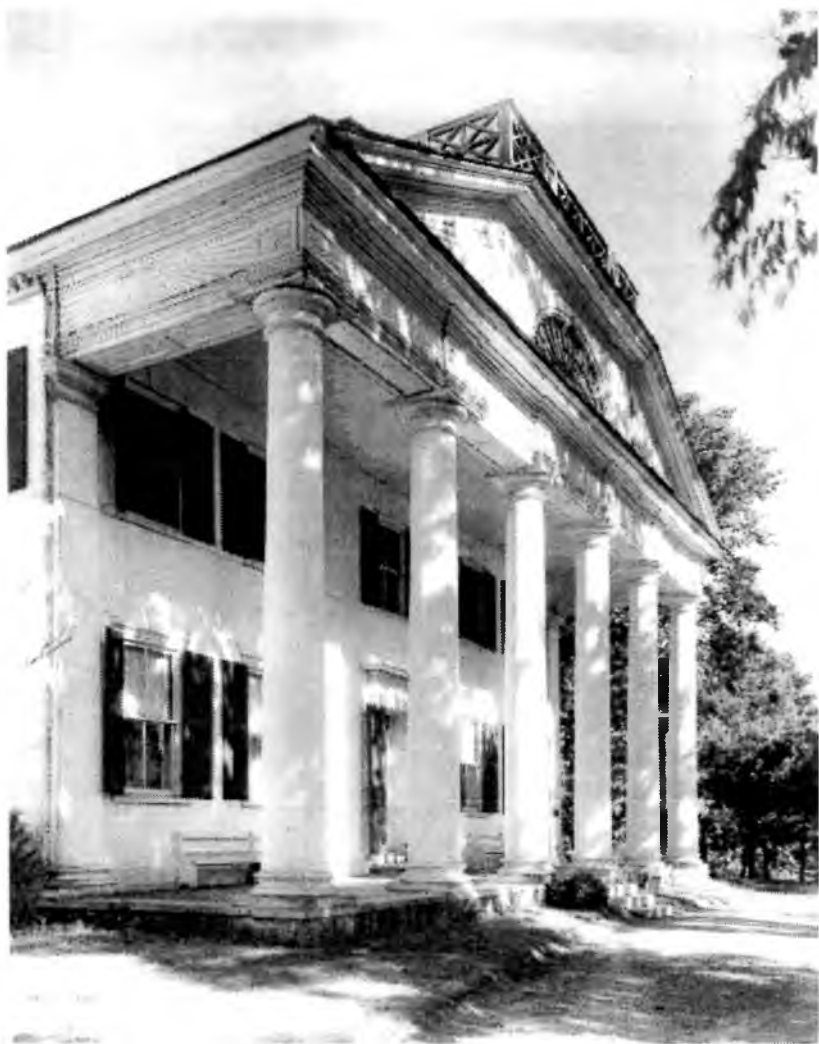
*Fig. 1 Portico, 1840s, at LeRoy Pope House. Huntsville, Madison County.*

One of Johnston's more successful Tennessee Valley images shows a building that is architecturally distinguished and historically significant. Johnston's image of it is captivating. It shows the elegant portico on the west side of the *LeRoy Pope House* in Huntsville (Fig.1, page 10). Begun in 1814 by the founder of Huntsville, Colonel LeRoy Pope (1765-1844), the initial portion of this large residence may be the oldest brick house in Alabama. The portico, a later addition designed by Huntsville architect George Steele in the early 1840s, features six substantial Tuscan columns with an unusual truncated pediment topped by a balustraded deck. Above the columns, on the face of the tympanum, is a reeded sunburst motif that is repeated on the front and sides of the frieze below.

to photograph its facade with the light coming from the left (Fig. 5, page 17). In the early afternoon, she shot the *LeRoy Pope House* in full sunlight (Fig. 1, page 10) and then the *Bibb-Bradley-Beirne House* (Fig. 7, above) in the lengthening shadows of the late afternoon sun.

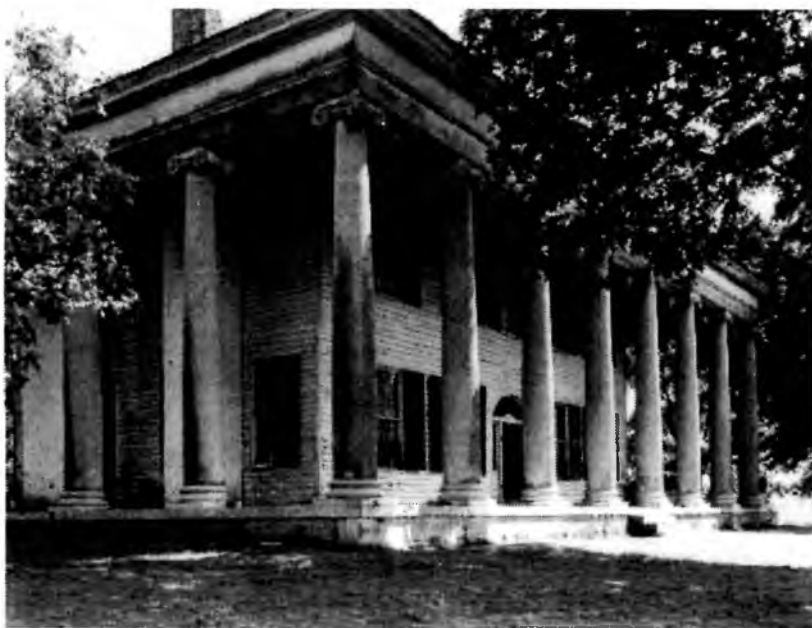
*Fig.2 The Forks of Cypress. 1830. Formerly near Florence, Lauderdale County. Struck by lightning and burned June 6, 1966.*

Among the now-gone Tennessee Valley buildings photographed by Johnston, the most grievous loss is *Forks of Cypress* (Figs.2 & 3, pages 12 & 14) north of Florence. It burned in June 1966 after being struck by lightning; ruins of its massive columns survive. An extraordinary building, the *Forks of Cypress* was probably designed by William Nichols and built about 1830 for James Jackson (1782-1840), a planter and breeder of nationally known race horses.

Johnston was clearly impressed by *Forks of Cypress* when she photographed it on May 14, 1939. She made ten photographs of it: the most views she made of any Alabama building. Seven are exterior shots, providing enlightening images of the impressive Ionic colonnade around the house. Three interior views show the elegant Federal detailing of the hall staircase and two graceful mantelpieces.

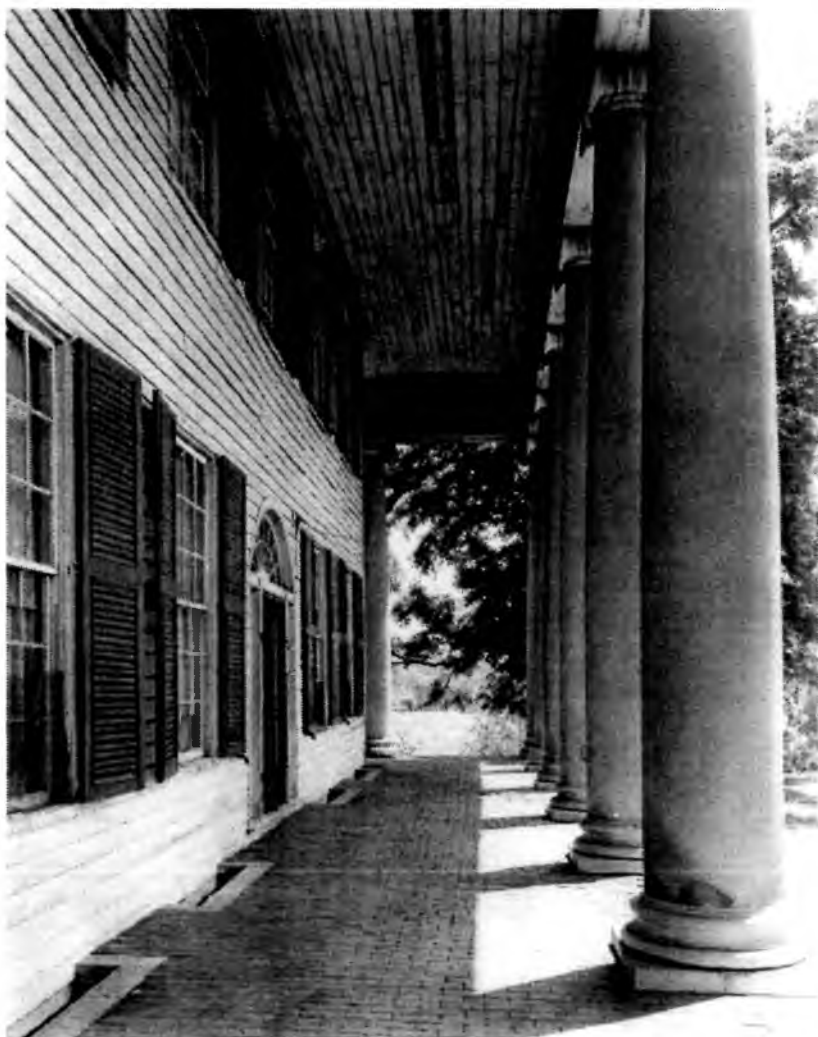
*Fig.3 Porch. **The Forks of Cypress.** 1830. Formerly near Florence, Lauderdale County. Struck by lightning and burned June 6, 1966.*

Perhaps the most evocative exterior view Johnston made at *Forks of Cypress* (Fig.3, page 14) looks along the porch of the main elevation. This photograph, too, is an exemplary image, distinguished by an artful composition of architectural form and pictorial pattern. At the left, it shows shuttered windows and the double-door main entrance, a view of distant foliage in the center, and the bases and massive columns of the main elevation colonnade at the right. The pattern of contrasting sunlight and shadow on the brick pavement neatly echoes

the rhythm of architectural elements on the left. These elements are nicely balanced in an elegant asymmetrical composition that effectively conveys the grandeur of this lost masterpiece. Similarly, in her oblique view of the main elevation (Fig.2, page 12), notice how she located her camera to show sunlight along the right edges of the columns.

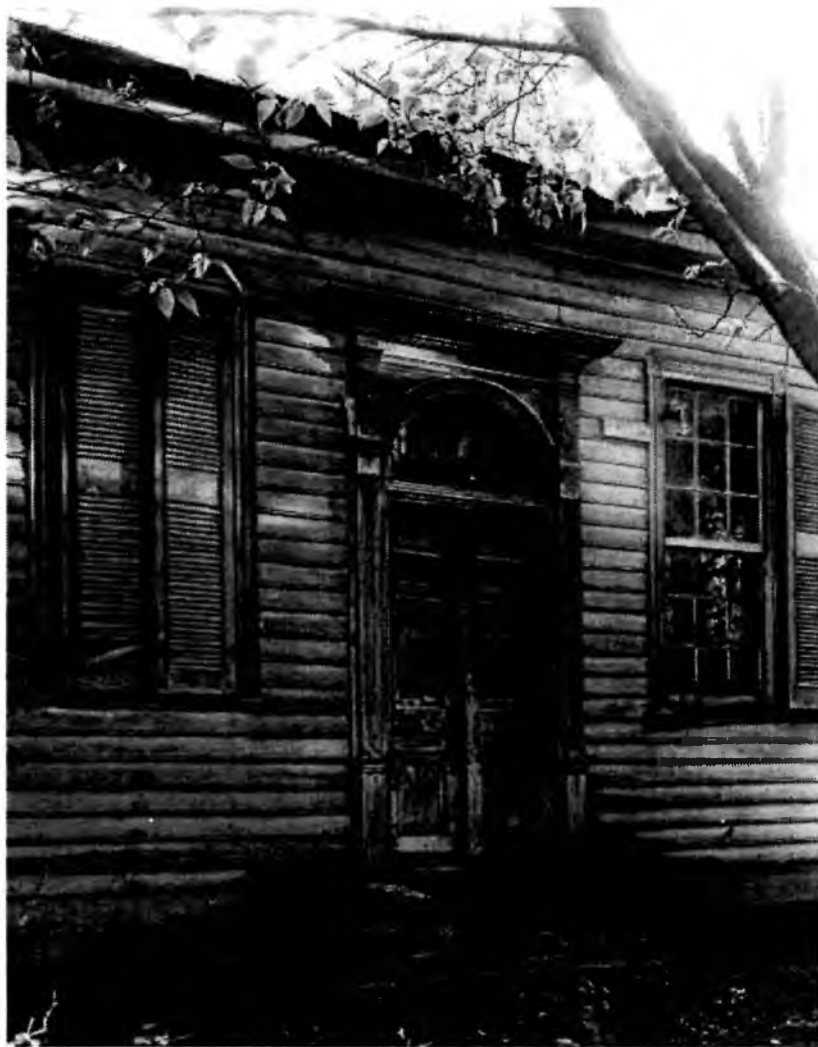
*Fig.4 Entrance. **W.W. James House**, circa 1825. Formerly near Courtland, Lawrence County. Demolished circa 1940.*

Such a view is seen in Johnston's image of an exceptional Adamesque fanlight doorway on a small Federal style home formerly in Courtland in Lawrence County, the W.W. James House (Fig.4, page 16). This view features an unusually detailed doorway of exceptionally sophisticated design. The paneled double doors, engaged side pilasters, carved sunburst motifs, and heavily molded cornice required considerable woodworking expertise. This doorway might be a demonstration piece, to show the skills of the home's initial owner Westwood Wallace James (1795-1866), who was a cabinetmaker from Virginia. Built about 1825, the house was sadly neglected in 1939, as seen in the missing stairs and shutter. It was demolished circa 1940, shortly after Johnston shot this telling detail of an exceptionally fine architectural element.

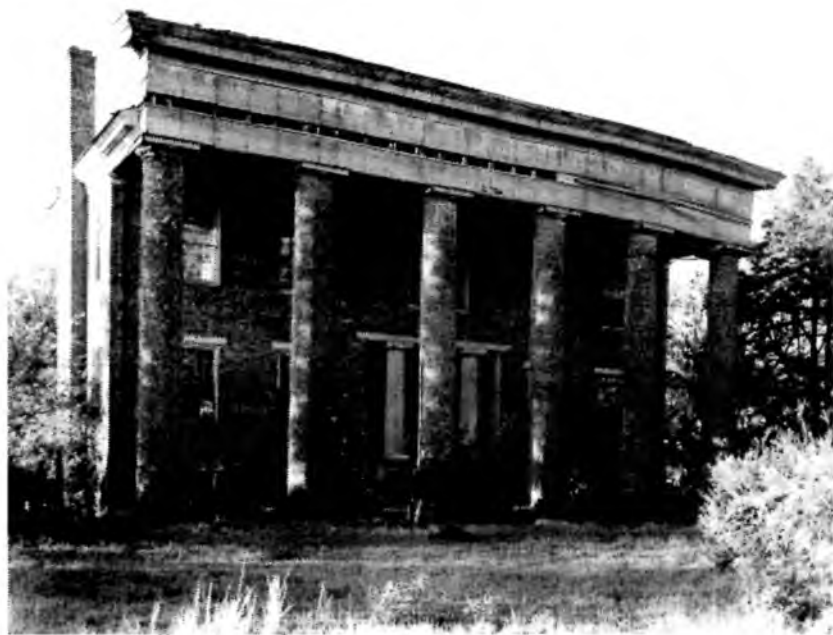
*Fig.5 David Wade House, circa 1840. Formerly near Huntsville, Madison County. Demolished 1940.*

Johnston addressed a similar challenge in her view of a lost Madison County home, the David Wade House (Fig.5, page 17), formerly north of Huntsville. Built about 1840, it too was deteriorating when she photographed it in May 1939. (It was subsequently demolished in the late 1940s.) Here, Johnston selected a distant overall view in order to include, and emphasize, the most distinctive architectural feature of the house, the massive oversized entablature above the columns. Even though the long gap across the wooden fabric shows that it had obviously lost much of its original detail, Johnston's image conveys a sense of its original imposing grandeur. She achieved this effect by positioning her large camera near the building so that her lens pointed upward at a moderately steep angle. In the resulting image, the large entablature dominates the scene, especially because its highlighted face contrasts so strongly with the dark shadowed walls behind the porch beneath it.

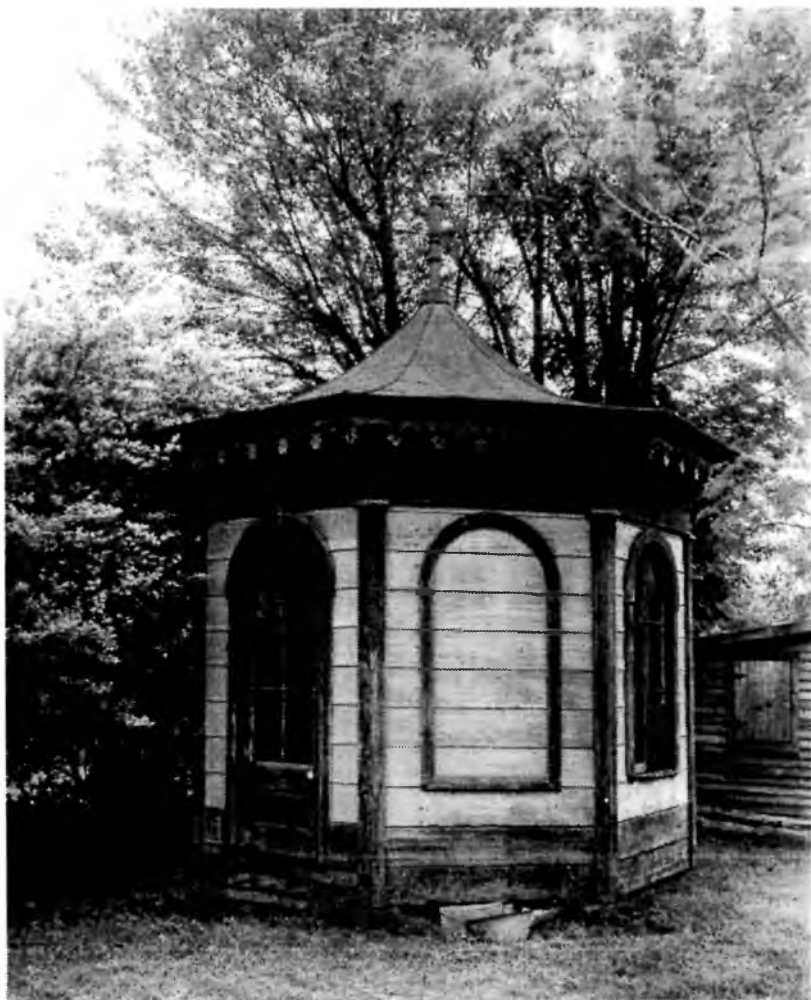
*Fig.6 Office, 19th century, at **Beaty-Mason House**, Athens, Limestone County.*

One of the few service buildings that Johnston photographed in the Tennessee Valley is an unusual small one-story octagonal frame building, an office at the *Beaty-Mason House* in Athens, Limestone County (Fig.6, page 19); a view of the entrance portico of the main house is discussed following. Dating from the mid-19th century, this charming little building features an arched doorway, matching windows, and a curving pyramidal roof, topped by a turned finial. Built probably as an office for an unidentified owner, it was photographed by Johnston for the same reason it has been preserved. This unusual survivor has distinguishing architectural features, unlike the typical service building that was usually razed when no longer needed for its initial use.

salient architectural feature, which is often a doorway or window, has vertical proportions, the vertical view can complement and enhance perception of the vertical architectural feature (See Fig.6 above). Also, the vertical view, like the partial view, can easily exclude undesirable adjacent distractions that would be seen in a horizontal view of the same feature. The vertical view is thus frequently employed in challenging situations.

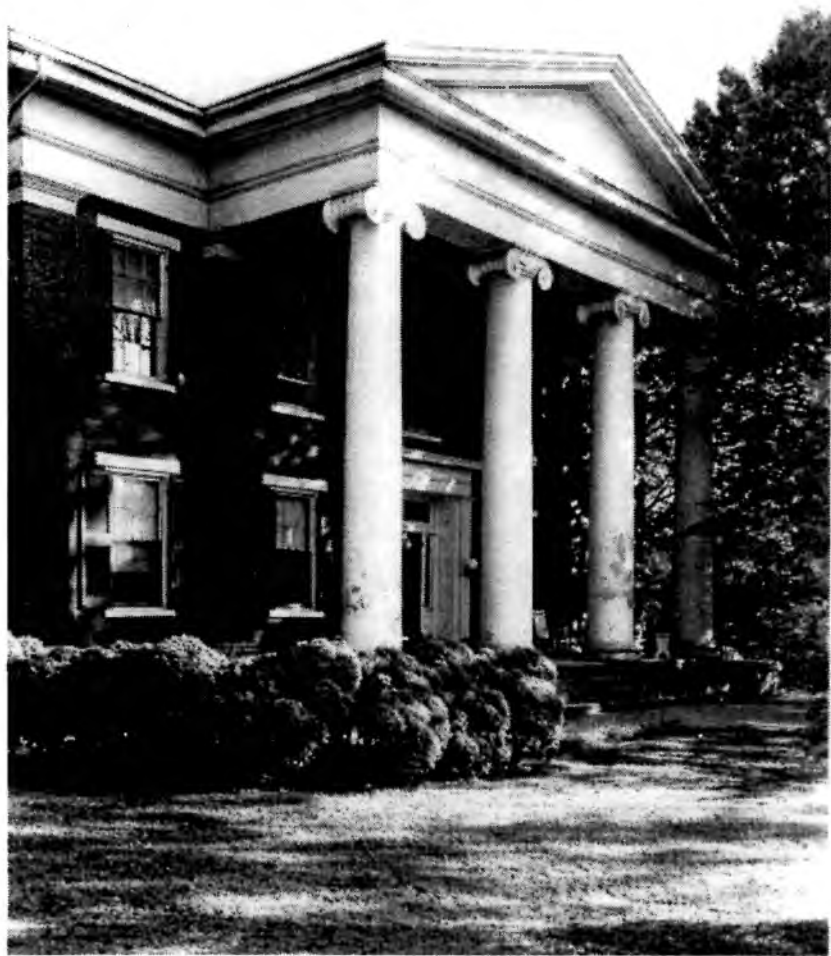
*Fig. 7 Bibb-Bradley-Beirne House, circa 1835. Huntsville, Madison County.*

We've already noted the critical contribution of strong sunlight in Johnston's successful images of the *LeRoy Pope House* and *Forks of Cypress*. Another fine Johnston image distinguished by effective use of sunlight is seen in her view of the *Bibb-Bradley-Beirne House*, located in the Twickenham Historic Preservation District, Huntsville (Fig.7, page 21). Photographed by Johnston in May 1939 on the same day as her views of the *LeRoy Pope House*, this view was taken probably later in the same afternoon, as shown by the long shadows on the lawn on the north side of the house.

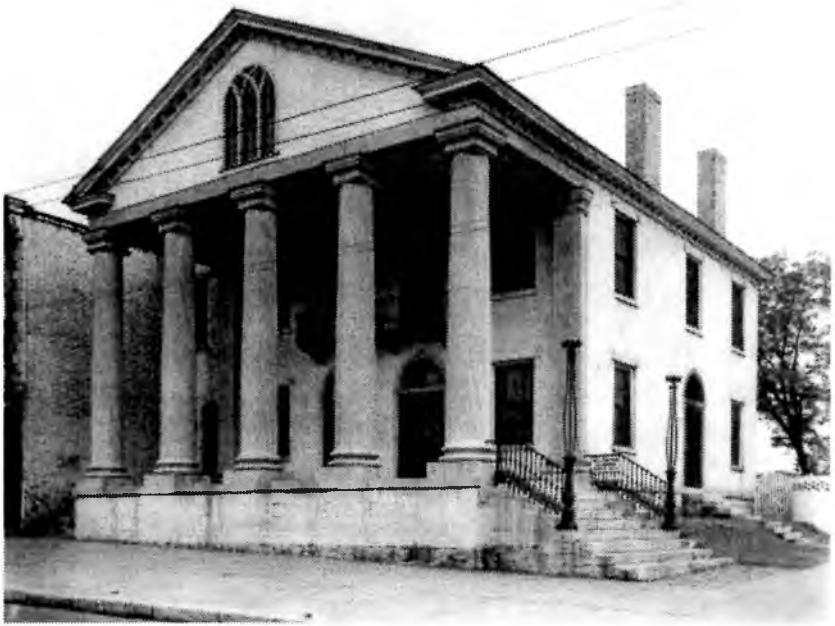
*Fig.8 Decatur Branch, State Bank of Alabama, circa 1834-1836. Decatur, Morgan County.*

Unusual materials and unique design elements distinguish the *Decatur Branch, State Bank of Alabama*, built about 1834-36 (Fig.8, page 23). Granite, rarely used in Alabama buildings, is the fabric of the impressive columns and the window transoms and sills. Also unusual is the 5-column portico. It is odd, literally and figuratively. An even number of columns—2, 4, 6, 8—is the norm for classic revival porticos. Also unusual are the square capitals (usually round) and the atypical arched window with Gothic tracery in the tympanum. This 1939 view documents a historic condition since changed; the arched window, probably a later addition, was removed during the 1979-80 reconditioning of the building.

Johnston's view was apparently taken on an overcast day, evident by the subdued lighting and the absence of highlights. In making the view, her camera placement may have been constrained by the building's urban setting, as suggested by the close cropping of the large neighbor building at the left side of the view. Notice also how she sited her camera to de-emphasize the utility wires by having one set overlap the tympanum rather than cutting across the columns below.

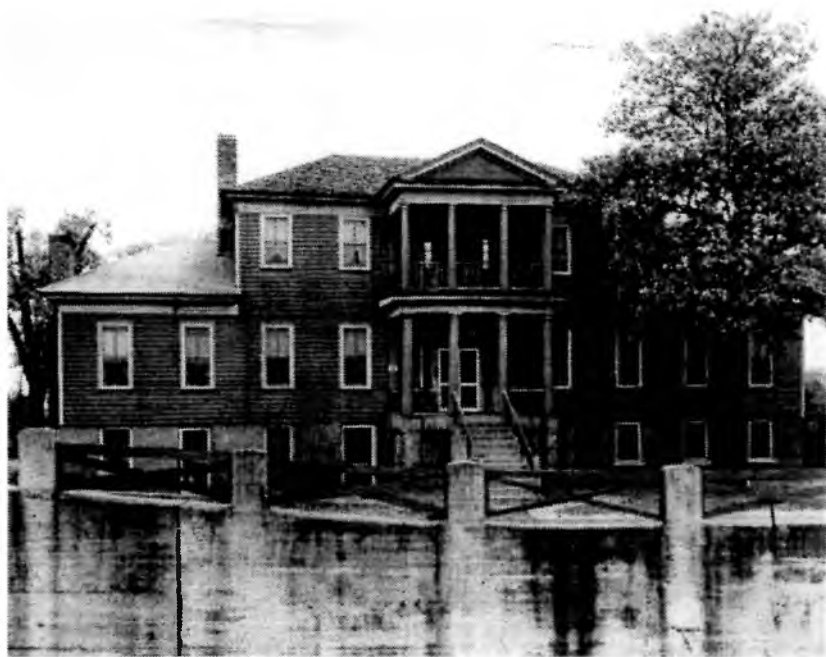
*Fig.9 Dancy-Polk House, circa 1829. Decatur, Morgan County.*

A different urban challenge is confronted in Johnston's view of the *Dancy-Polk House* (Fig.9, page 25). Built circa 1829 for Colonel Frank Dancy, this wood frame structure on a high brick foundation is one of the oldest surviving buildings in Decatur. An unusual profile—a two-story central core flanked by one-story wings—and a Palladian-style double porch on the east elevation are prominent features of this building. However, the best views of these features are severely constrained by a deep railroad cut constructed near the building after it was completed. The railroad cut dominates the foreground of any overall view of the east side of the house and the Palladian porch. Another impediment was a large tree to the right of the porch.

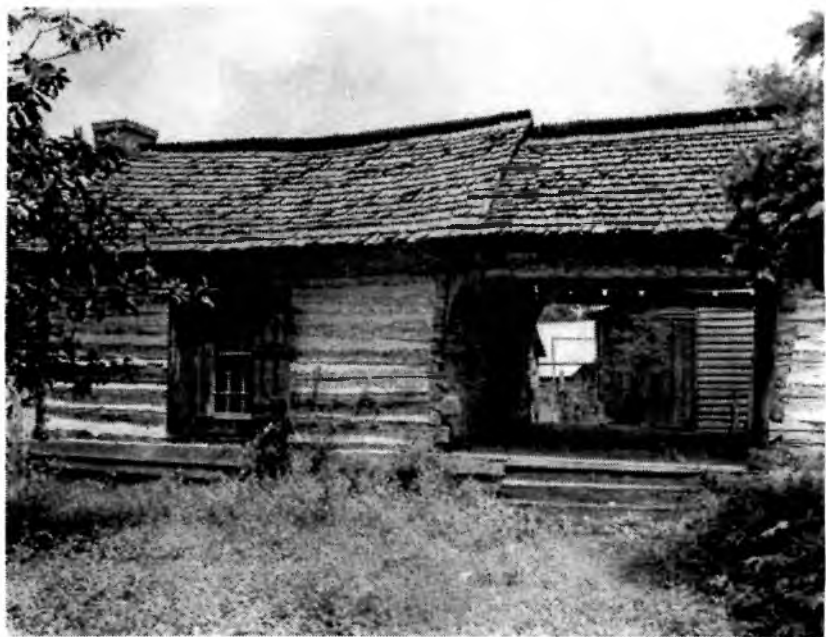
*Fig.10 Log house, circa 1818, at Pond Spring (Gen. Wheeler home), near Courtland, Lawrence County.*

Johnston encountered obscuring foliage at the earliest Tennessee Valley building that she photographed, a log house at *Pond Spring*, the later home of General Joseph Wheeler in Lawrence County, east of Courtland (Fig. 10, page 25). Built about 1818 probably by the Hickman family, this log house is constructed of hand-hewn logs, in the traditional mode used by the first generation of settlers in this area. It has a dogtrot plan of two square *pens* separated by an open breezeway covered by a roof joining the pens. The pens were probably constructed at different times, as suggested by the break in the roof line. Johnston did not make an entire view of this interesting early survivor, probably because full views were apparently obscured by nearby trees. She made a partial view of it, showing only the left pen and the open breezeway. To make this view, she had to carefully site her camera to shoot between the two trees seen at the left and right edges of her view.

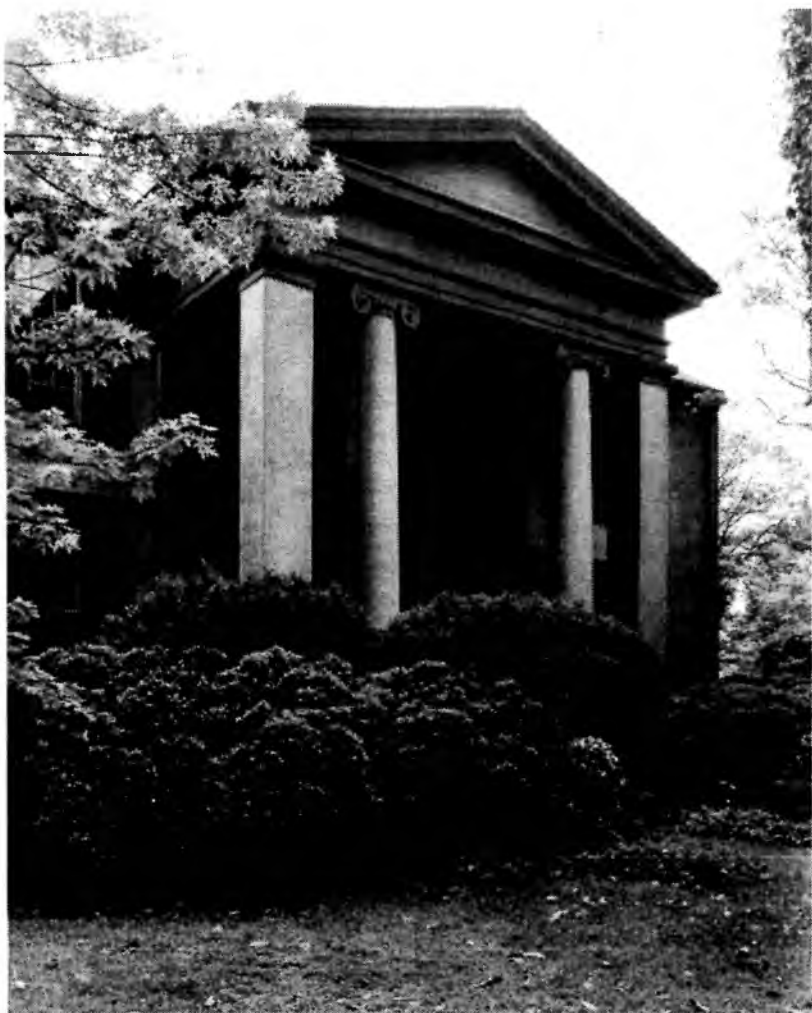
*Fig. 11 Portico, 1845, at **Beaty-Mason House**, Athens, Limestone County.*

Similarly, large boxwood shrubs dominated the foreground of views of the 1845 entrance portico of the *Beaty-Mason House* in Athens, Limestone County (Fig. 11, page 27). Featuring two full-height Ionic columns, this grand portico was designed by architect Hiram H. Higgins for Capt. John Mason and added to the front of a substantial brick home built in 1826 by Robert Beaty, Mason's father-in-law. (The house became the official residence of the president of Athens College in 1960.) Johnston's vertical view, probably taken on an overcast day, made the most of a challenging situation. The vertical format complements the height of the tall columns. She placed her camera to make a pleasing contrast of rounded boxwood mounds seen against the taut hard geometry of the classical revival architecture.

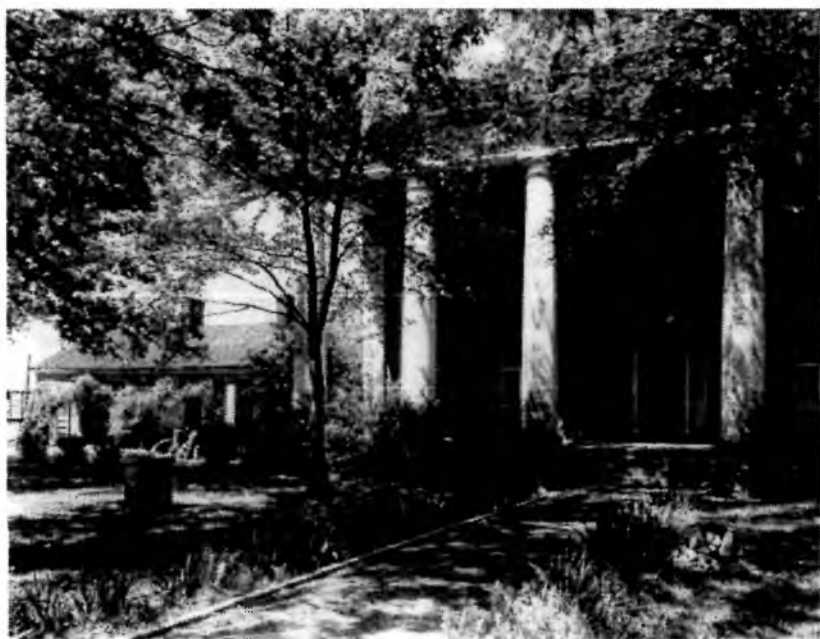
*Fig.12 Portico, left side. Belle Mina, circa 1826-35. Near Mooresville, Limestone County.*

The exterior shots of *Belle Mina* all show partial views of different aspects of the building. None show the entire portico, probably because of the obscuring trees. Taken on a sunny day, these views are enlivened by strongly contrasting highlights and shadows. One view emphasizes the gracious ambiance of *Belle Mina*'s setting (Fig. 12, page 28). Dappled patterns of sunlight and dark shadows pervade the view. Tree foliage, grass tufts, and the brick entrance walk are primary motifs, seen in front of the left of the portico and a one-story service wing in the background. A second partial view, with a tighter, close-in vertical format (Fig. 13, page 29), emphasizes two sunlit portico columns framing the elegant fanlight doorway of *Belle Mina*'s main entrance.

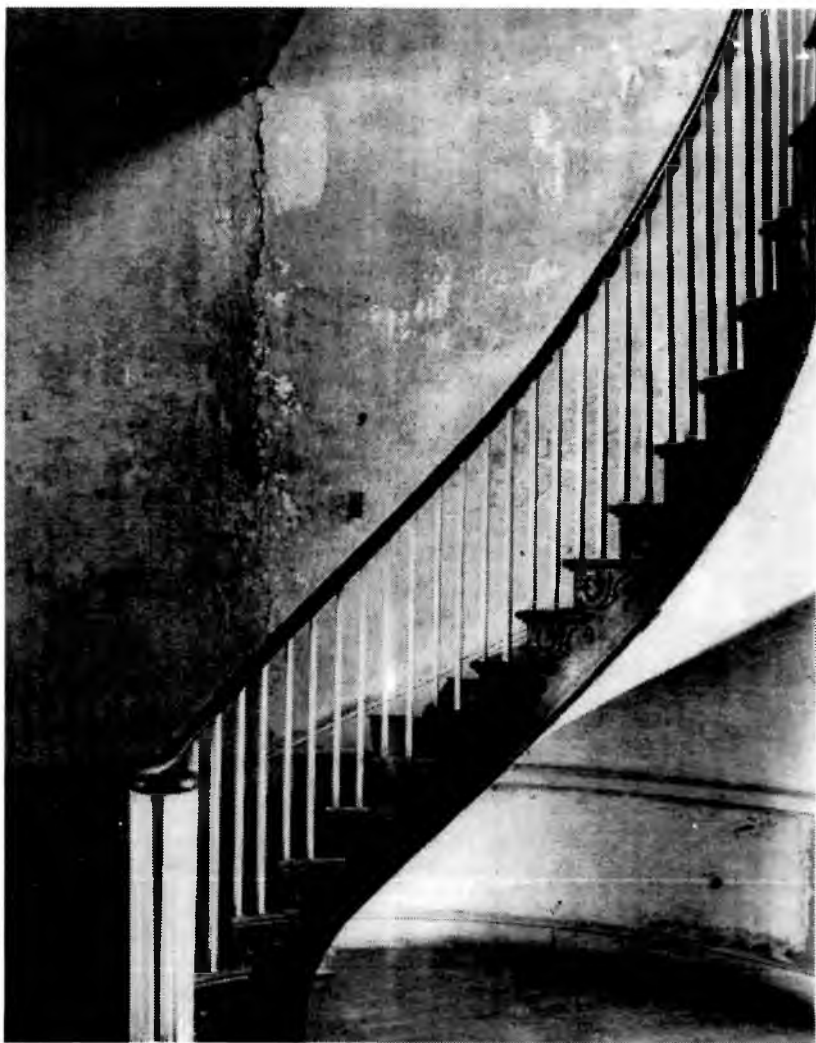
*Fig.14 Spiral Stairway. **Belle Mina**, circa 1826-35. Near Mooresville, Limestone County.*

Belle Mina has exceptionally fine Federal period woodwork, exemplified here by the stair's intricate scrolled endpieces. In Johnston's image the carefully composed vertical format emphasizes the elegant shape of the stairway, spiraling upward to the right. It is further enhanced by the soft lighting, probably obtained by opening the wide main entrance door at the opposite end of the main hall (Fig.13, page 29).

Another challenging factor in making interior shots is seen in this view. When fabric or paint has deteriorated near a primary feature, it may be difficult to compose an interior view to exclude the distracting blemish. Here, the peeling paint on the wall would have been hard to exclude from any view of this staircase.

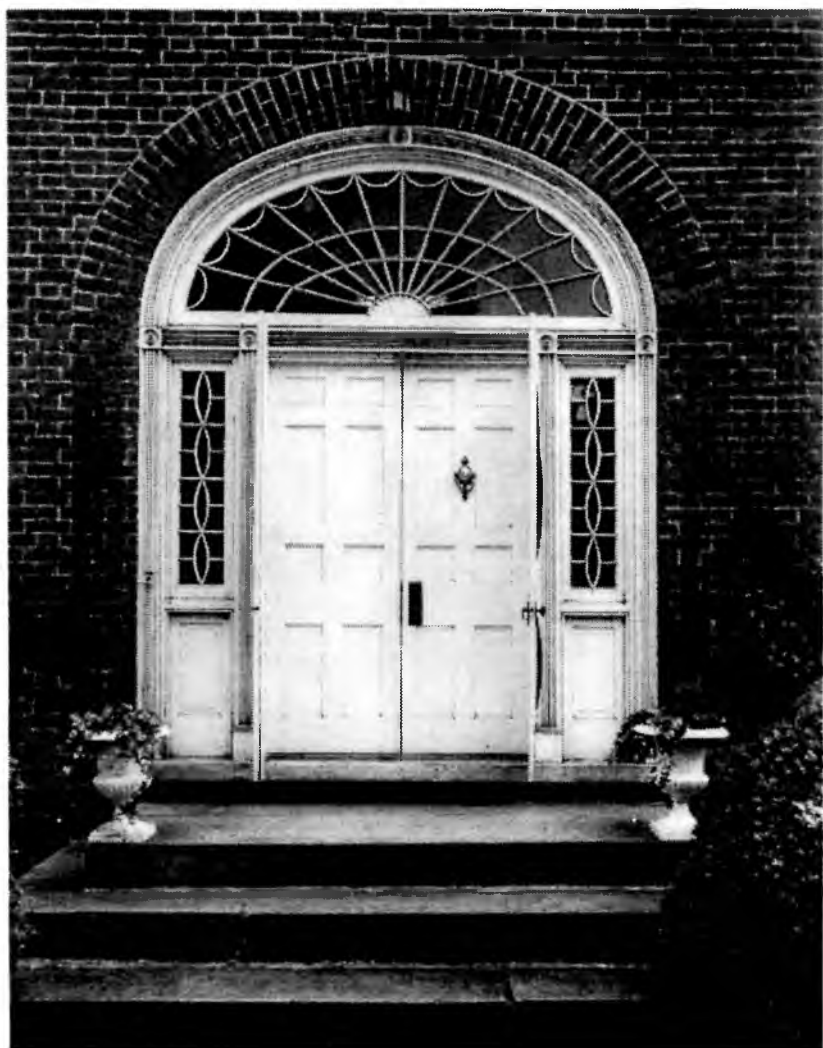
*Fig.16 Fanlight doorway. Woodlawn, circa 1825. Near Florence, Lauderdale County.*

Coming from the right, this lighting probably came through the open double doors of the main entrance. It is also seen in Johnston's exterior detail view showing *Woodlawn's* large fanlight doorway (Fig. 16, page 34). This vertical format view emphasizes the unusual granite entrance steps, fine tracery of the fanlight doorway, and Flemish bond pattern of the brick exterior.

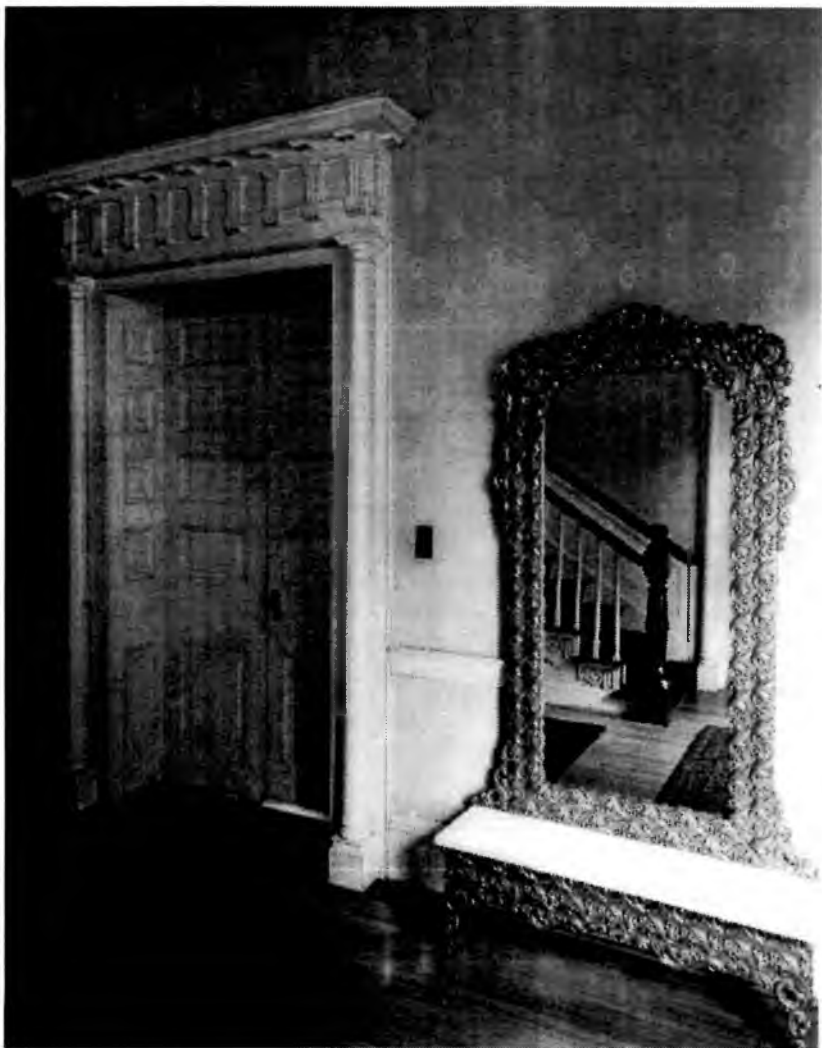
*Fig. 17 Doorway, mirror, and reflection. Rhea-Burleson-McEntire House, circa 1836. Decatur, Morgan County.*

At the *Rhea-Burleson-McEntire House* in Decatur, Johnston made only interior detail views. Built in 1836 for John Sevier Rhea, grandson of Tennessee Governor John Sevier, this grand house is located on the south bank of the Tennessee River. It has exceptionally elaborate interior woodwork, as seen in Johnston's carefully arranged view of a doorway and hall mirror (Fig. 17, page 35). This view in the main hall shows one of the most sophisticated Federal style doorways in the Tennessee Valley, featuring paneled double doors framed by an impressive engaged columnar architrave. Notice the reflection in the gilded mirror bench at the right of the view. Its reflected image shows the foot of the staircase, dado paneling, and carved doorway on the opposite side of the hall.

Imagine the amount of time needed to set up this dense complex view of doorway, mirror, and reflection, and to wait for the optimum moment when light would be streaming through the main entrance door (out of the view) at the right. This detail interior view is shot in vertical format, as seen elsewhere in situations where Johnston wanted to focus viewer attention on significant architectural elements. (The vertical format is used in three of the four interior views she made of the *Rhea-Burleson-McEntire House*.)

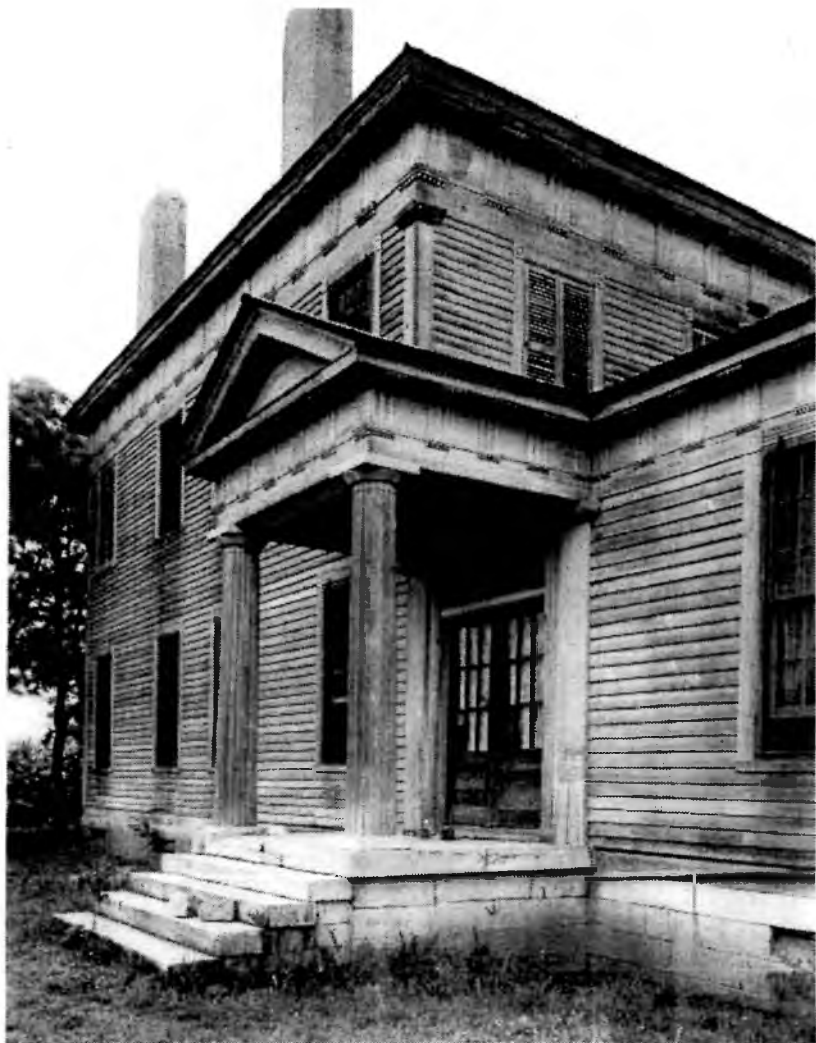
Fig. 18 Side portico. **Barton Hall**, circa 1847-49. Near Cherokee, Colbert County.

Its complex plan features a Doric entrance portico on the two-story main body of the house, and two one-story rear wings with Doric side porticos and a loggia. A sense of one important element of this plan is effectively conveyed in Johnston's well-composed view of a side portico (Fig. 18, page 37). It shows a unique feature of *Barton Hall*, the refined Doric entablature with tryglyphs and metopes located on the frieze of every portico, and on all sides beneath the roof edges. Notice also the carved moldings about the windows and the engaged corner pilaster seen above the portico.

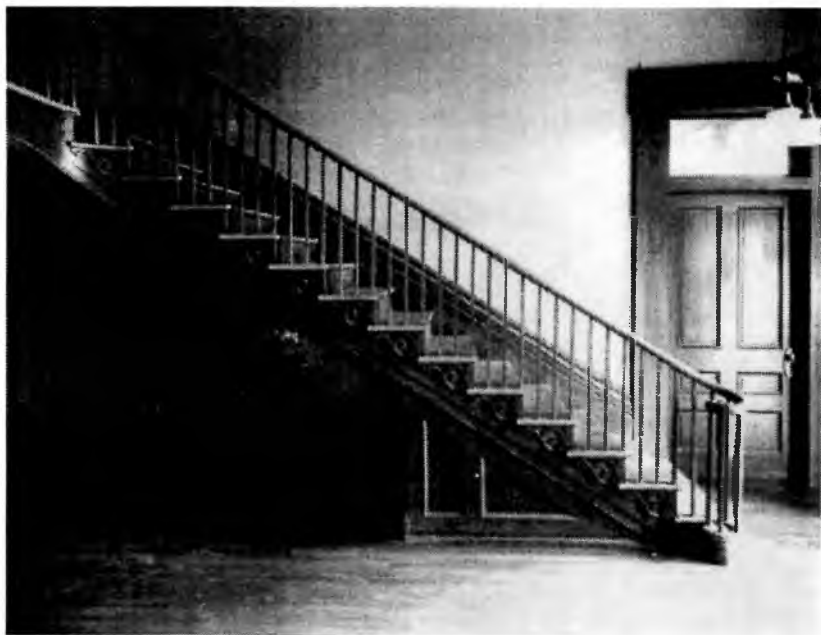
*Fig.19 Flight of stairs. Barton Hall, circa 1847-49. Near Cherokee, Colbert County.*

Johnston's two interior views of *Barton Hall* both show the unusual stairway that dominates the main hall. The more effective view of this complex structure is a partial view that focuses on a single element, a flight of stairs (Fig. 19, page 38). The view features one of the flights that rise from each end of the main hall. They ascend in a series of double reverse flights connected by bridge-like flying landings. This remarkable structure is challenging to photograph in its entirety in any condition. Using only available natural light, Johnston's views convey a convincing sense of its complexity and unique architectural character.<sup>12</sup>

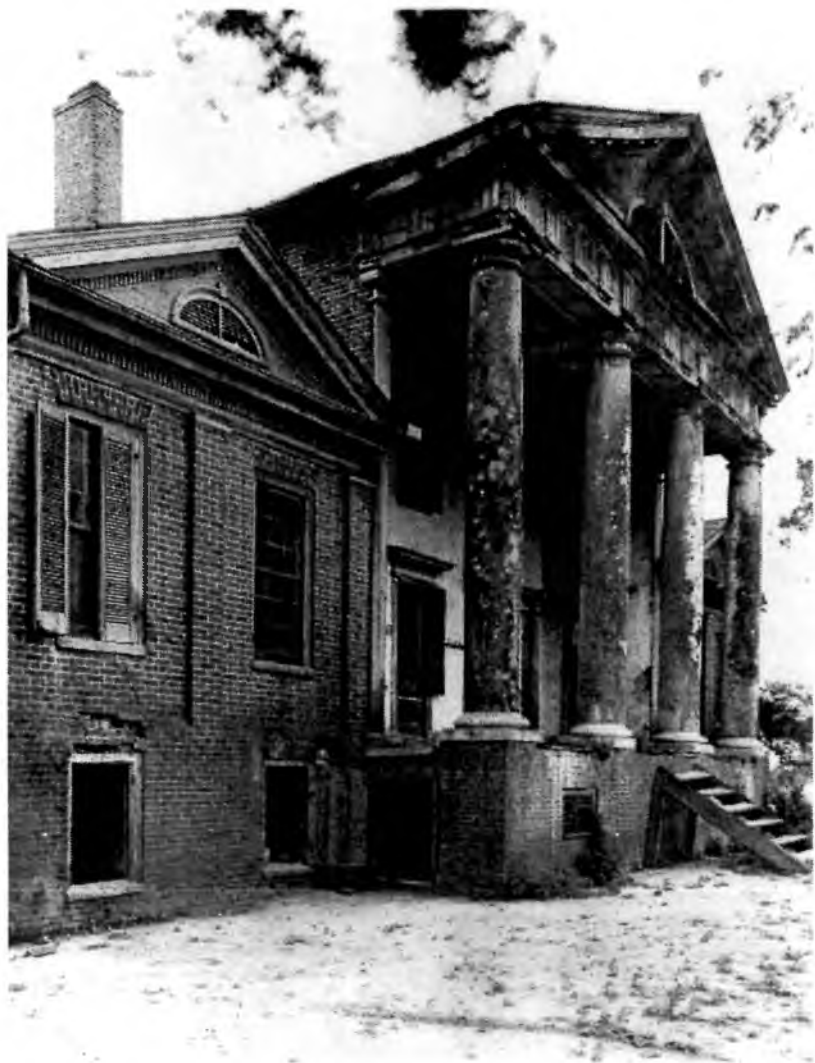
*Fig.20 Saunders-Goode-Hall House, circa 1830-35. Near Town Creek, Lawrence County.*

The *Saunders-Goode-Hall House* is located north of Town Creek in Lawrence County. It was built in 1830-35 for the Rev. Turner Saunders, planter and Methodist minister from Brunswick County, Virginia. It has been cited as an "outstanding expression in Alabama of Jeffersonian classicism exhibiting Palladian influence."<sup>13</sup> The

*Saunders-Goode-Hall House* is constructed of brick in a three-part H-shape plan, with a central two-story pavilion flanked by one and one-half-story wings.

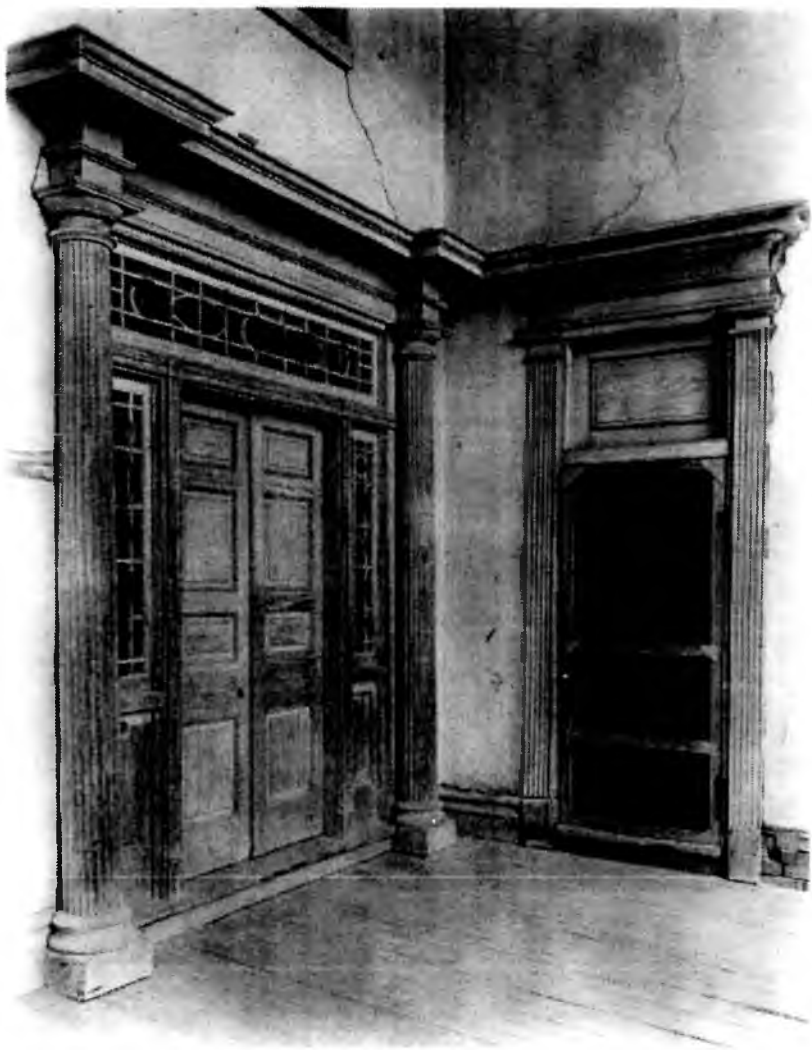
*Fig.21 Two doorways on portico porch. **Saunders-Goode-Hall House**, circa 1830-35. Near Town Creek, Lawrence County.*

*The doorways in this view can be glimpsed between the portico columns in the overall view (Fig.20) on the facing page.*

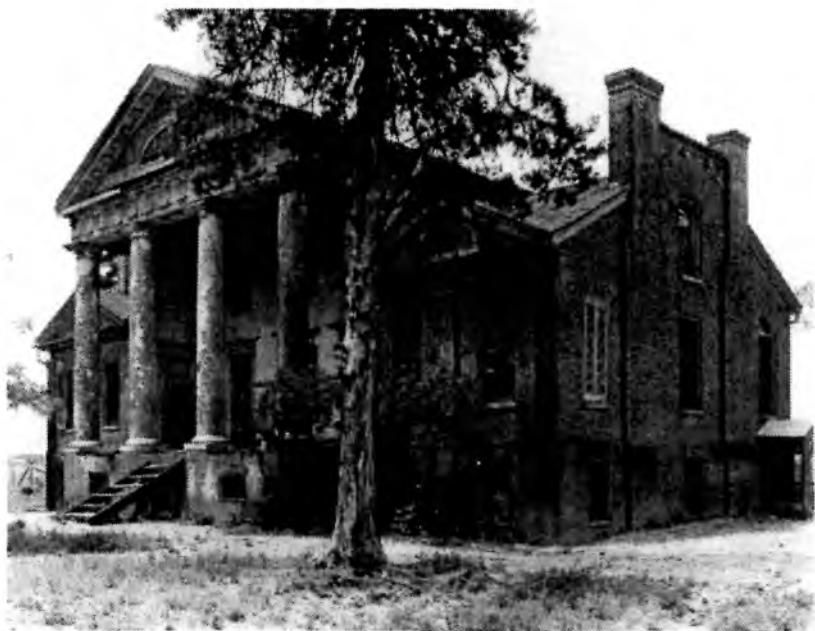
*Fig.22 Portico and right wing. Saunders-Goode-Hall House, circa 1830-35. Near Town Creek, Lawrence County.*

A more distant oblique view, looking left, features the portico and right wing (Fig.22, page 42). It shows the raised basement and the intricate brickwork of the parapeted end chimneys. It also shows yet another instance where a well-placed tree presented an interesting challenge to a photographer. Here, Johnston sited her camera to compose her view with the trunk just to the right of the portico columns and much of the foliage above the roof.
