Preserving a Legacy: An Architectural History of the I. Schiffman Building, 1845-2017

Katherine L. Stamps

Stamps, Katherine L. (2017) "Preserving a Legacy: An Architectural History of the I. Schiffman Building, 1845-2017," *Huntsville Historical Review*: Vol. 42: No. 2, Article 5.

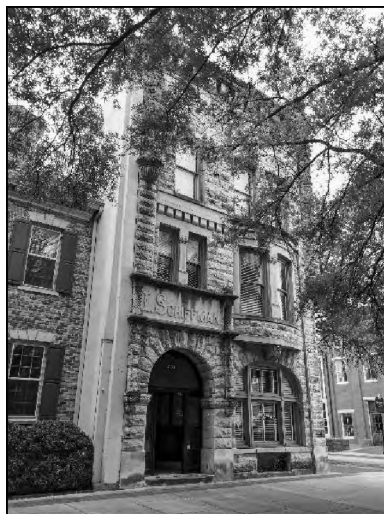
Figure 1. I. Schiffman Building, west elevation. Photo credit: K. Stamps, May 13, 2017.

The I. Schiffman Building's original design consisted of three symmetrical bays divided by pilasters with simple moldings and dentils. Housing the Smith, Herstein & Co. dry goods store ca. 1860, this three-story structure became a bustling component of Huntsville's economy.

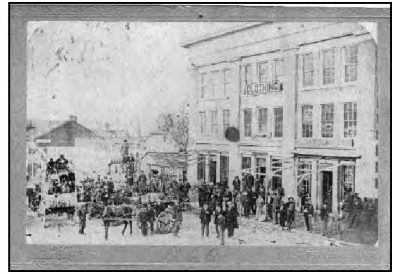
Figure 2. I. Schiffman Building ca. 1860s during Smith, Herstein & Co. ownership. Photo credit: Huntsville Madison County Public Library.

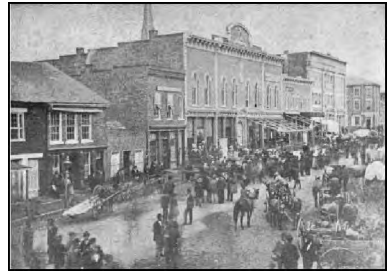
Figure 3. I. Schiffman Building and post-Civil War development in downtown Huntsville. Photo credit: Huntsville Madison County Public Library.

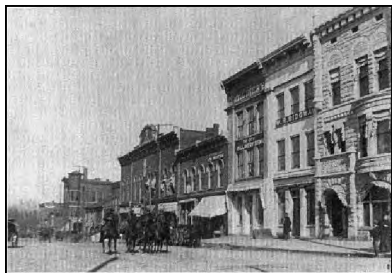
Figure 5. I. Schiffman Building ca. late-19th century after Southern Savings and Loan 1895 renovation. Photo credit: Huntsville Madison County Public Library.

The building was given a new, quarry-faced limestone façade which was “splendidly arched over the vestibule entrance,” according to the *Weekly Mercury* of March 13, 1895: “The side wall was plastered and scored to resemble masonry. The entrance was shifted to the north side of the façade and a large window opens into the president’s office. Above the entrance is a dressed stone slab bearing the name “I. Schiffman,” and above the window is a heavy keystone carved with a foliate design. The second floor has two narrow windows over the entrance topped by a smooth stone lintel and a small-scale replica of the cornice.

On the third floor two windows are grouped above the bay while the third is centered over the entrance. A dressed stone lintel extends across the façade and forms the base for stone arches which spring over each window. Each corner is accented by an attenuated turret that extends above the heavy stone cornice. The cornice continues along the side wall of the building which is divided into five recessed bays by plain pilasters and an entablature that were features of the antebellum structures. The windows were enlarged during the 1895 remodeling and an entrance added in the last bay.”⁶

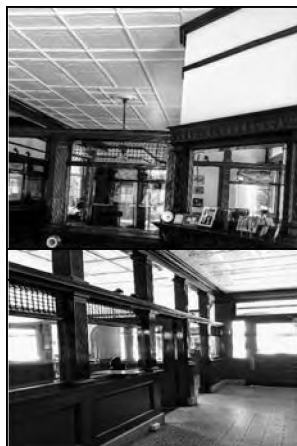
Figures 9-10. I. Schiffman Building, first floor interior, photos taken by K. Stamps on

The 1895 renovation reconfigured the interior floor plan to side hall and offices on all three floors. The building has retained a significant portion of the character-defining features installed during this renovation including pressed tin ceilings, carved cherry wood on the first floor, oak on the second and third floors, mission style chandeliers that used carbide for lighting, corner fireplaces with carved mantels, and two walk-in vaults located on the first floor and basement.⁷

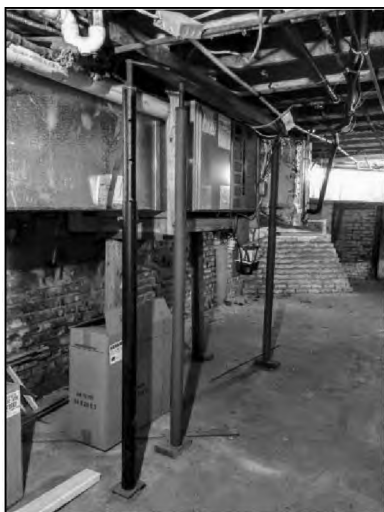
Figure 11. I. Schiffman Building, basement interior. Photo credit: K. Stamps, April 13, 2017.

Stones from the 1845 foundation are still visible in the basement. Support poles and beams have been installed over the years to reinforce settling issues. "Since it was built in 1845, the flooring needed some additional support," said Goldsmith. The walk-in vault and triangular bases of the fireplaces installed during the 1895 renovation can also be seen.

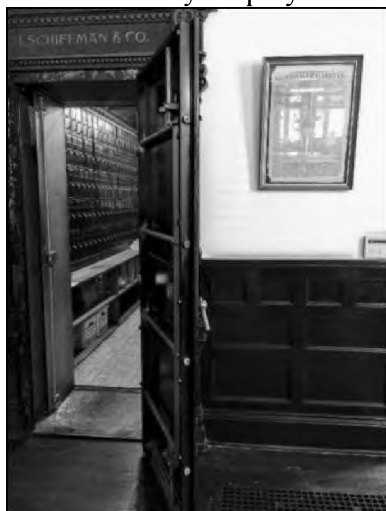
Figure 14. I. Schiffman Building, first floor vault detail. Photo credit: K. Stamps, April 13, 2017.

Modern lighting was added to illuminate the walls of metal drawers in the large walk-in vault on the first floor used by both the Southern Savings and Loan Company and I. Schiffman & Co. to store client records. Remnants of protective rubber treads can be seen on the wood flooring, installed to keep the bookkeepers' benches from sliding as they stood at the 1895 cherry desk that was built in place because of its large size. Tiny holes from carpet staples are also visible in the wood. Goldsmith's grandfather, Lawrence

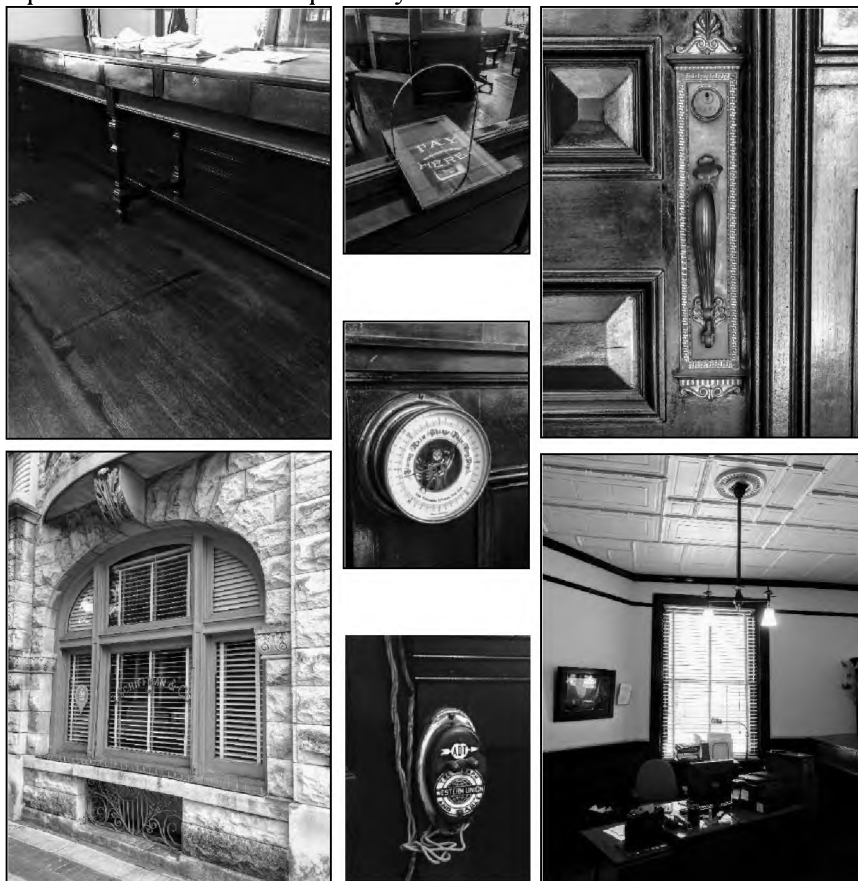
Figures 15-21. I. Schiffman Building, first floor details. Photo credit: K. Stamps, April 13, 2017.

B. Goldsmith, Sr., installed a row of blunted iron spikes along the sill of the arched front window to keep people from sitting on the ledge when they came to town on Saturdays. Although the windows are original to the 1895 renovation, broken panes are replaced as needed. Goldsmith said they are very expensive to replace and have to be specially ordered.

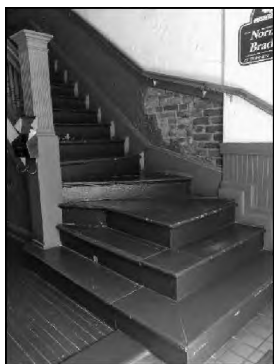
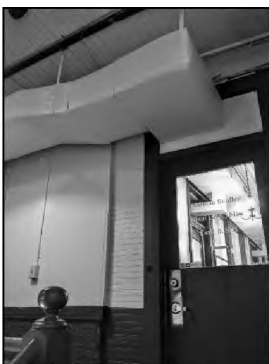
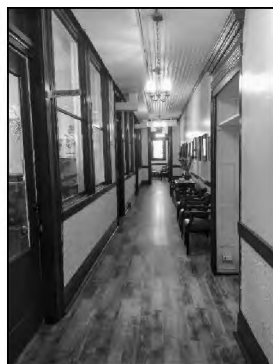
Figures 22-24. I. Schiffman Building, stairwell and second floor details. Photo credit: K. Stamps. April 13, 2017.

There is no elevator in the building and the interior staircase extends from the basement to the third floor. The first floor rear vestibule was enclosed in the 1920s. Plywood was removed from the stairwell walls and replaced with beadboard during the 1998 renovation. A small area of plaster was left unrepaired in order to reveal a section of brick wall on the first floor of the stairwell. The rear of the building was bricked up during the 1950s to 1960s. A formerly exterior window between the first and second floors has been frosted over in order to conceal the brick wall behind it.

One of the major challenges was to add heating and air conditioning to the second floor. The building does not have a crawl space and Goldsmith wanted to avoid lowering the ceiling to disguise the HVAC system. She had to be creative to incorporate this modern element into a 19th-century structure. After consulting with the Department of the Interior tax credit reviewer, they agreed to use the transoms over each door to funnel the ductwork.

removed old carpeting. Due to the second floor being occupied by a tenant at the time, Goldsmith was unable to remove the asbestos tile flooring and restore the original wood. Installing laminate wood flooring on top of the asbestos was a reasonable alternative that offered a traditional appearance and protected the original wood flooring underneath.

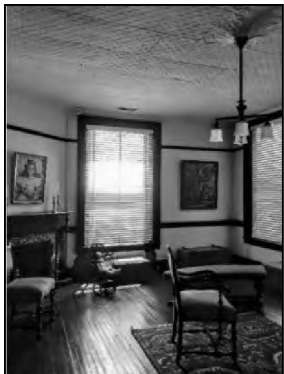
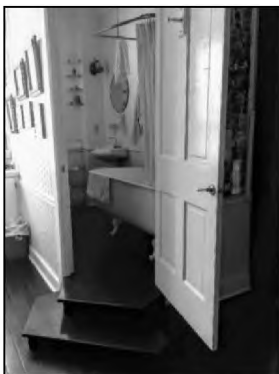
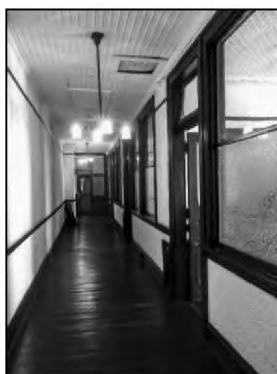
Figures 25-27. I. Schiffman Building, third floor interior. Photo credit: K. Stamps, April 13, 2017.

While the third floor has also retained the side hall and offices plan, it was renovated as rented apartment space during the early 1900s when the Southern Savings and Loan Company was having financial difficulty. They installed a kitchen and bathroom, converting the offices into bedrooms. During the 1998 renovation, new cabinets, a washer and dryer, hot water heater, and appliances were installed in the kitchen. Because there was no crawl space in the 1845 building, the bathroom floor was raised at that time to accommodate the plumbing. Goldsmith raised the kitchen floor in 1998 to be more compatible with the raised bath flooring and replaced the old plumbing with new PVC pipes.

Built-in oak cabinetry provides closet space and 1920s furnishings collected by Goldsmith's father and grandfather decorate the rooms. Copies of family portraits adorn the original 1895 plaster walls using the original picture molding also installed in 1895. The original paintings having been donated to museums and replaced with copies. Goldsmith searched for and found period-appropriate Mission-style chandeliers during her time living in New Orleans. She also installed period tiles from New Orleans around the fireplace to replace those that had been broken to match the original 1895 tiles.

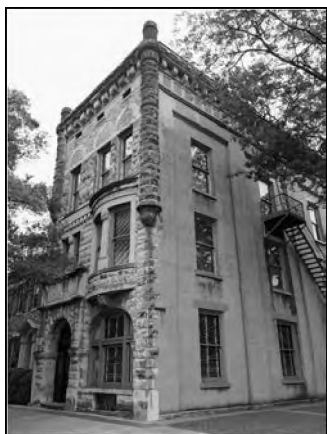
Figure 28. I. Schiffman Building, southwest exterior elevation. Photo credit: K. Stamps, May 13, 2017.
