The Historic Huntsville Quarterly

19th Century Dependencies: An Overview

Linda Bayer Allen

19th-Century Dependencies

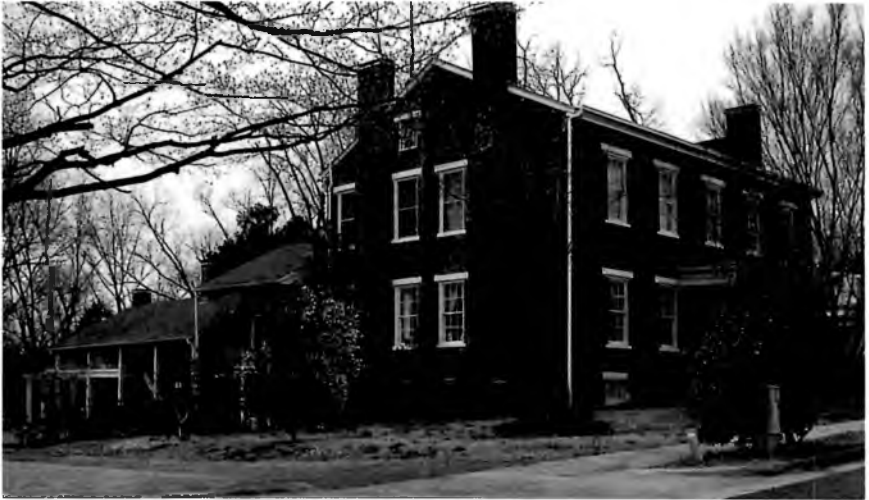
The house at 518 Adams Street is a notable example illustrating how the kitchen and servants' quarters were frequently attached to the main house. Photograph by Linda Allen, 2006

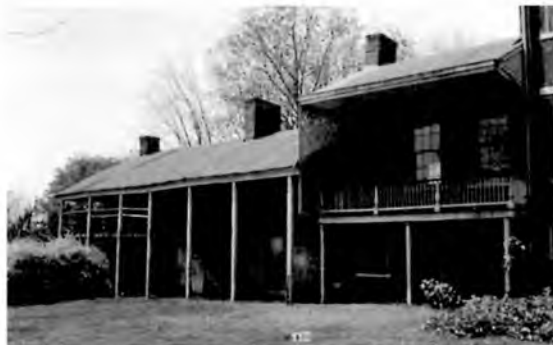
In 1934, the 518 Adams house was documented in drawings and photographs by HABS. The two-story section on the far left provided living spaces for house slaves, the adjacent section without a balcony but with the largest chimney would have been the kitchen, and the taller two-story section on the right provided access to the house and dining room. Photograph by W. N. Manning for HABS, 1934

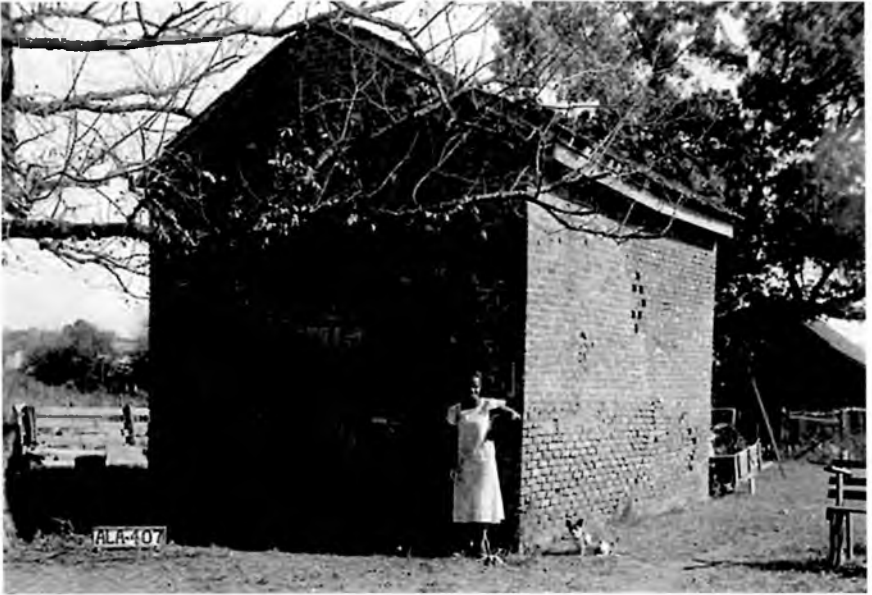
The importance of the smokehouse can be inferred by its proximity to the rear of the main house. This brick example from New Market illustrates a common local design with a vertical-plank door, diamond-patterned vents on each wall, and front gable roof. Photograph by Alex Bush for HABS, 1935

airtight so there were no windows and only one door. To keep the fire going and the smoke moving slowly past the meat without overheating it, small vents were installed in brick structures near the eaves; wooden smokehouses usually relied on the natural leakage between weatherboards for ventilation. Meat usually was cured in the smokehouse prior to smoking by placing it in salt in hollowed-out log troughs. Smokehouses were built in a variety of forms, including one- and two-story, brick or frame, with hipped or gabled roofs. Because the smokehouse contained the owner's yearly supply of meat, the keys to it were closely guarded. Today, most extant smokehouses appear to be used for storage.

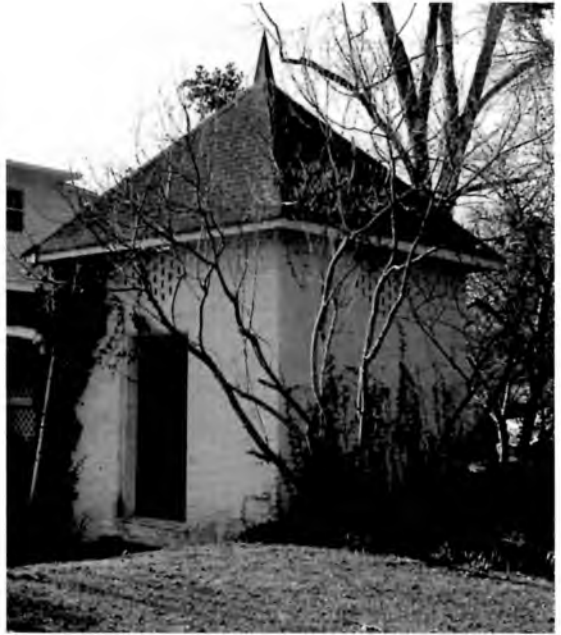
This extant smokehouse behind the house at 609 Adams was constructed in the 1870s, which may account for its reduced proportions. Although the main house was of frame construction, the smokehouse was brick and topped with a pyramidal roof and finial. Photograph by Doug Brewster, 2004

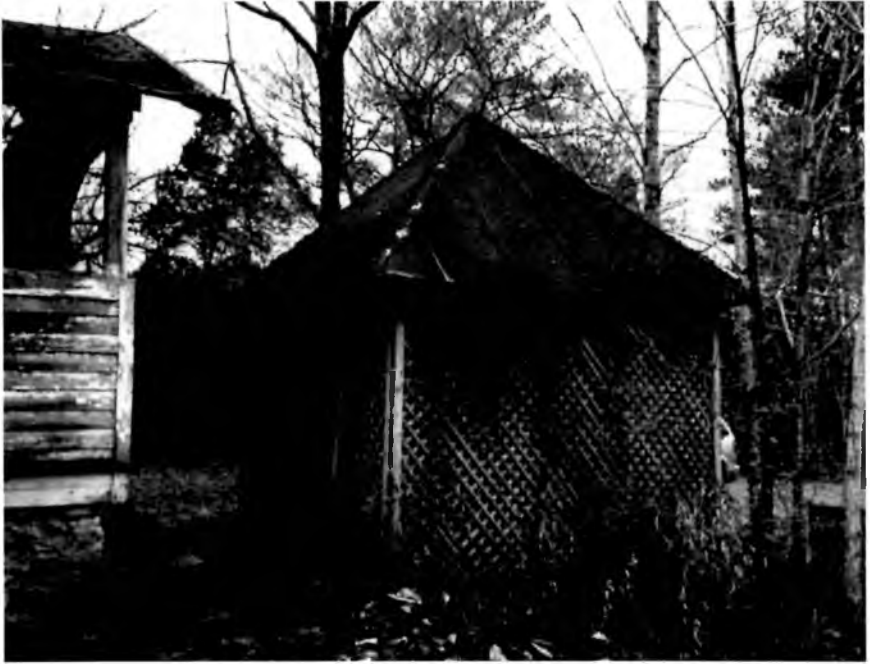
This well house on Jeff Road was located just feet from the kitchen; its square shape, pyramidal roof and latticed walls are characteristic of many such dependencies. It and the house were burned in 2003. Photograph by Linda Allen, 2003

People who could afford the expense had a private well dug on their house lot, which was sometimes supplied with a pump. The well opening usually was surrounded by a three-foot-high wall, either square or round, to prevent people and animals from falling in. A roof, frequently pyramidal, was placed over the well and walls would be left open or filled with lattice. If the well had a pump, it might be located inside the kitchen structure or on a porch; but until the installation of city sewers, all used water still had to be carried back outside for disposal. Surviving well structures today tend to accommodate overflow possessions if they are even partially enclosed.

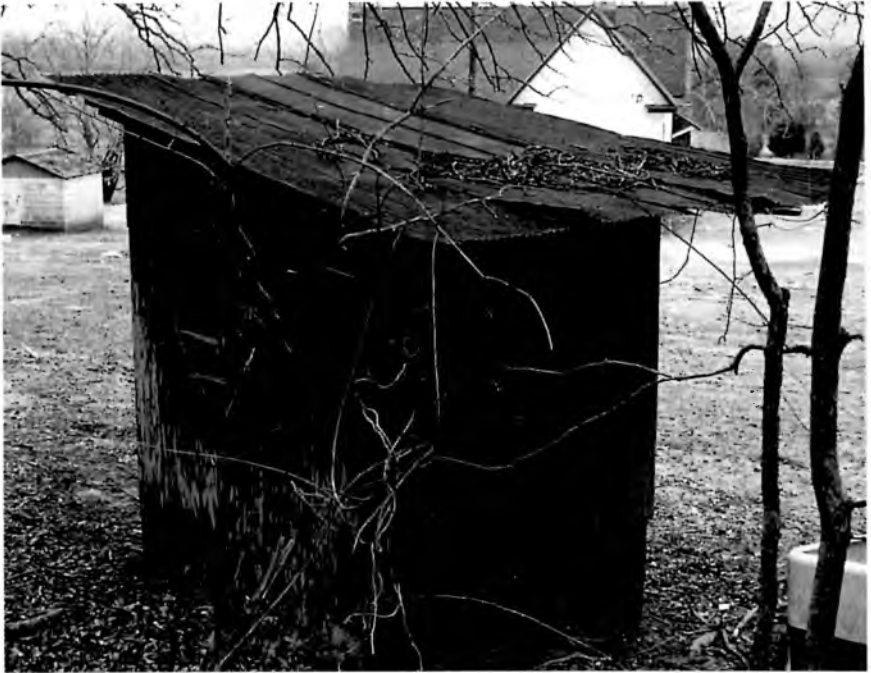
This Jackson County privy, still standing but abandoned, illustrates a primitive example of a necessary house; a sloped roof to keep off rain, one small window for ventilation, and an opening in the bottom of the rear wall to facilitate cleanout. Photograph by Linda Allen, 2005

Cleaning the privy pit was simplified if the structure was easily moved; some had a hinged lower section on the rear wall to facilitate access for emptying, which had to be done regularly. Cities had scavengers who, for a fee, traveled the alleys at night removing and disposing of the privy contents, leading to the term night soil. In the later 19th century, the process could be completed using a hose and pump rather than a shovel. By the late 1890s, the Huntsville City Council became serious about extending both water and sewer lines throughout the city, which greatly enhanced daily life and community health. By 1924, the city code required that all places of residence and employment be provided with a sanitary water closet and that it be connected to a public sewer main. It was a misdemeanor to use a privy not fitted with a catch receptacle, and where no sewer service was available, the owner was billed by the city for weekly cleaning and disinfecting of such receptacle. The code

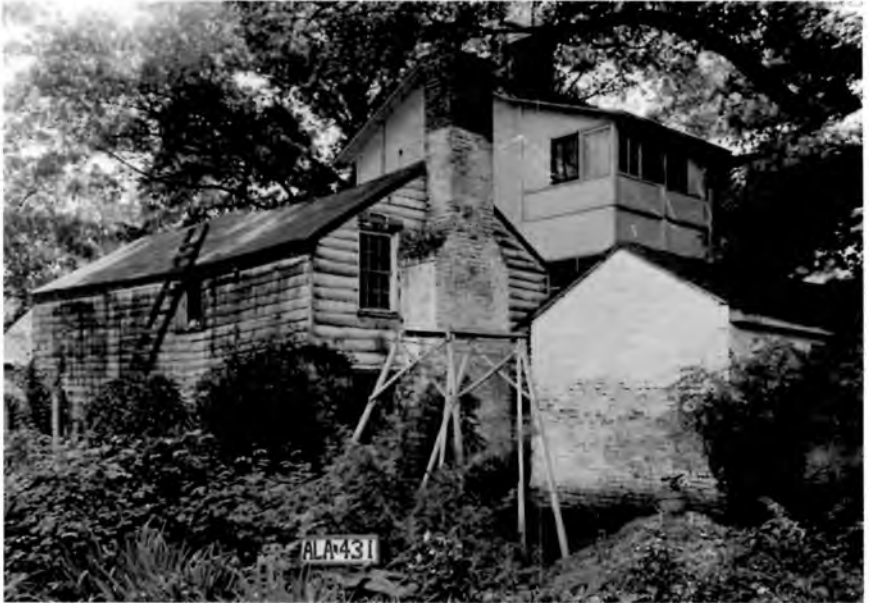
A rear view of the Cabaniss outbuildings as they appeared in 1935. The small brick structure on the right contained the dairy and well house; the larger two-story frame structure was the kitchen, slave quarters, and smokehouse. Demolished. Photograph by Alex Bush for HABS, 1935

The other surviving outbuilding, which sat perpendicular to the larger one, was a combination well house and dairy of one story, the two parts distinguished by differing construction materials. The well house was of frame construction with three latticed walls; in one corner was a rectangular stone trough, used to cool perishable foods. The dairy, which shared the cedar-shingled roof, had brick walls on all sides with access only from the well house. Two 19-inch-tall louvered openings on opposite walls provided ventilation. A second larger trough located on the north wall
