Other Case Histories: A Glimpse of What Was and What has Become

Other Case Histories: A Glimpse of What Was and What Has Become

by
Harvie Jones

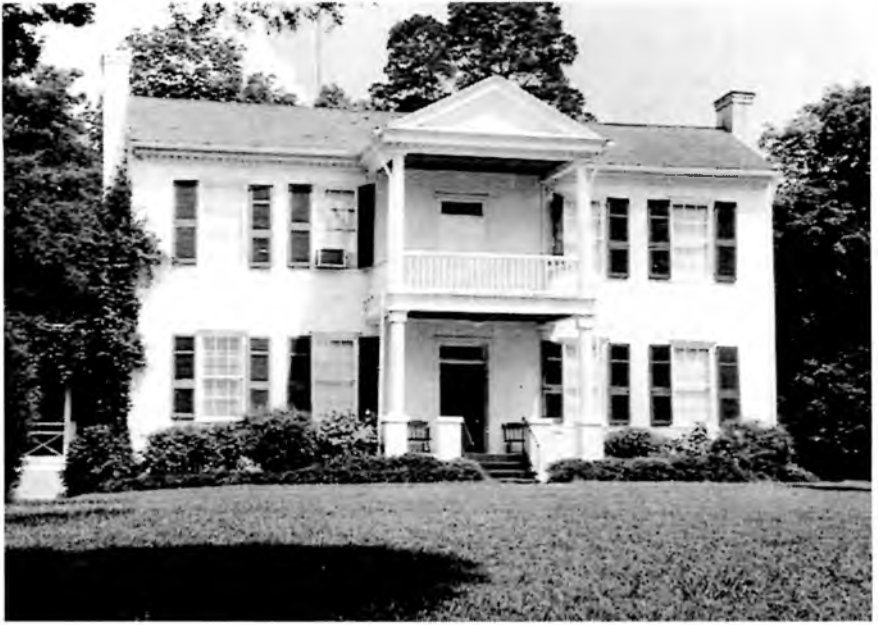
BEFORE Picture taken in 1985.

Cedarhurst originally had a refined double-tier, eight-columned Tuscan-order Palladian style portico as did many country houses of the early 19th century. In the early 20th century, half of the columns were removed (leaving two columns per floor instead of four) and the first floor columns were cut short and mounted on heavy brick piers in an apparent attempt to give the portico a modern bungalow appearance. However, the original interior features were mostly retained.

In 1982, the house and its once-rural surrounding acres were purchased for a townhouse development. The developer wisely chose to retain this fine Federal Period house and restore it as a guesthouse and for social functions for the townhouse residents.

Many developers would have bulldozed such a house without a second thought; and Huntsville is fortunate that we still have this excellent early house, now carefully restored, with its original and beautiful Palladian double-tier Tuscan portico brought back.

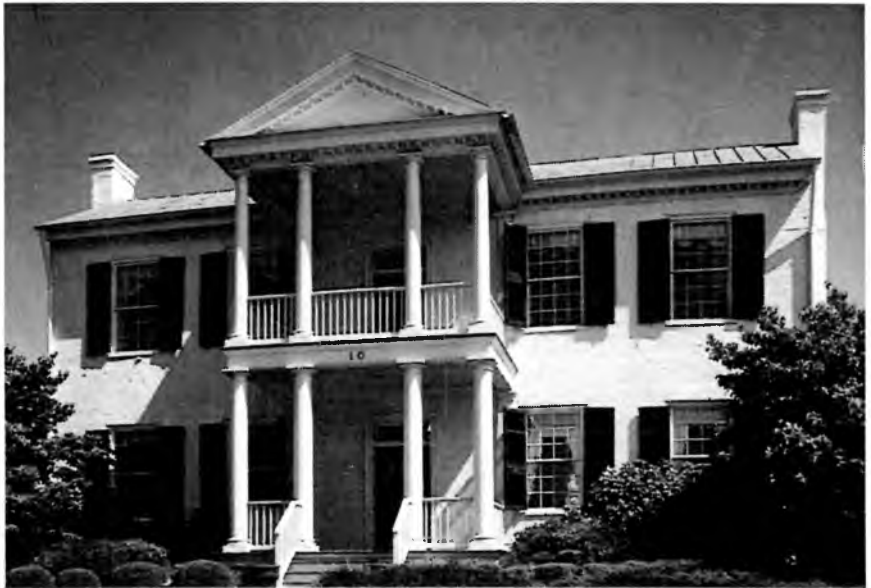
AFTER Picture taken in 1992.

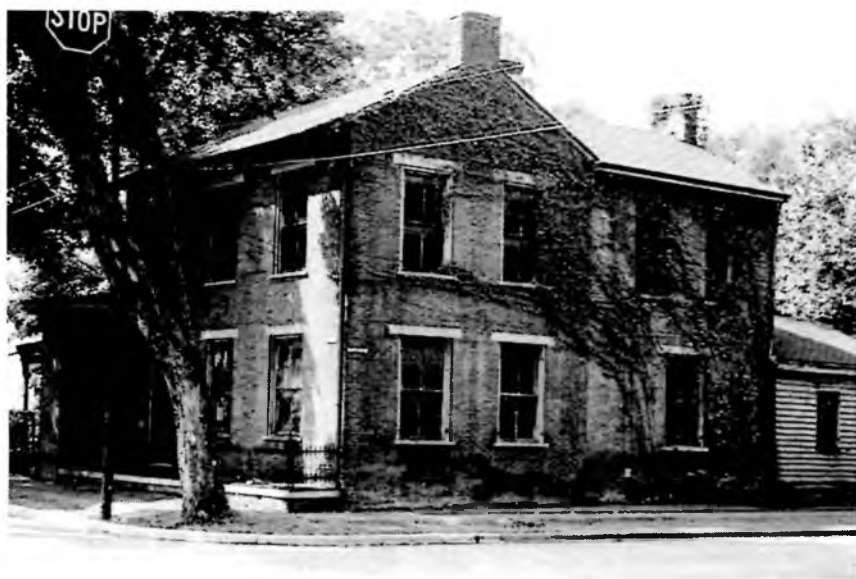
In 1970, the Sprague-Chadwick House had been long empty and in disrepair and was known to local children as “the haunted house.” Its owner offered to donate its bricks to the proposed Constitution Hall Village since it was assumed the late-Federal Period house was of no value. The front porch was rotten and collapsed, windows were broken, paint peeled, etc.

BEFORE Picture taken in 1970.

But, as is usually the case, the derelict appearance was just easily- fixed cosmetics, and the house was extremely sound and intact. The rotted porch was an inappropriate late-Victorian addition and was well-gone. The house was purchased for land-value alone, since the previous owner apparently assumed the house was not worth anything and was then nicely renovated for professional offices. The new owner obtained beautiful and prestigious historic offices for only about two-thirds the cost of a modern-design, new, ordinary office building of the same floor area.

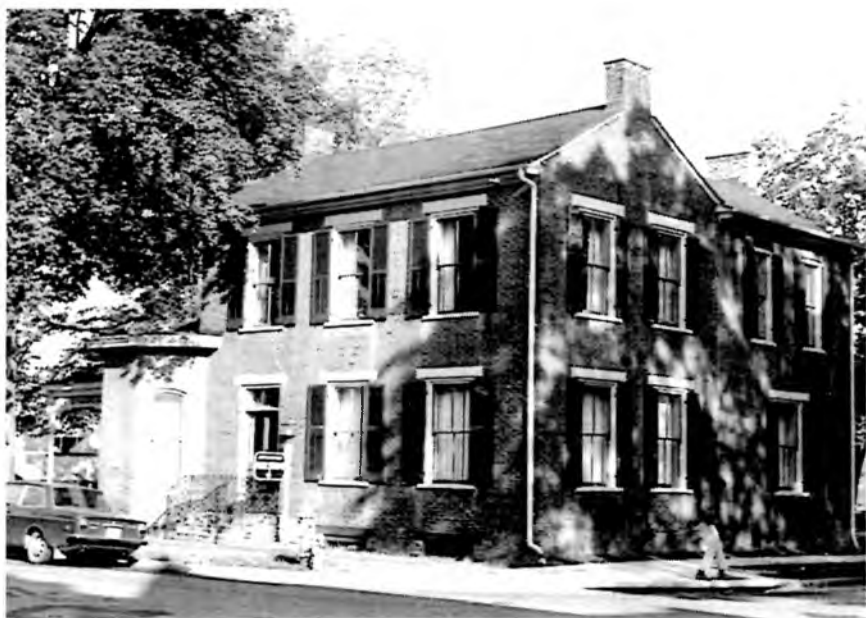
AFTER Picture taken in 1985.

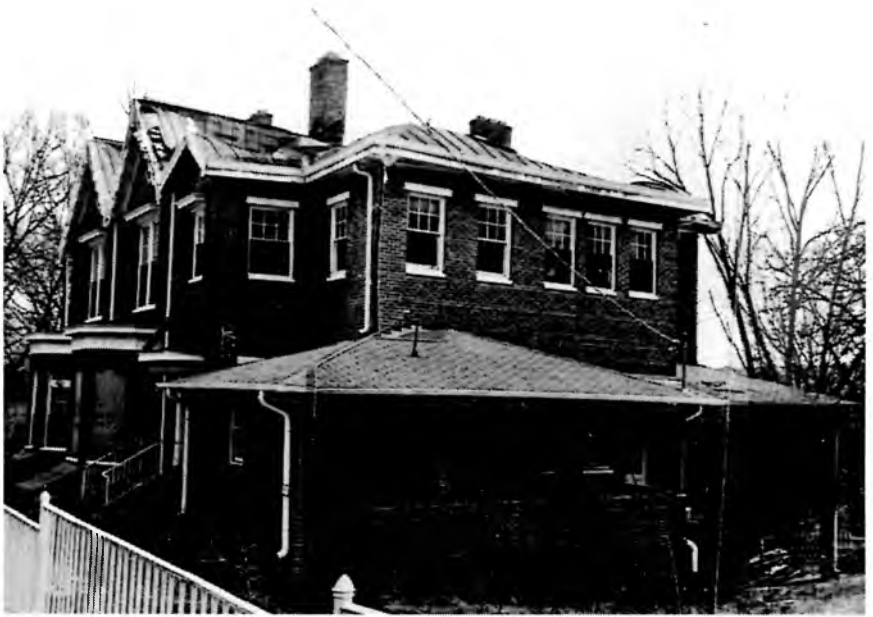
BEFORE Picture taken in 1974.
Includes a 1960s carport and kitchen addition.
(Taken after the 1973 fire.)

The Ward House originally had a tower, as evidenced by the 1871 “Bird’s Eye View” of Huntsville and clear clues on the bobbed-off tower. By 1970, a steel outside stair led to second-floor apartments and the house had been generally cut up in an ad-hoc manner. In 1973, a major fire unroofed the house, and thus it sat until 1974, with no roof, resulting in significant damage to its elaborate decorative plaster. However, since 19th century wood is highly rot-resistant, there was little permanent damage to the framing and flooring.

In 1974, after about two years with no roof, the house was roofed and dried-out. Later in the decade some renovation occurred. Beginning in about 1990, the house was thoroughly restored, including the reconstruction of

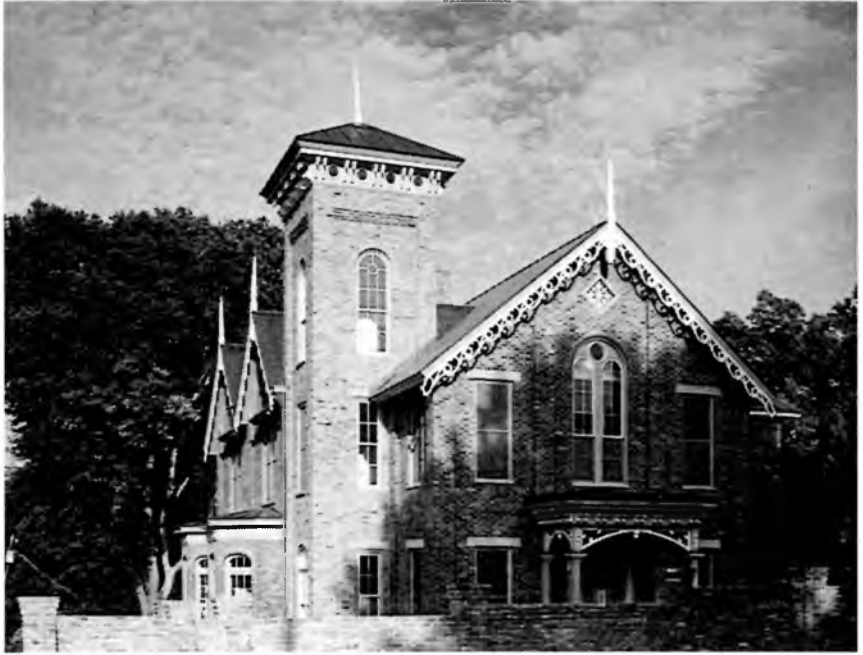
AFTER Picture taken in 1996.

its missing tower, with conjectured details similar to other towers of the mid-19th century. The house is once again a beautiful and historic element in Huntsville's historic districts.

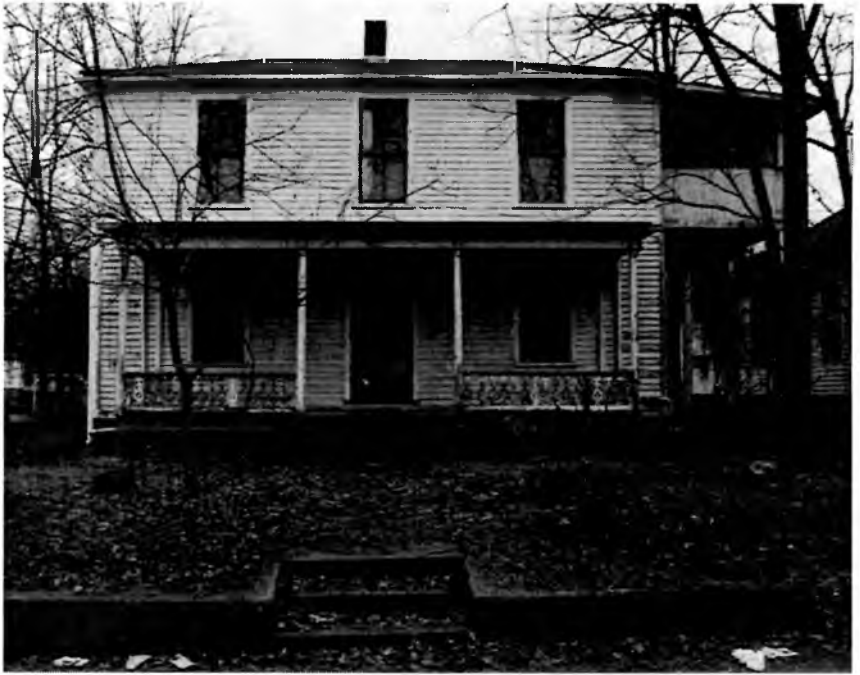
BEFORE Picture taken in 1979.

This late-Victorian house on Walker Avenue was, in 1979, abused and cut into several makeshift apartments. The scroll-brackets at the front porch columns were gone, an awkward second-floor extension on posts projected on the west side, and the house was empty and neglected. The house was purchased for about what the land alone was worth, because its owner thought the historic house was valueless.

The restoration was easy because the fundamental structural and decorative elements were mostly intact and in good technical condition. The restored cost was considerably less than for a new, modern-design house of the same floor area.

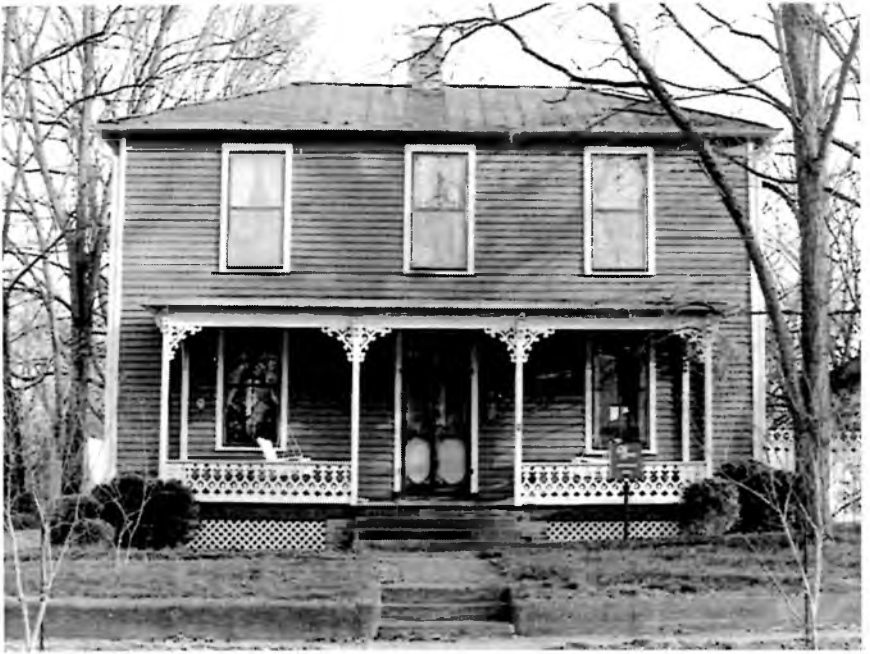
AFTER Picture taken in 1994.
