# The Historic Huntsville Quarterly

Volume 27  
Number 3 *Upon This Rock: A Foundation in  
Stone Construction*

## Modern Examples of Stone Construction: A Pictorial Survey

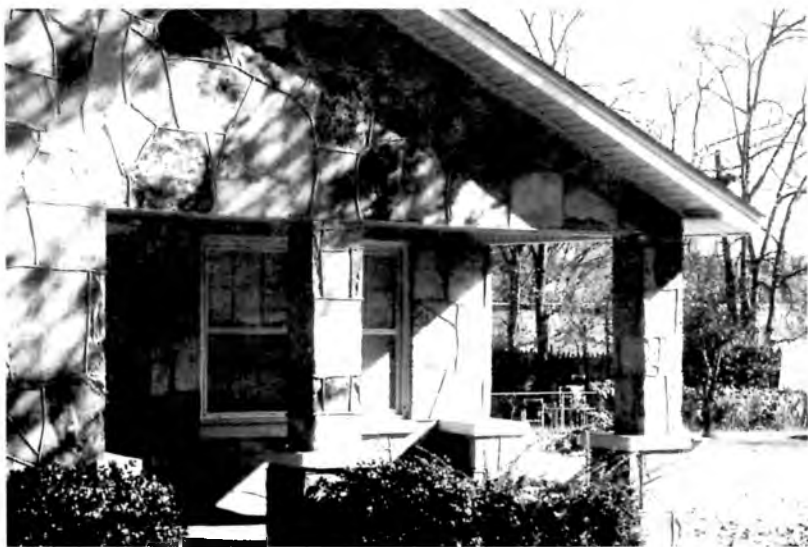
*Kildare Street—The random mosaic facade of this early- to mid-1900s bungalow is apparent due to the shallow recess of the window and door. The long span of the overhang porch is also accomplished with a thin steel plate or beam that is able to bear the weight of the stone veneer. A true stone span would rely on a slight arch to distribute the weight or long stone or reinforced concrete lintels. The perfectly square corners of the posts, the straight courses, and the thickness of the squared ashlar revealed at the corners suggest the stone is just a covering around the true structural members beneath. The mortar joints are raised and beaded, a practice that is mainly decorative and weathers poorly. This home sits directly across the street from “Kildare.”*

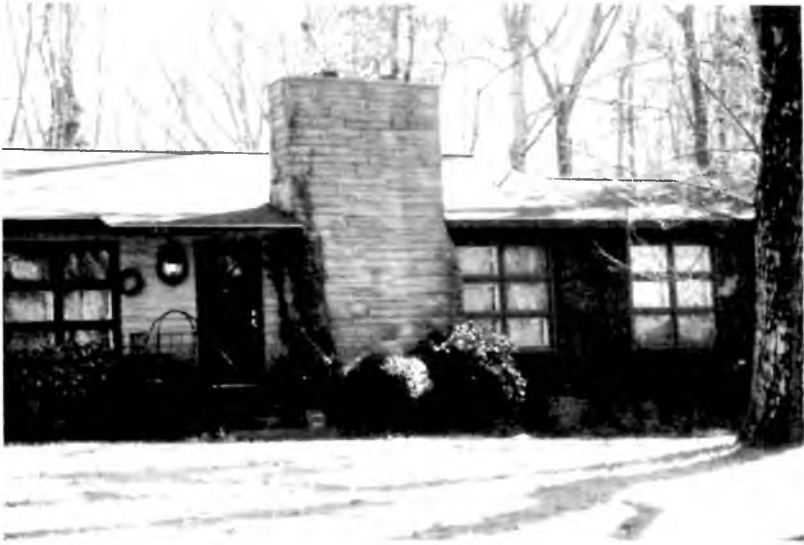
*5409 Panorama—The random broken-coursed ashlar of this ranch is typical of homes from the 1940s through the 1970s. The squat horizontal massing of the chimney is a direct influence of the Prairie School style. This example seems to be actual stone because of the variation in color, even on single stones, and the non-repetitive shapes. A cast concrete ashlar of this type would include similar, if not identical, “irregular” stones within the pattern.*

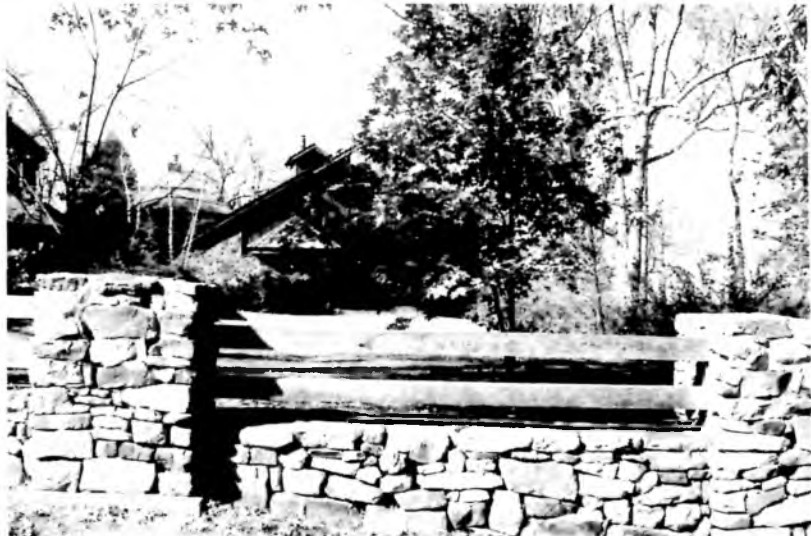
*5510 Panorama—This fence, reconstructed in 2000 from recycled stone on the site, rests on concrete foundations to prevent collapse and incorporates an uncoursed, raked mortar design to give the illusion of a dry-mortar, fieldstone fence. The home behind it shows an applied stone veneer panel.*
