The Historic Huntsville Quarterly

Volume 27
Number 3 *Upon This Rock: A Foundation in
Stone Construction*

THE HISTORIC HUNTSVILLE QUARTERLY OF LOCAL ARCHITECTURE AND PRESERVATION

Stone Construction: A History and Primer

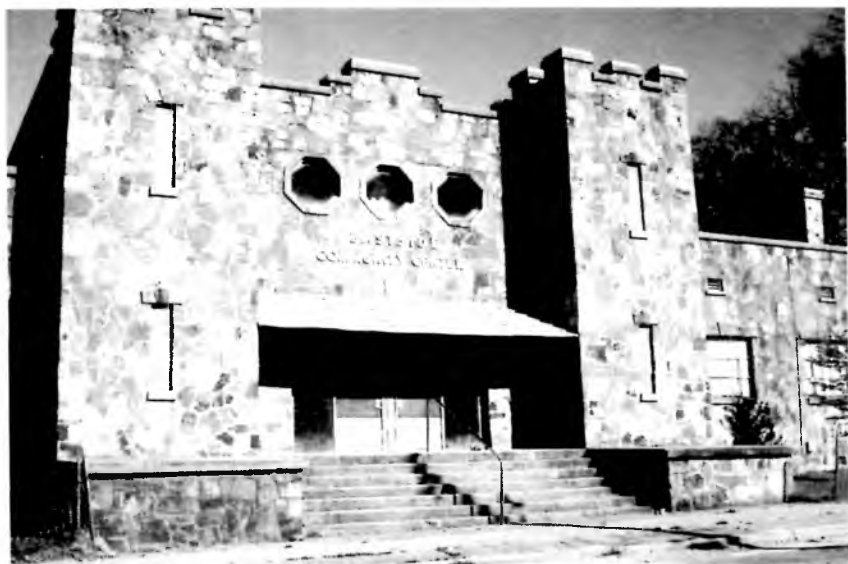
The Eastside Community Center, Old Town—Threatened by road development and expansion, this crenellated, castle-like building is a prime example of uncoursed random stone work used for public buildings in the early 1900s. Repointing and the stone's durability have helped the structure weather many uses.

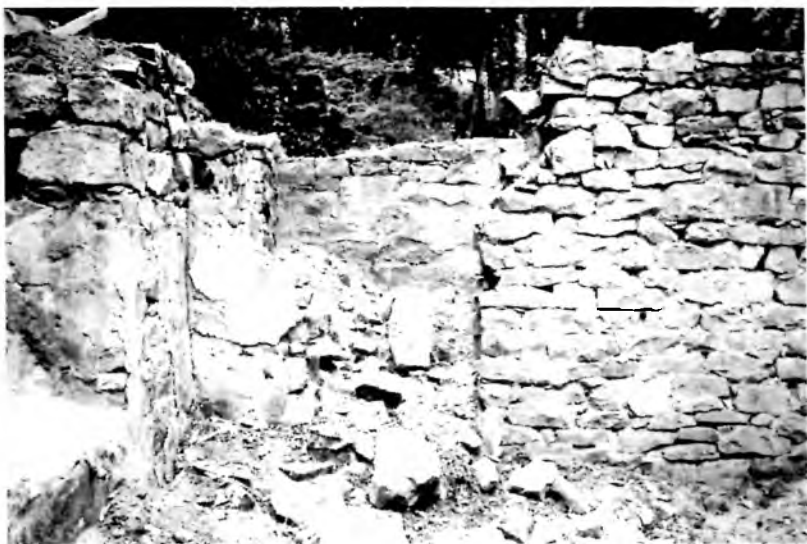
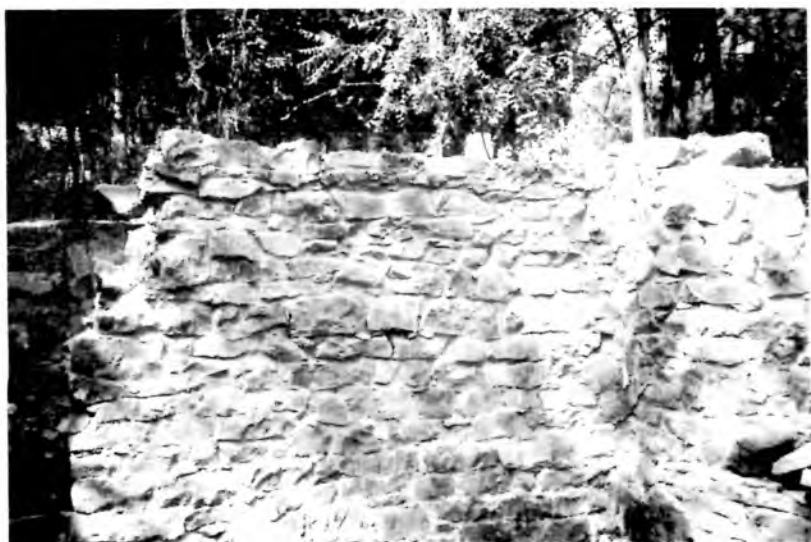
Monte Sano (Chapman) Dairy—The 19th century limestone cooling barn of the dairy sits near a springhouse and bottling barn. Before the Gladstone Place Homeowners Association stabilized the stonework in 1995, the rubble interior of the wall was exposed (top). Stonemason Robert Ervin repointed the walls with a lime-based mortar and constructed a random cement cap to stop further weather deterioration. Photos by Diane Ellis.

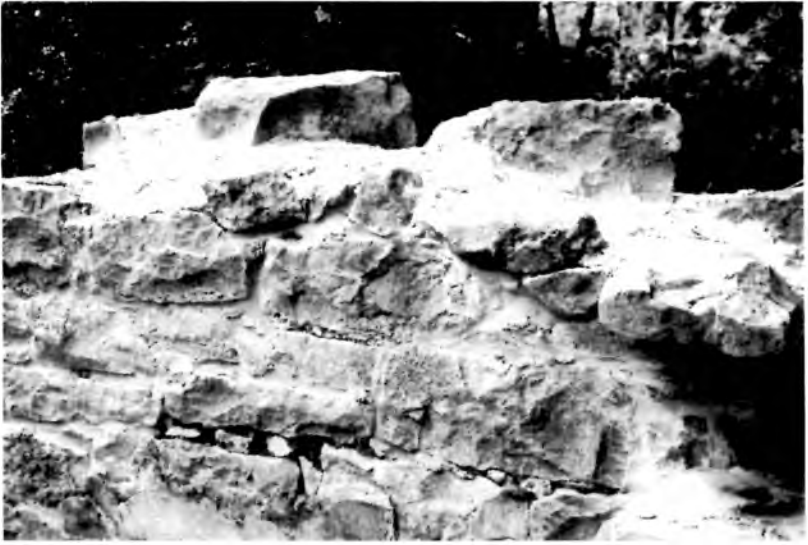
Monte Sano (Chapman) Dairy—The preserved ruins of the roughly-coursed, undressed limestone walls illustrate the vernacular use of stone. The thick stone walls also helped the dairy maintain cool temperatures for their products. Photo by Diane Ellis.

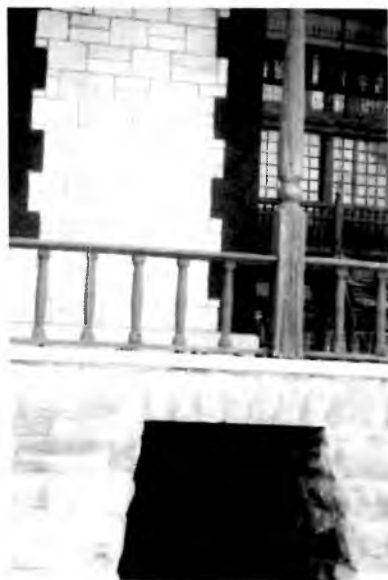
"Kildare"—The O'Shaughnessy home has a foundation of rusticated limestone. The first-floor facade is a combination of a variation on broken range ashlar finished with patent-hammering and painted brick quoins. Photo by H. Cross.

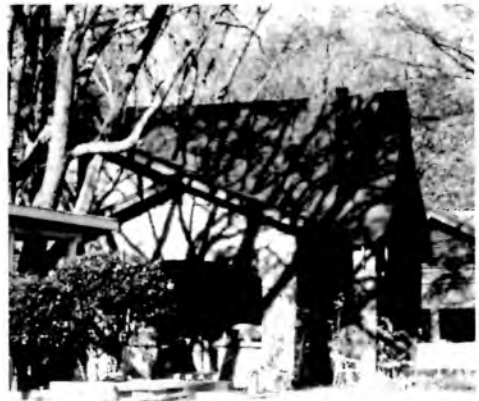
Stone bungalow along Oakwood Drive—Low heavy arches of porch and unraised foundation maintain a connection to the earth appreciated by Arts and Crafts builders. Photo by H. Cross.

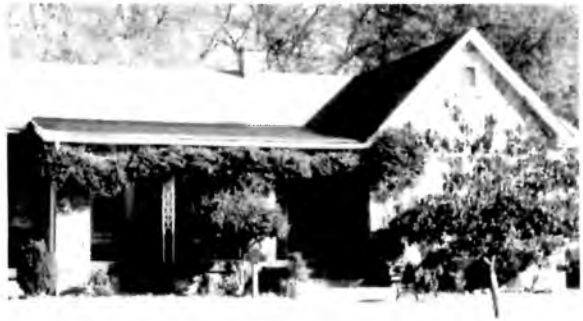
2335 Brandon—A later stone bungalow which incorporates broken range and random range ashlar as well as brick around wall openings and tile on the porch and stairs. Photo by H. Cross.

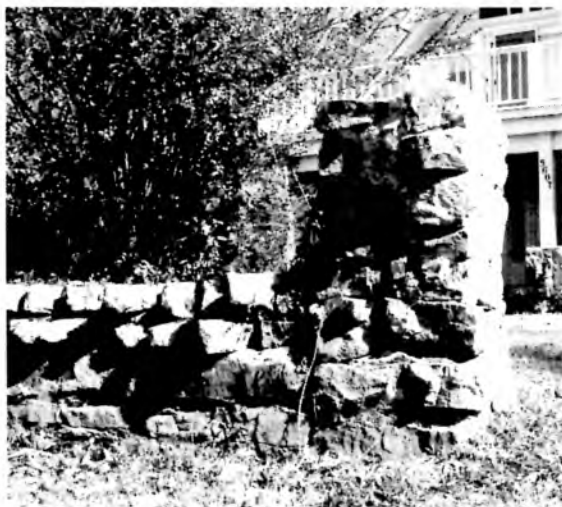
5607 Panorama—This rubblework fence in front of a stone/frame house incorporates found shapes as well as stone roughly cut for the top two courses of jagged, pointed projections.

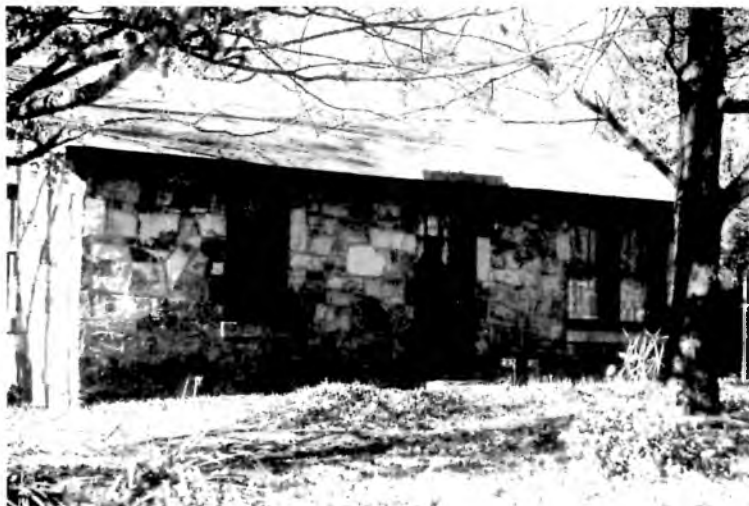
3618 Fearn—Random range rubblework on a solid stone wall home. The stone window sills are sloped away from the window and contain a drip edge (a shallow groove underneath the front edge) so that water drips to the ground instead of running back toward the stone where it can wear away mortar. Photo by H. Cross.

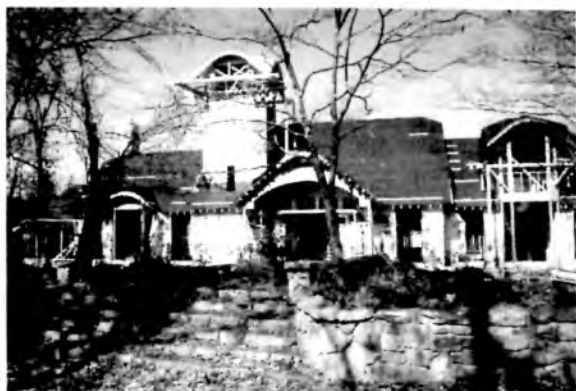
3021 Panorama—Stone steps and wall surrounding the patio from the Pierce house as they exist today. New construction of a frame home sits behind the stone structure. Photo by H. Cross.

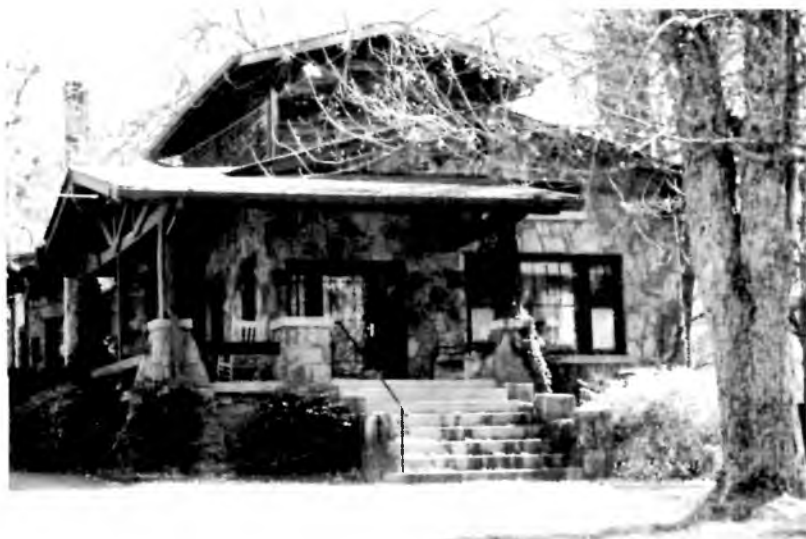
1711 Monte Sano Blvd.—The Orendorff home is an Arts and Crafts two-story stone and wood structure that incorporates random range ashlar on the main home and rubblework with slight coursing for the piers that support the porch and front steps. Photo by H. Cross.

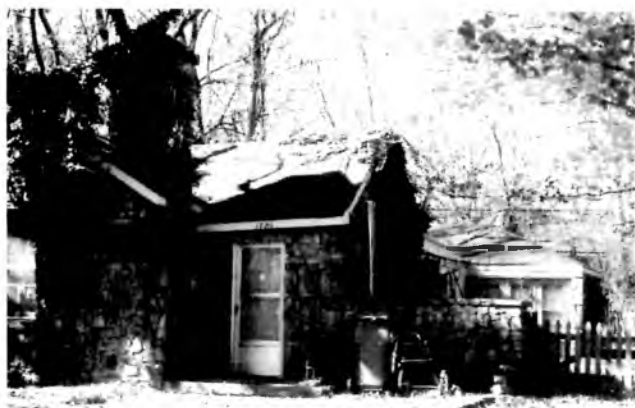
1726 Monte Sano Blvd.—The Judd home displays rubblework with thick, irregular mortar as well as rough stone window sills and lintels. Also note the flagstone path from the front door. The tile roof no longer exists and evidence of modern plumbing can be seen to the right of the door. Photo by H. Cross.

Another notable survivor is the S.W. Judd home, an Arts and Crafts/Craftsman-style stone dwelling situated at 1733 Monte Sano Blvd. A Tennessee native, Searcy Judd was a professional photographer and a widower who came to Huntsville in 1903. He built his stone retreat on Monte Sano almost entirely by himself on weekends in the years that followed, and completed it in the late 1920s.

The one-story horizontal design was intended to blend into the land, neatly integrating the home with the surrounding woodlands. The

home had a tiled roof and sash windows. While its interior—including informal room arrangements and a rough, stone-faced fireplace—seems in

keeping with Judd's widower status, he was a stickler for detail to the exterior's Arts

and Crafts style: a long gable to cover the side porch, stone accents carried over to the steps, terraces and garden walls, and ornate wrought iron topping the low stone wall that fronted the property. Though the back part of the structure was lost to fire in the middle part of the century and had to be rebuilt, the tornado that ripped through the property in 1974 and felled nearly every tree in sight did only very minor damage to the Judd home—attesting to the strength and durability of its stone construction.

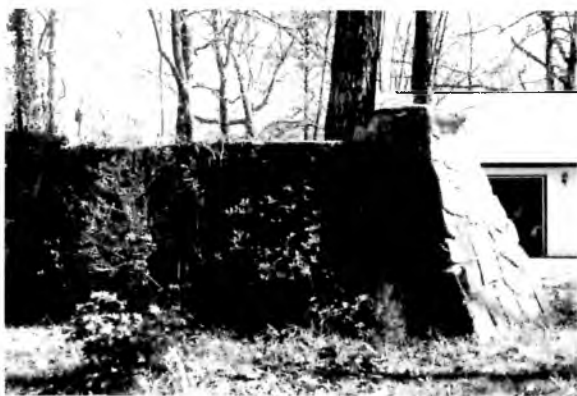
The CCCorps camp wall—Composed of stone piers with a stone wall between, the wall flanks the intersection of Highland and Monte Sano Blvd. The wall contains stone that has been surface dressed to maintain the slope of the piers but otherwise left in irregular shapes. Photo by H. Cross.

The Corps also erected the low stone wall at the camp's entrance, which—like the cabins—remains intact to this day. In addition, they erected a one-story stone structure with ell projections and gables that would originally serve the Corps as a lodge and tavern and later would become a home for the park rangers. This

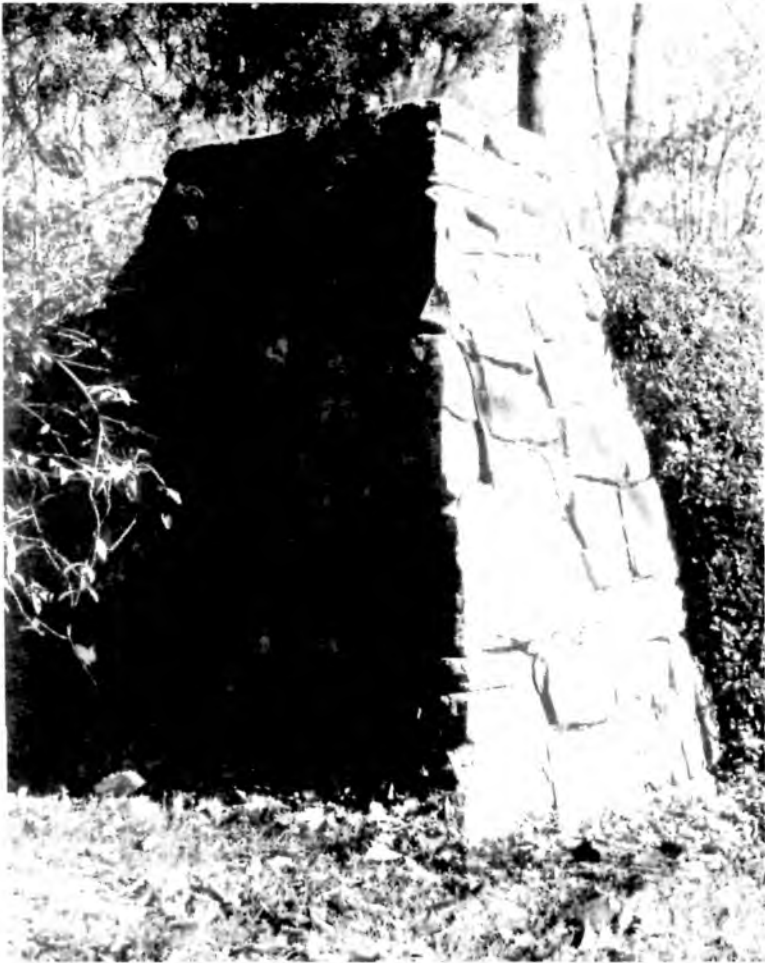
Civilian Conservation Corps Camp Wall—Corner of Highland and Monte Sano Blvd. camp wall pier. Photo by H. Cross.

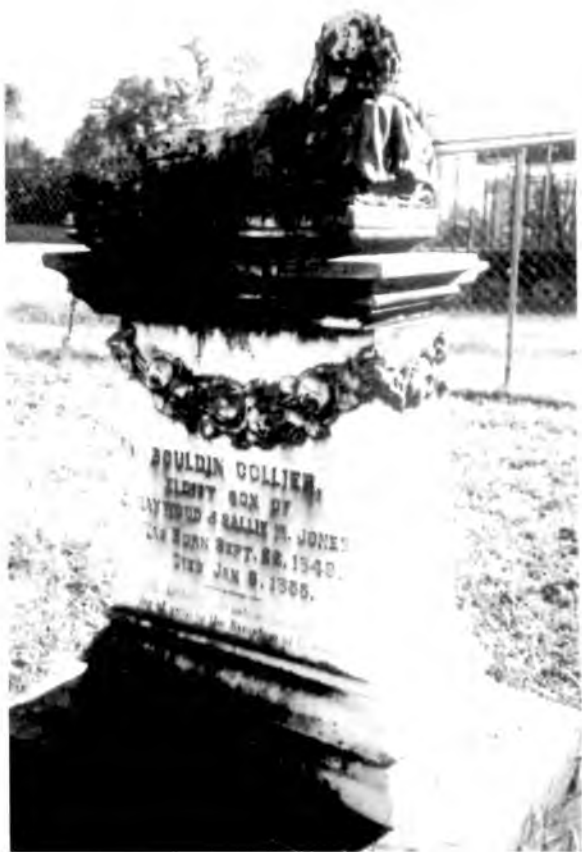
Headstone of Bouldin Collier—Signed by the A.A. Baker marble yard, this example of carved white limestone illustrates the ability of the material to withstand weathering and pollution.

One example of the A. A. Baker Marble Yard's work is found in the Jones-Donnell family cemetery in a cotton field in Greenbrier, AL. The stone was erected for five-year-old Bouldin Collier Jones, who died in January 1855. The child

was the son of John Haywood Jones and his wife Sallie of Athens. The memorial consists of a reclining child on a carved cloth-draped pillow atop a platform raised above the stone's molding capital. The concave and convex series of cove molding designs show the delicate and geometric carving skills of the mason. These elements were designed to allow shadow and light to delineate the strong horizontals in contrast to the vertical stone and the more organic forms of the child. A garland of intricately detailed flowers and leaves crowns the face and sides of the stone. The white limestone has collected permanent shadows of grime and the crisp edges are slightly weathered. The lettering however, is still deeply etched into the surface—even the misspelled “eldist.” The monument bears the signature “A. A. Baker, H. V. Ala.”

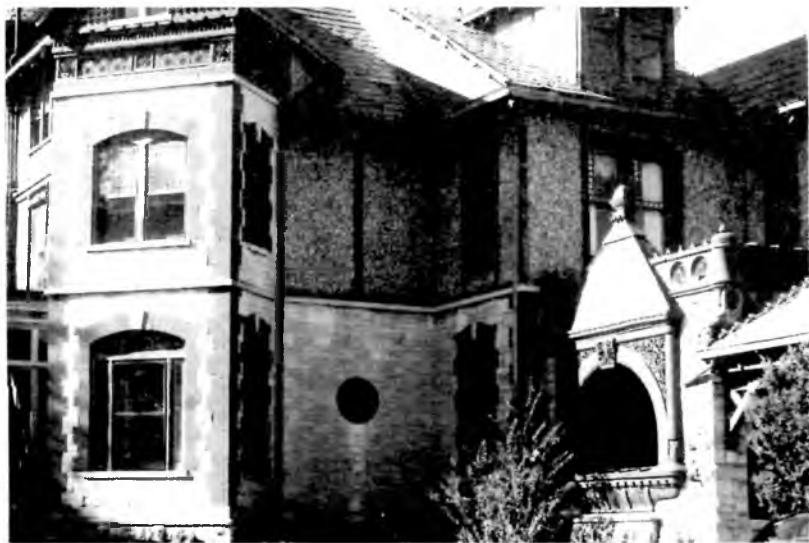
Kildare—The O'Shaughnessy home displays a rusticated foundation and porte cochere piers, dressed ashlar with painted brick quoins, carved stone details around peaks, and a slate roof. The third floor facade is composed of stucco and pebbles. Photo by H. Cross.

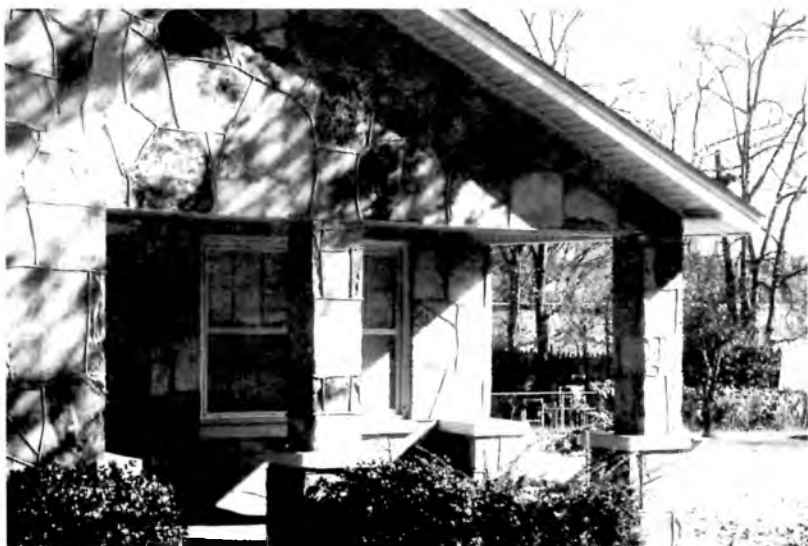
Kildare Street—The random mosaic facade of this early- to mid-1900s bungalow is apparent due to the shallow recess of the window and door. The long span of the overhang porch is also accomplished with a thin steel plate or beam that is able to bear the weight of the stone veneer. A true stone span would rely on a slight arch to distribute the weight or long stone or reinforced concrete lintels. The perfectly square corners of the posts, the straight courses, and the thickness of the squared ashlar revealed at the corners suggest the stone is just a covering around the true structural members beneath. The mortar joints are raised and beaded, a practice that is mainly decorative and weathers poorly. This home sits directly across the street from “Kildare.”

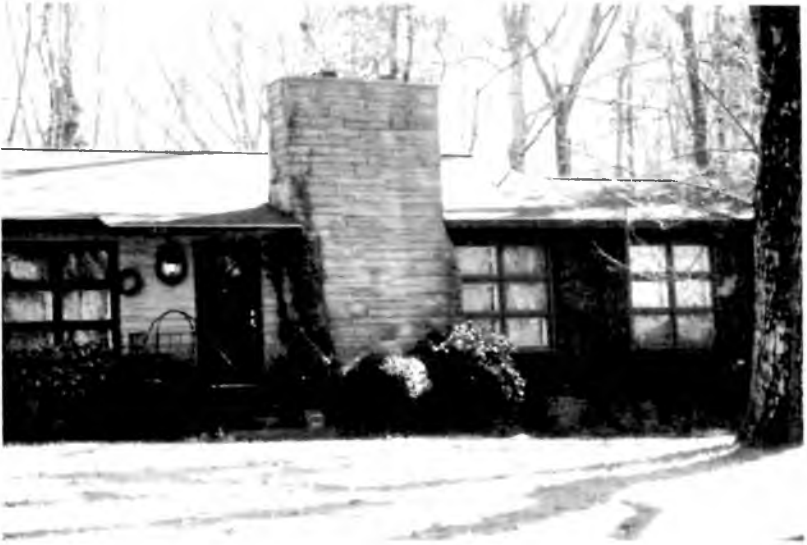
5409 Panorama—The random broken-coursed ashlar of this ranch is typical of homes from the 1940s through the 1970s. The squat horizontal massing of the chimney is a direct influence of the Prairie School style. This example seems to be actual stone because of the variation in color, even on single stones, and the non-repetive shapes. A cast concrete ashlar of this type would include similar, if not identical, “irregular” stones within the pattern.

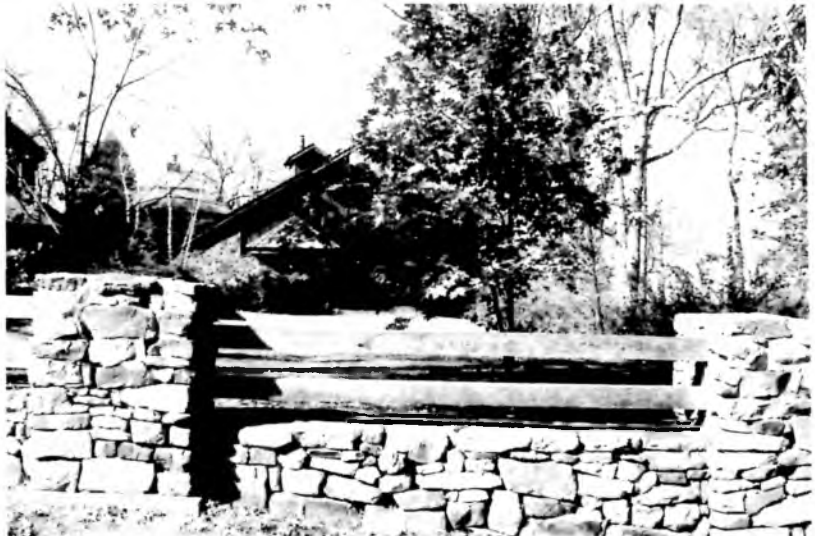
5510 Panorama—This fence, reconstructed in 2000 from recycled stone on the site, rests on concrete foundations to prevent collapse and incorporates an uncoursed, raked mortar design to give the illusion of a dry-mortar, fieldstone fence. The home behind it shows an applied stone veneer panel.
