Volume 28  
Number 1 *A Model Restoration: The 1887  
Goldsmith-Donovan House*

## Joe Watson's Restoration of the 1887 Goldsmith-Donovan House

Joe was restoring the 1887 Goldsmith-Donovan house (See fig. 1, page 13), at 506 Franklin Street in the Twickenham Historic District. He planned to restore the house, then sell it to finance long trips to South America and Bhutan, Tibet, and other remote areas of Asia.

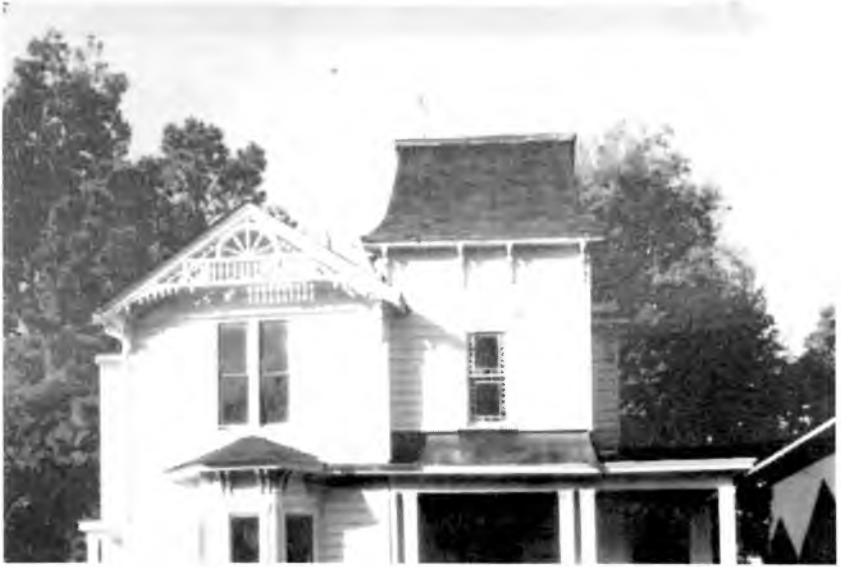
*Note: All photographs are by Harvie P. Jones, FAIA. Courtesy of Lynn Jones.  
Figure 1: East front, Goldsmith-Donovan House, as it looked in 1996.*

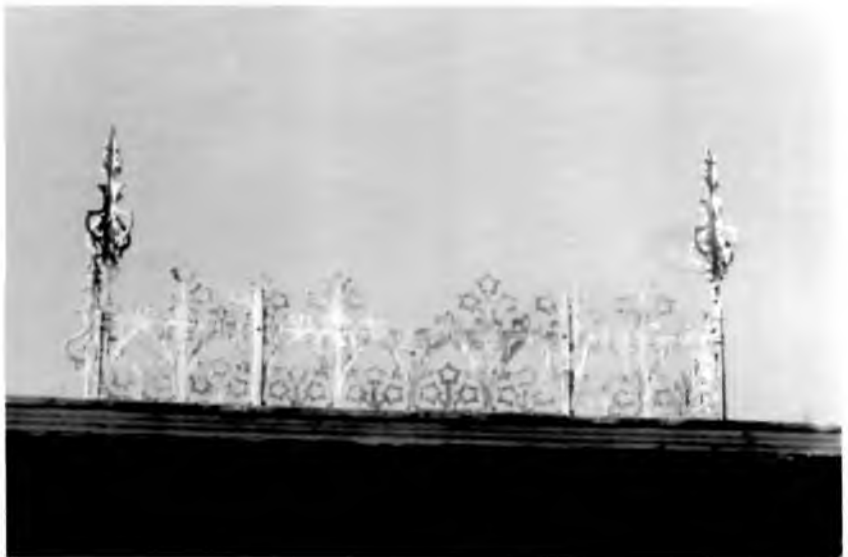
*Figure 2: Metal cresting, tower. Goldsmith-Donovan House in 1996. Behind the finial at the right, a finial is missing.*

The gable's gingerbread ornament was rotten, held together only by the paint. It would have been prohibitively expensive to restore it, so Joe contented himself with a plain gable. The ironwork cresting at the top of the tower was in good condition. It was removed and bead-blasted to remove old paint, then repainted. Only one finial was missing. Joe had it duplicated and replaced.

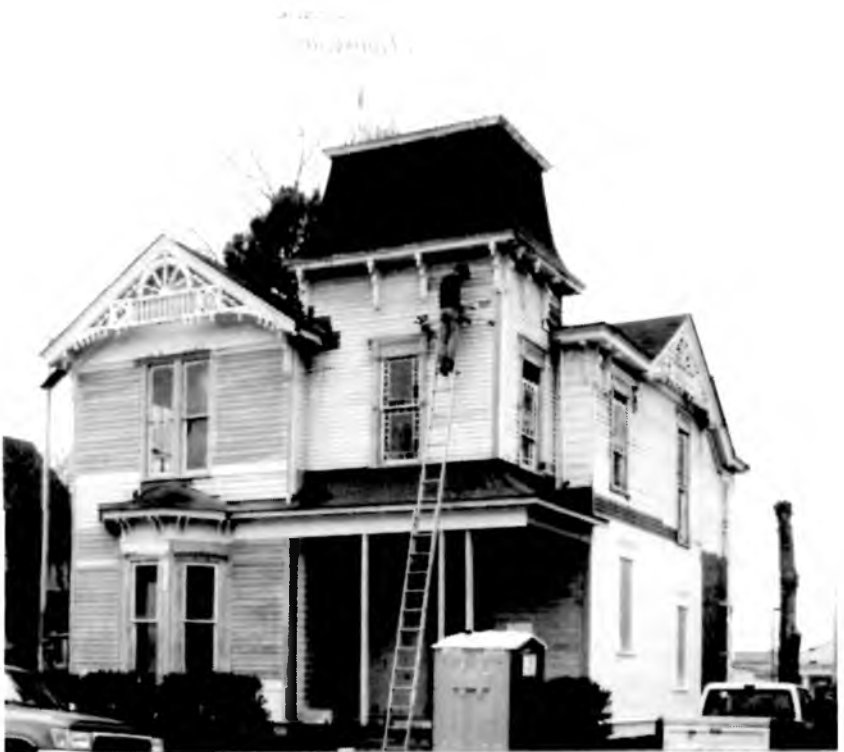
The next step was to repair the roof, making the house watertight: a necessary step before interior work was done. Then he started removing the siding (See fig.3, page 14) and assessing the house's exterior ornamentation.

*Figure 3: East front, Goldsmith-Donovan House, during restoration, December 1997. Joe Watson is atop the ladder:*

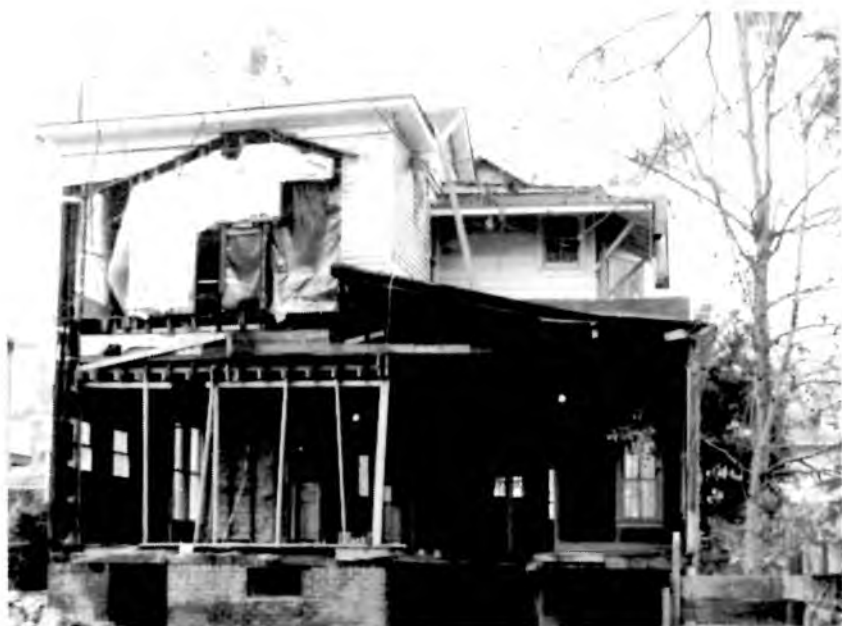
When Joe acquired the property, a later addition jutted west from the back of the house. It was in poor shape and made of poor materials (in his notes on the Goldsmith house restoration, Harvie Jones noted it as a "makeshift addition"). The Huntsville Historic Preservation Commission approved a request to remove it (See fig.4, page 16). It was replaced with an addition, based on a sketch by Harvie Jones, that provided more living space on the ground floor.

*Figure 4: West rear during 1997 restoration, after removal of “makeshift addition.”*

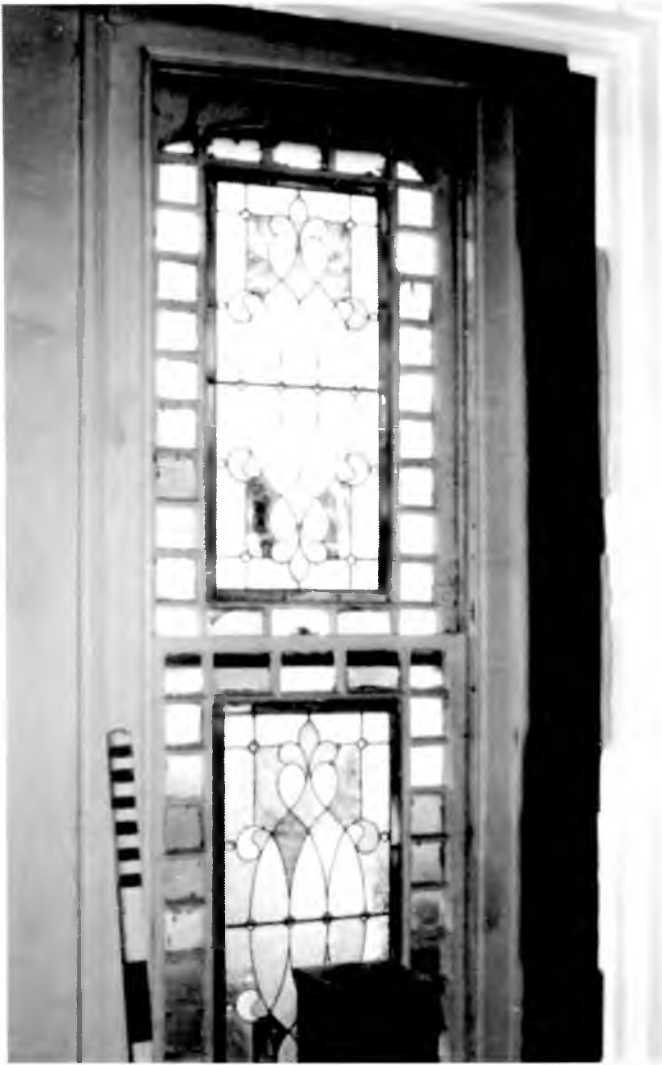
The house’s hardwood floors and woodwork (mostly walnut and oak) were in good condition. However, much of the woodwork had been overpainted, as seen on the molding of the stained glass window (See fig.5, page 18) at the top of the elaborate staircase. The staircase itself had been overpainted in black and white (See figs.6-7, pages 19, 20). The floors were redone by a friend, but Joe himself stripped “acres of paint” from the old hardwood staircase, mantels and trim (See fig.8, page 21.)

*Figure 5: Original stained glass window at top of staircase, December 1996.*

Joe soon learned to use exactly the right amount of heat from a heat gun so that he could strip the old paint in long sheets from the wooden surfaces. Under the white-painted mantels was fine walnut and oak, originally surfaced with shellac to give a sheen and make cleaning easy. The shellac layer was a bit of luck, for it was resistant to paint removers and the heat gun, so that Joe had a useful stopping point for his removal efforts.

Once the old paint was gone, Joe removed the shellac with denatured alcohol. When all surfaces were clean, he oiled the wood, using his own mixture. The staircase was particularly responsive to his procedures and is now, in Joe’s view, “the most spectacular staircase in Huntsville.” In all, Joe estimates that he spent about seventy hours a week, for two and one-half years, restoring the Goldsmith house. “All the people who worked on the house were my friends, from the guy who did the floors to the friend who helped me put up the dry wall.” In addition Joe spent many hours talking with Harvie Jones about the project, its progress and its challenges.

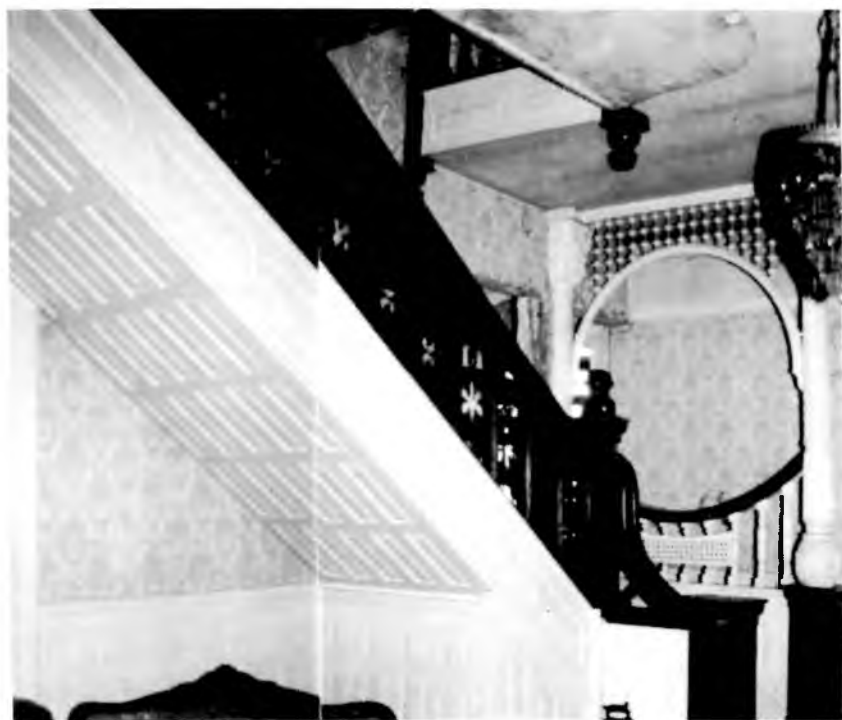
*Figure 6: Entry hall before renovation. Note black and white paint on staircase.*

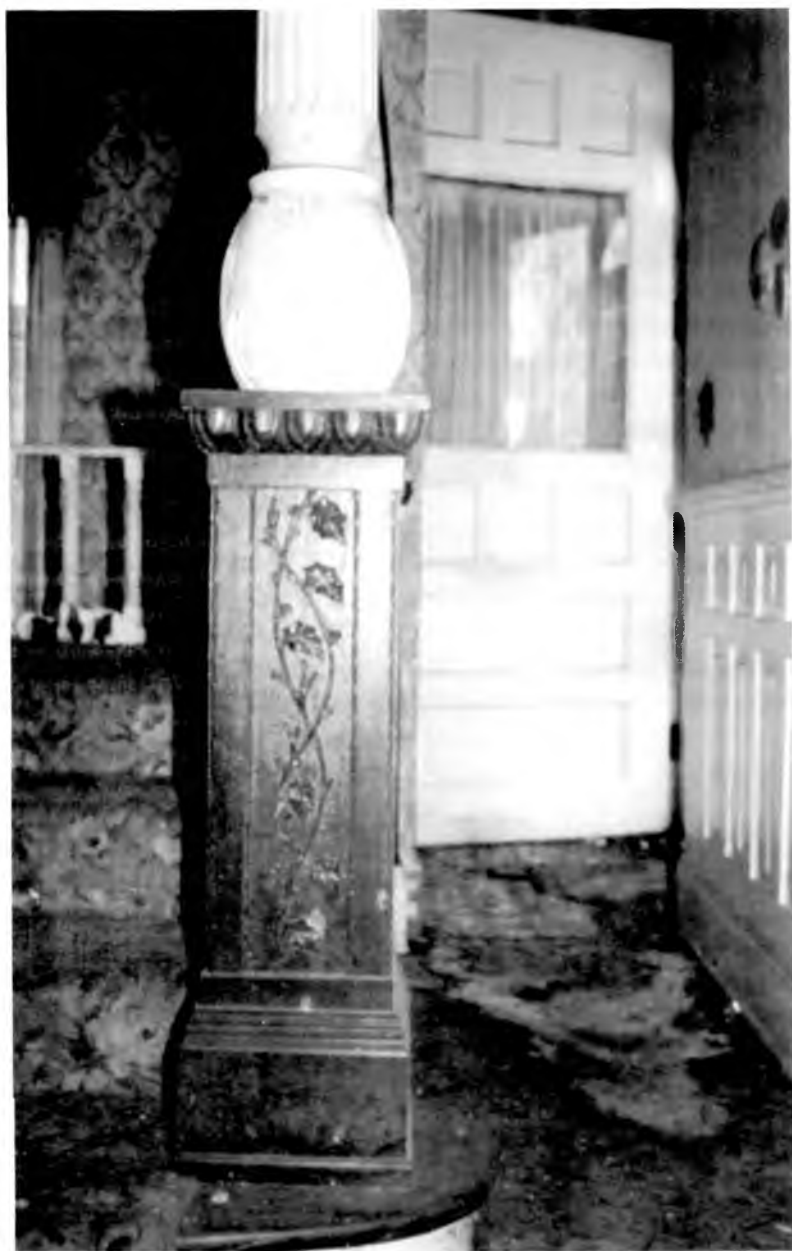
*Figure 7: Detail of staircase, December 1996, before removal of black and white paint.*

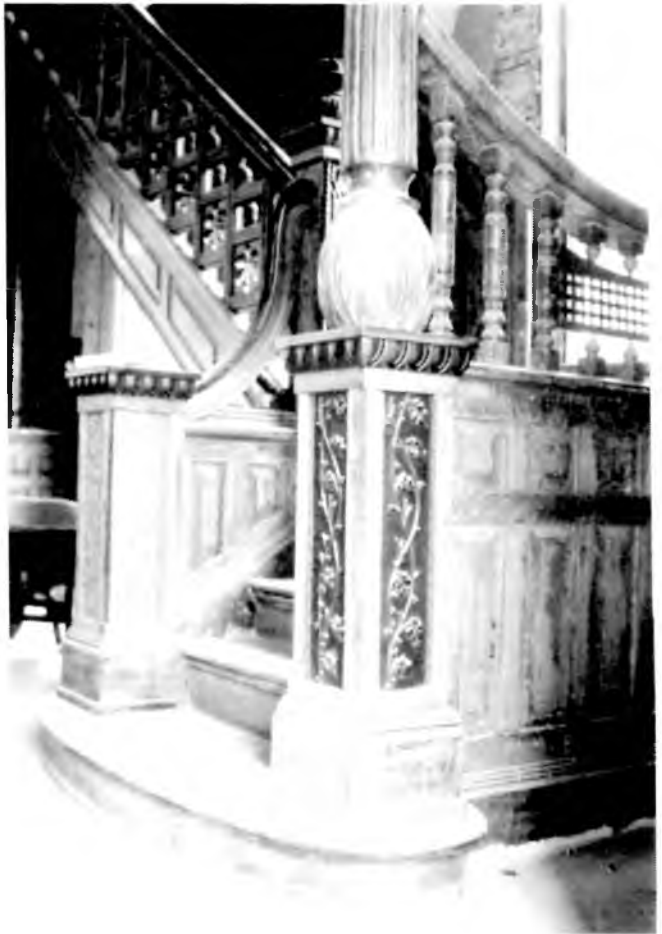
*Figure 8: Staircase during cleaning, December 1997. Some of the black paint remains.*
