Volume 30
Number 3 *The Russel Erskine Hotel*

The New Russel Erskine

MIKE HOLBROOK

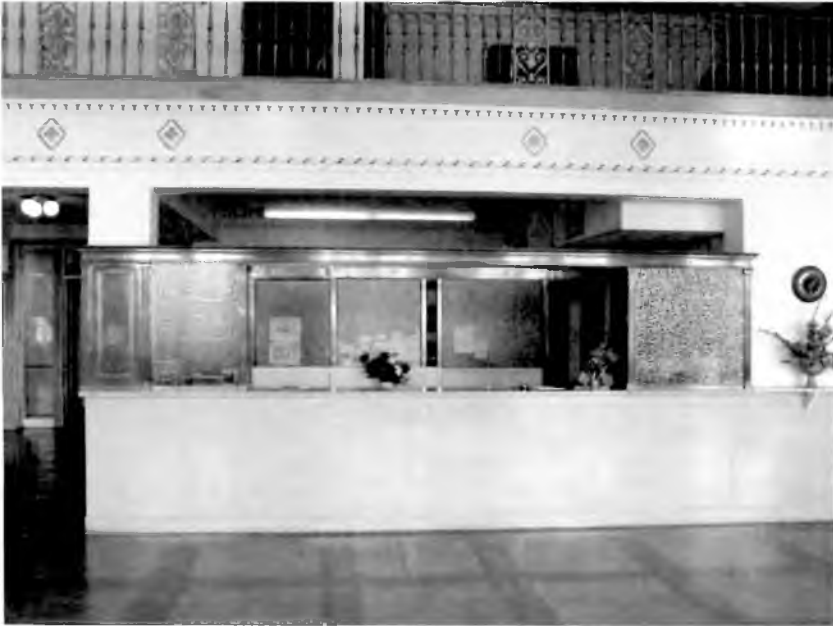
Front desk west elevation, 2004. Courtesy Fuqua Osborn Architects

Once work is complete in the tower, the main and ground floors will be vacant for the final work, which involves not only rehabilitation of the remaining living units but the restoration of the historic lobby and ballroom. Fortunately, these areas survived the previous renovation with few changes (most of which are easily reversible), such as the inappropriate doors and glass installed at the front desk and the ballroom entrance, and the off-the-shelf replacement light fixtures that are inappropriate for such a grand space. The original decorative finish on the classical plaster moldings was covered with a coat of paint that obscured the detail. The current rehabilitation calls for some of the decorative painting on the ornate plaster moldings to be restored, the front desk glass to be replaced with period appropriate glass, the ballroom doors
